ARCHITECTURAL INTENSIVE INVESTIGATIONS

D.C. TO RICHMOND SOUTHEAST HIGH SPEED RAIL

Architectural Intensive Investigations for the Washington, D.C. to Richmond Southeast High Speed Rail (DC2RVA) Project

DHR #2014-0666

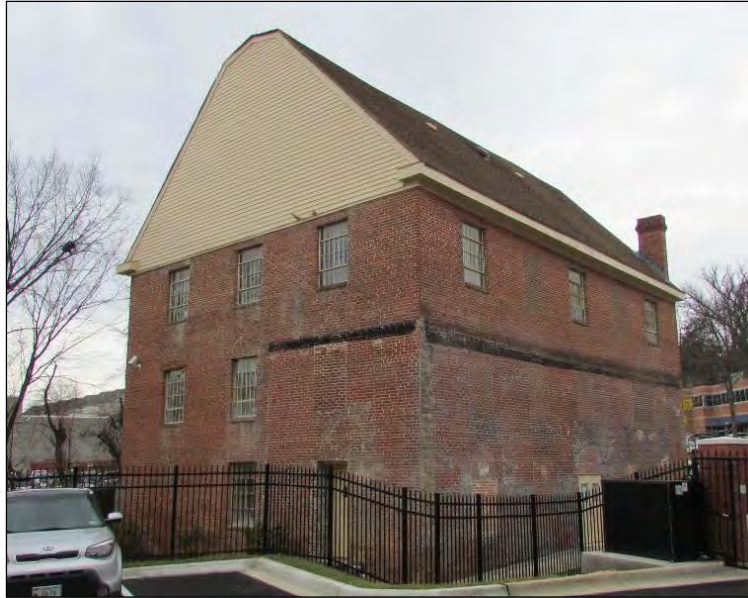
FIGURE 3-10: SOUTHEAST OBLIQUE

The primary entrance, centered on the façade (north elevation), is filled with a double-leaf, metal, paneled door with a single light with decorative overhead track wooden sliding doors. A wood lintel is situated above the entry. Other fenestration includes twentieth-century, metal-frame windows consisting of a 12-light, hopper window with six-light, fixed windows set above and below (Figure 3-9). All windows feature brick sills composed of headers. Ghosts of window openings are visible on what is now the first floor of the east elevation. A set of rounded brick steps provide access to the primary entrance. A one-story addition at one time extended from the east and south elevations of the building but was demolished circa 2016 (Nationwide Environmental Title Research [NETR] 2016). A scar from the former addition is visible between the first and second stories (Figure 3-10).

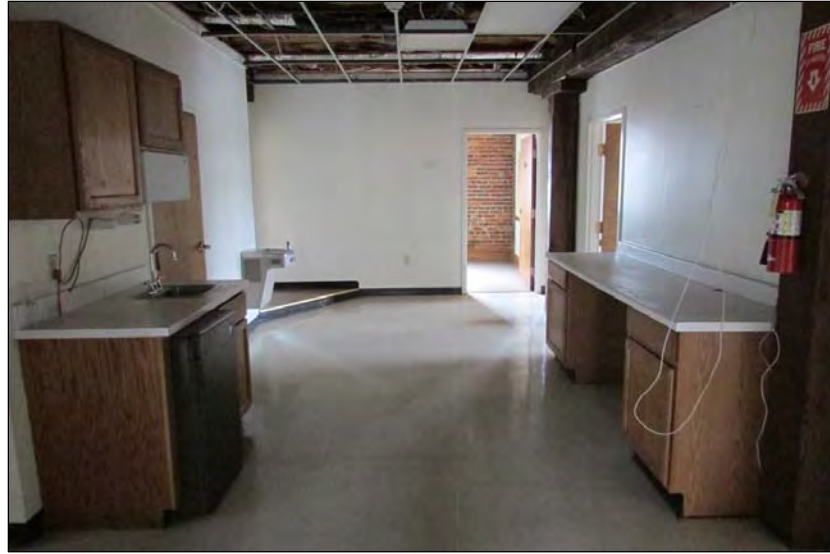
FIGURE 3-14: SECOND STORY INTERIOR, FACING SOUTH

Access to the basement and second story is provided through a partially enclosed, drywalled stairwell, centrally located on the eastern wall. The interior of the second story has been partitioned into offices with drywall inserted between the support posts up to the joists, creating nine rooms around a central common space (Figures 3-13 and 3-14). It has a drop ceiling; the panels were mostly absent and the ceiling rafters and wiring are exposed. Interior brick walls are exposed along the north, east, south, and west interior elevations. All interior fixtures on the second story are modern.

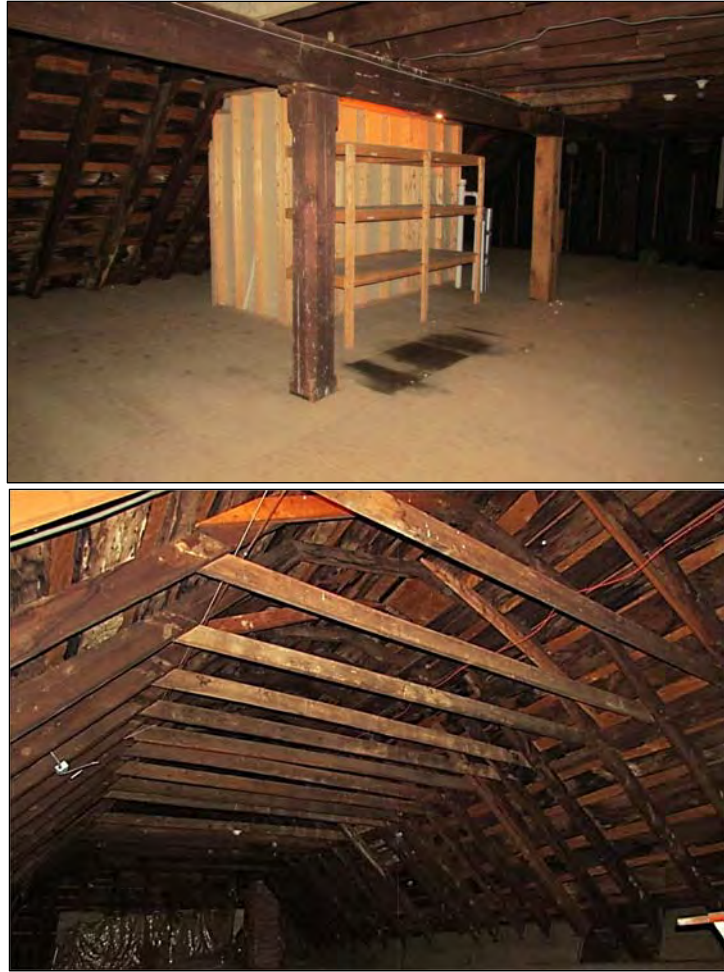
FIGURE 3-16: THIRD STORY INTERIOR, FACING SOUTHEAST (TOP); ROOF STRUCTURAL SYSTEM IN ATTIC, FACING SOUTHWEST (BOTTOM)

The east-side stairwell also provides access to the third story (Figures 3-15 and 3-16). This space is unfinished and undivided. The floor is covered by plywood. Historic windows on the interior are also covered by plywood. A shaft opening in the floor on the northeast end of the room previously provided space for mill equipment. Ceiling joists show notching indicative of previous room configurations. There is ladder access to the attic in the northeast section of the room. The attic features two flues: one in the northeast corner and a second at the west end of the south elevation, similar to the third-story plan (Figures 3-15 and 3-16). Like the third story, the floor of the attic is covered by plywood sheets. Some roof rafters and sheathing boards appear to be recent replacements while others show evidence of possible fire or smoke damage.

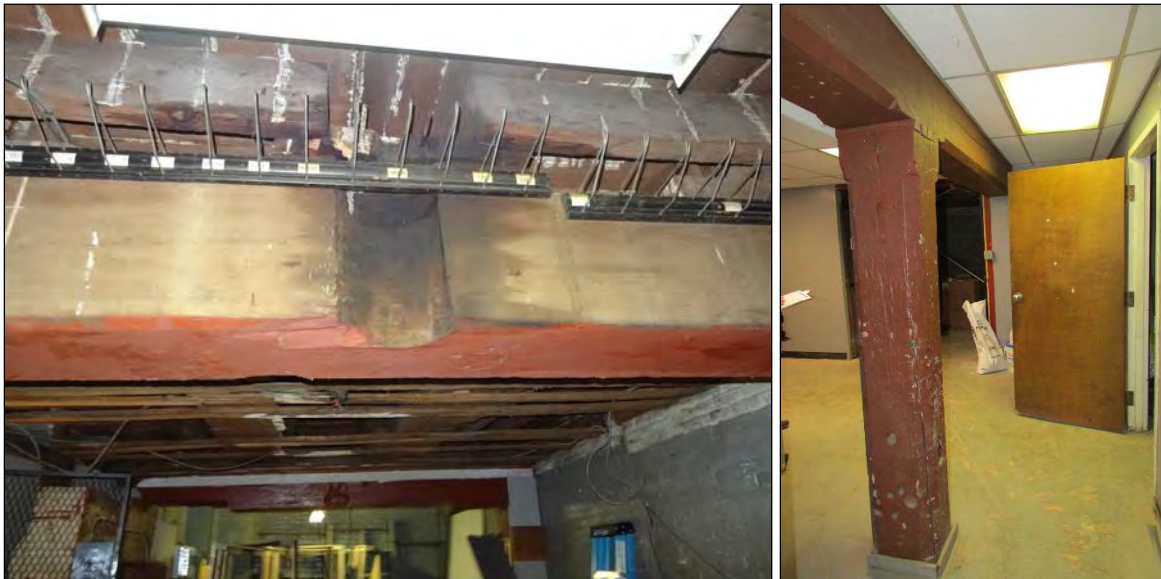
The basement is accessed by a stairwell on the east side of the first story and from the exterior by double-leafed metal doors on the east elevation (Figure 3-17). The basement features exposed chamfered support posts, interior drywall walls, and a drop ceiling (Figure 3-18). Shaft marks visible on ceiling joists in the basement are indicative of the use to grist first flour and then corn, most notably activities of the early-twentieth century (Wigglesworth 1975:50) (Figure 3-18). Other beams show indications of equipment attachment and detachment over the years.

FIGURE 3-18: EVIDENCE OF MILL SHAFT IN WESTERN STORAGE AREA OF BASEMENT, FACING SOUTH (LEFT); BASEMENT, FACING WEST (RIGHT)

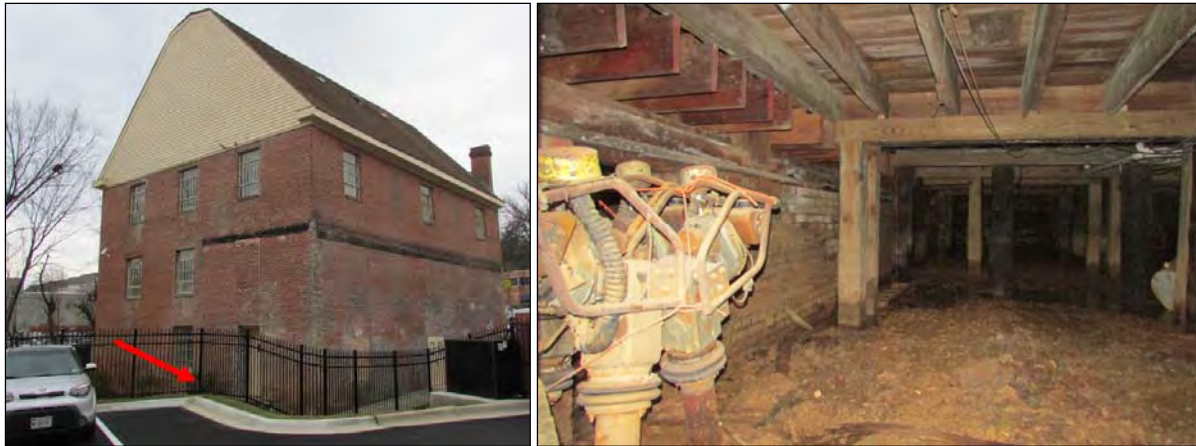
A subbasement is accessed by descending stairs on the south elevation of the building (Figure 3-19). At the bottom of the stairwell, an uncoursed stone foundation is visible. Entry to the subbasement was not possible due to flooding; however, support posts, electrical pump equipment, brick walls, and ceiling joists were visible from the stairwell (Figure 3-19).

FIGURE 3-19: SUBBASEMENT ENTRANCE (DENOTED BY RED ARROW), SOUTHEAST OBLIQUE (LEFT); VIEW OF SUBBASEMENT, FACING NORTH (RIGHT)

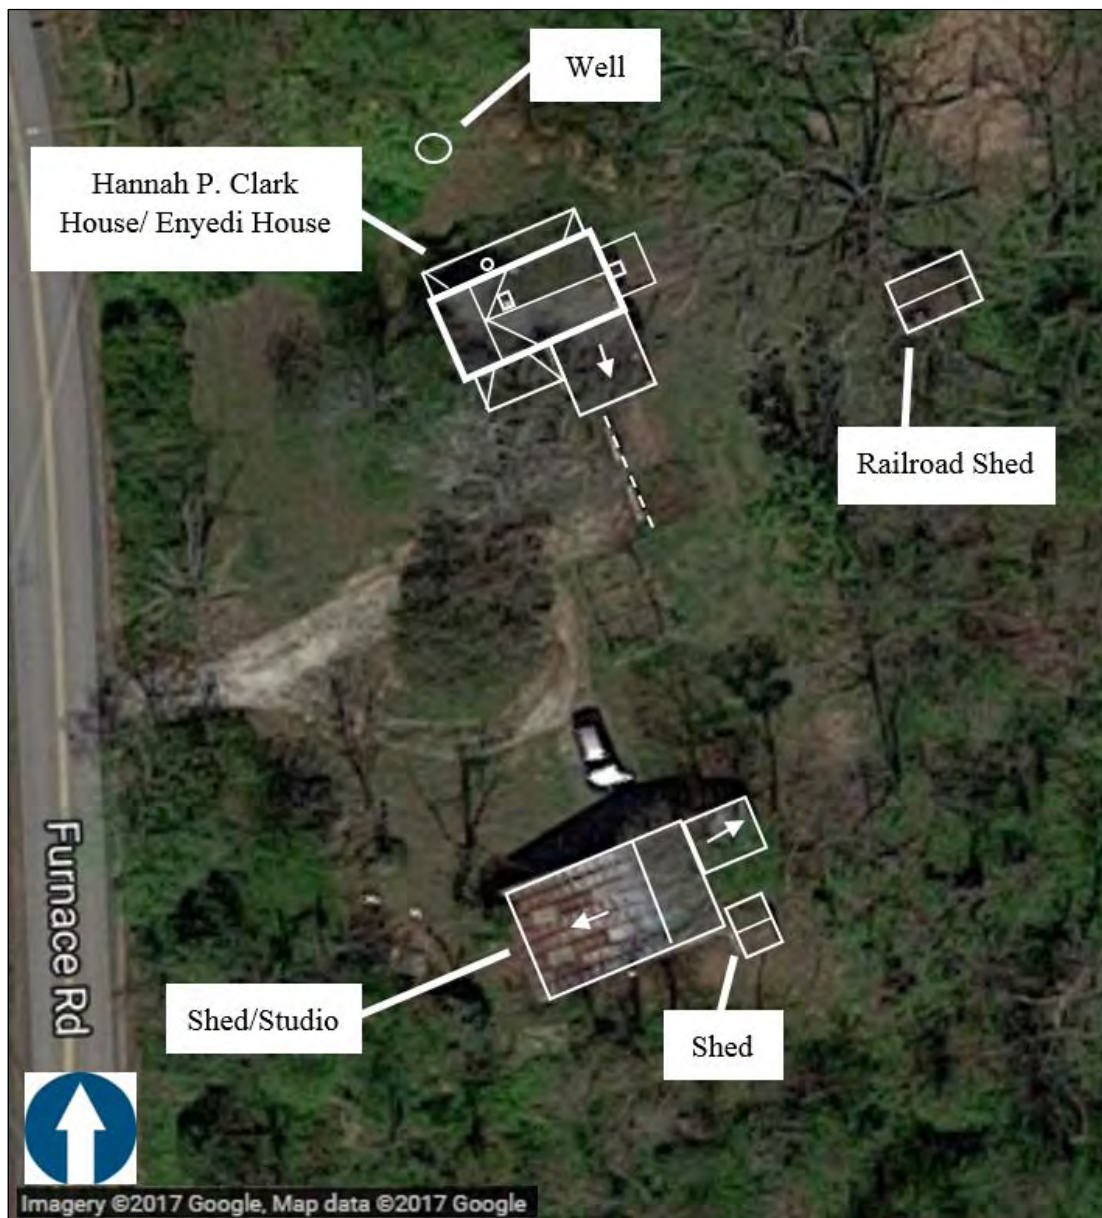
The property's primary resource is a two-story, four-bay, single-family dwelling constructed in 1839 in a vernacular gable-and-wing form (Figure 3-26). According to the owner and a FCPA architectural historian, the earliest portion of the building was constructed with vertical logs; however, this was not apparent during the current inspection (FCPA 2014). The continuous brick foundation is parged and supports a frame structure clad in weatherboard siding with wood corner boards (Figure 3-27). The moderately pitched, cross-gabled roof is clad in asphalt shingles with boxed eaves featuring a simple wood cornice with partial eave returns. An exterior-end chimney clad in weatherboard siding is centered on the northeast elevation, and an exterior metal flue protrudes from the first story of the northwest elevation of the core of the building.

**FIGURE 3-26: DETAILED SITE PLAN OF HANNAH P. CLARK HOUSE
(GOOGLE EARTH 2017) (NOT TO SCALE)**

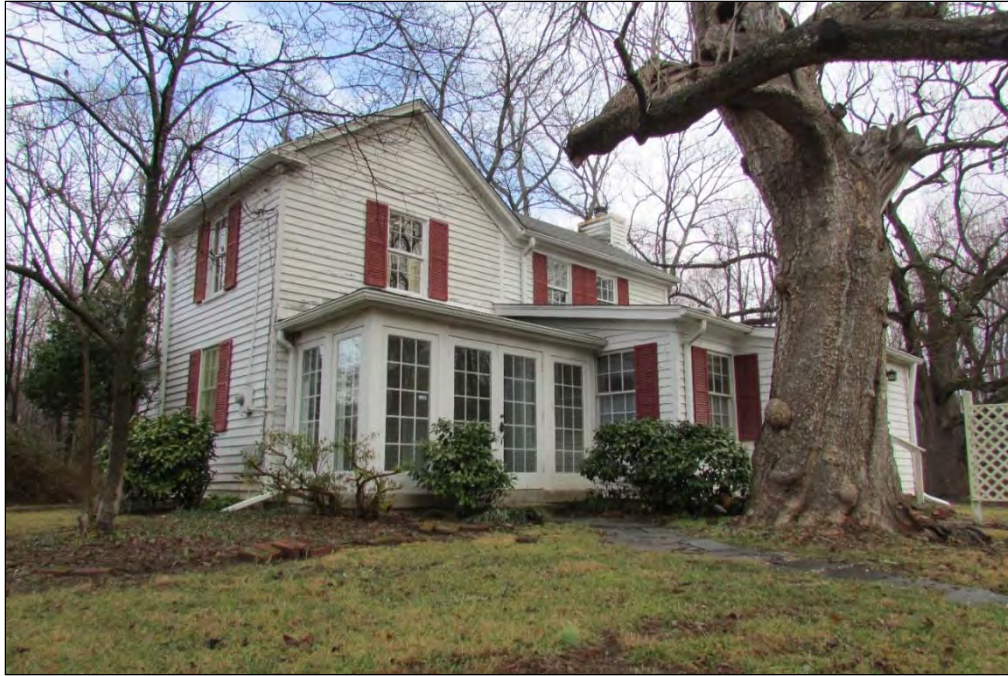
FIGURE 3-27: SOUTH OBLIQUE OF THE HANNAH P. CLARK HOUSE

Two one-story additions extend from the southeast elevation: an enclosed porch containing the current primary entrance and an enclosed sun room (Figure 3-27 and Figure 3-28). The entry porch is covered by a shed roof and was built sometime between 1890 and 1940 (Peebles 2014: 30). The sun room is covered by a hipped roof and features floor-to-ceiling, multi-light windows. This addition was built in the same phase as the entry porch between 1890 and 1940, and enclosed in the 1980s during the Enyedi ownership (Peebles 2014:49).

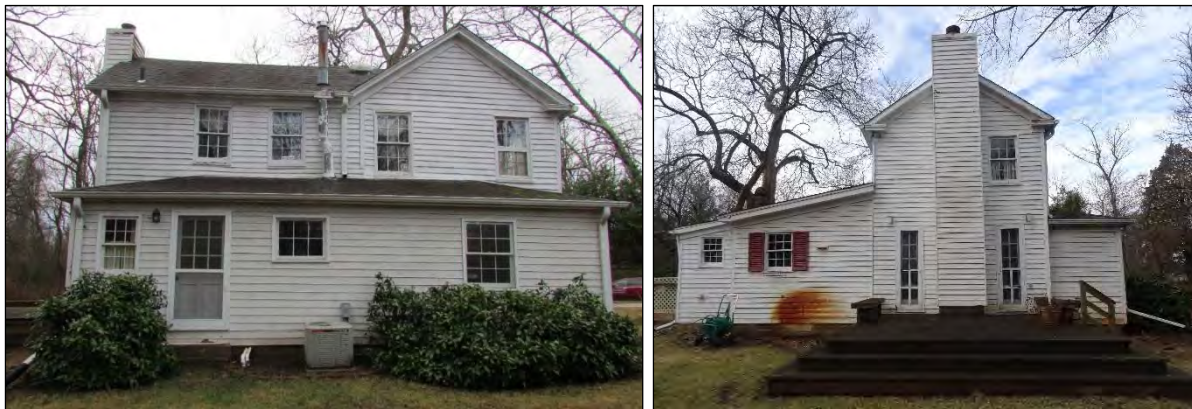
The current primary entrance, filled with a single-leaf, paneled, wood door covered by a wood screen door, is situated on the southeast elevation of a one-story, shed addition on the rear (southeast) elevation of the building. Another entrance is located on an enclosed porch that spans the northwest elevation (Figure 3-28). This entrance is filled by a single-leaf, wood, paneled door covered by a metal-framed screen door and accessed by a set of concrete steps. The porch is clad in weatherboard siding and covered by a hipped roof sheathed in asphalt shingles. It features two six-over-six, wood-frame, double-hung-sash windows and one fixed six-light window. Other fenestration includes six-over-six, wood-frame, double-hung-sash windows, most of which are

FIGURE 3-28: NORTHWEST ELEVATION (LEFT); NORTHEAST ELEVATION (RIGHT)

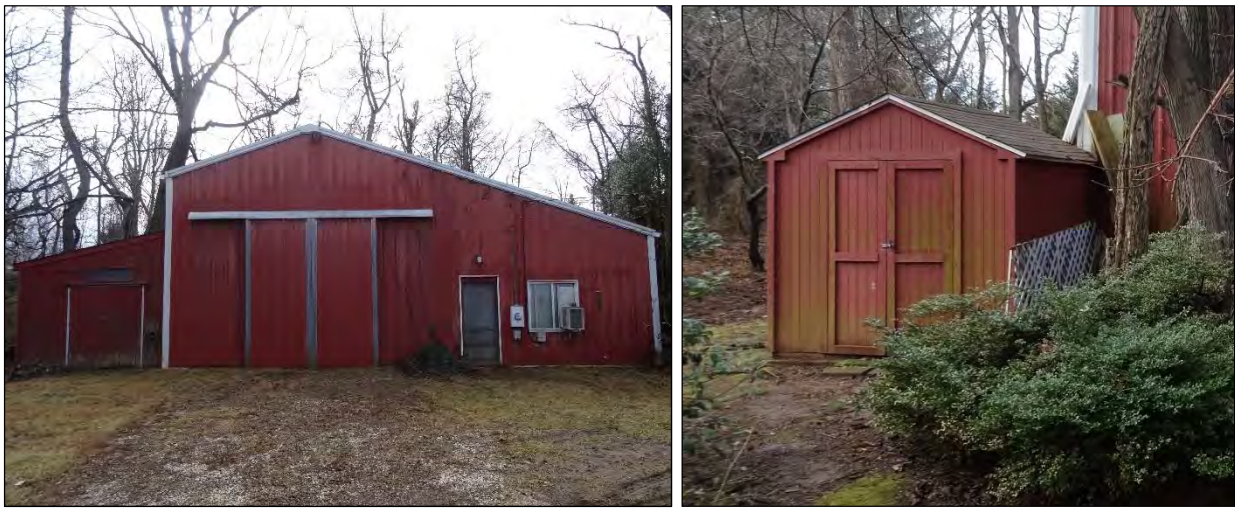
A circa-1987, one-story, three-bay, shed/studio is located southeast of the dwelling (Figure 3-29). It sits on a continuous concrete foundation while its structural system is clad in snap-on, batten with clip, metal siding. The front-gabled roof is sheathed in corrugated metal. Fenestration includes a single-leaf, metal, pedestrian door; a large, double-leaf, sliding metal door; and sliding

metal windows. A one-story shed addition extends from the northeast elevation and is clad in T1-11 siding. A set of double-leaf, T1-11 doors and a three-light transom mark its northwest elevation. A one-story, one-bay, prefabricated shed constructed around 2000 is located immediately south of the studio (Figure 3-29). It is clad in T1-11 siding and covered by a front-gabled roof. A double-leaf, board-and-batten door is located on the northeast elevation. A circa-1980, concrete well superstructure is located east of the primary resource (Figure 3-30). It is covered by a circular concrete well cap. An additional one-story, one-bay shed of frame construction with vertical wood siding is located northeast of the primary dwelling (Figure 3-31). A single-leaf, five-panel, wood door is located on the southwest elevation. The roof and southeast elevation are dilapidated and the structure is in poor condition. The shed was possibly used by railroad foreman associated with the RF&P Railroad and was built between 1925 and 1943 (Peebles 2014:124).

FIGURE 3-29: STUDIO, NORTHEAST ELEVATION (LEFT); SHED, SOUTHEAST ELEVATION (RIGHT)

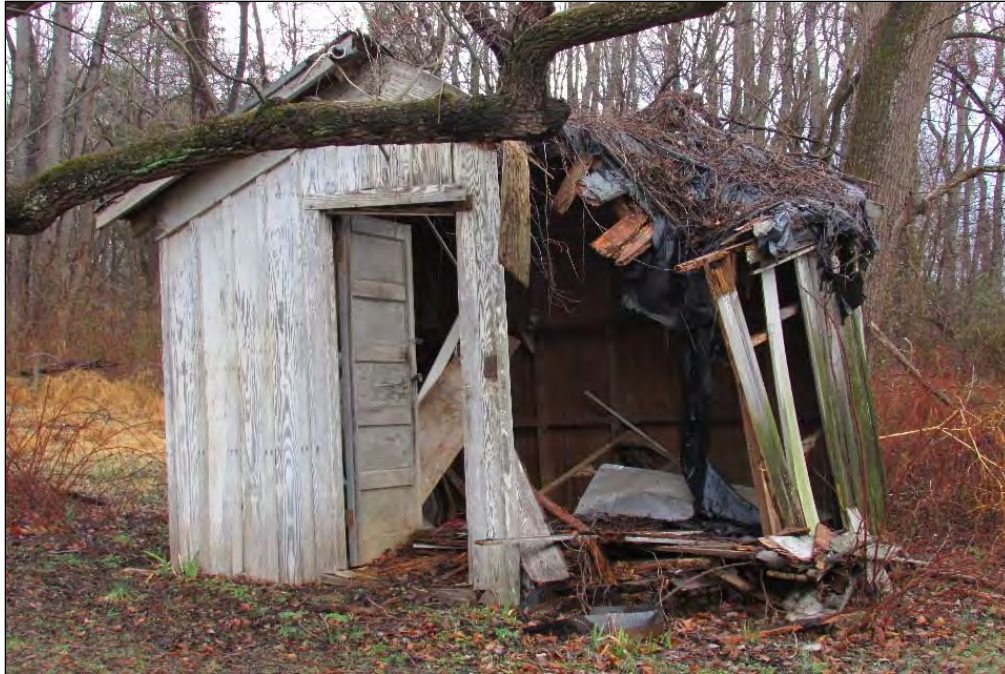
FIGURE 3-31: SOUTH OBLIQUE VIEW OF RAILROAD SHED. NOTE: THE DILAPIDATION OF THE NORTHEAST ELEVATION

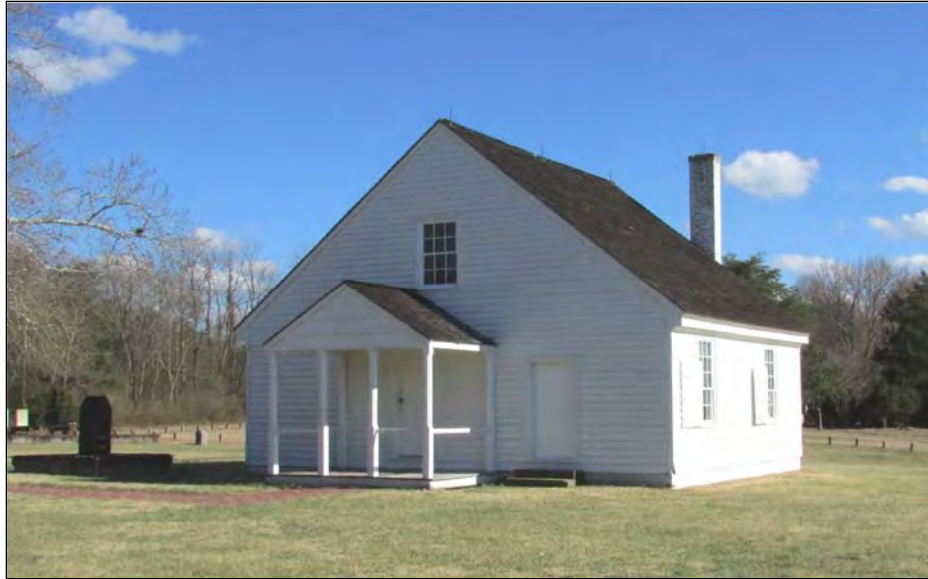
The primary entrance is located on the northwest elevation and is filled by a single-leaf door of vertical wood boards accessed via a one-story, front-gabled entry porch with wood deck and chamfered wood posts (Figures 3-39 and 3-40). The porch is supported by brick piers. A secondary entrance is located to the west of the primary entrance and is filled with a similar single-leaf door of vertical wood boards, with concrete steps. Fenestration on the northeast and southwest elevations include nine-over-six, double-hung-sash, wood windows flanked by board-and-batten shutters. A six-over-six, double-hung-sash, wood-framed window with thin muntins is centrally placed in the gable ends.

FIGURE 3-39: WEST OBLIQUE OF SHRINE BUILDING

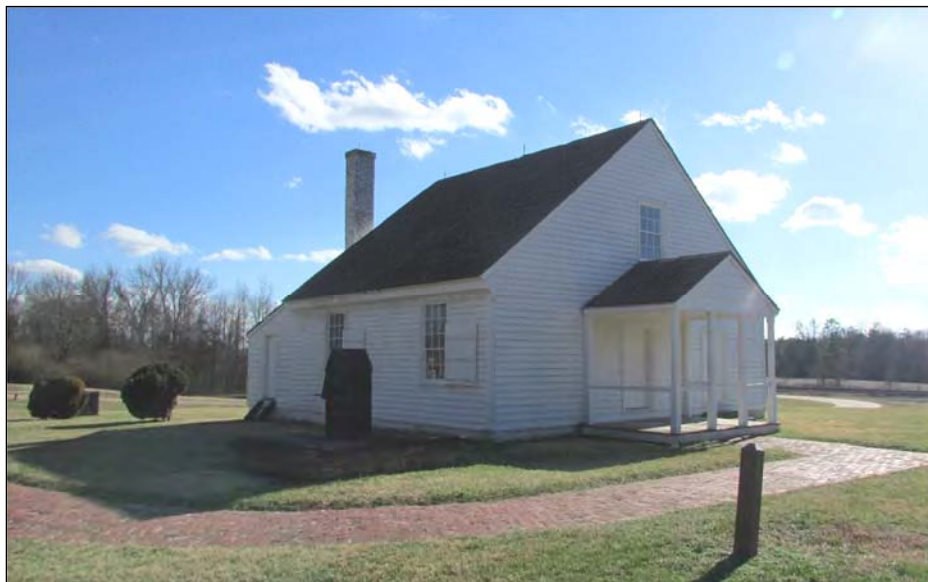
FIGURE 3-40: NORTH OBLIQUE OF SHRINE BUILDING

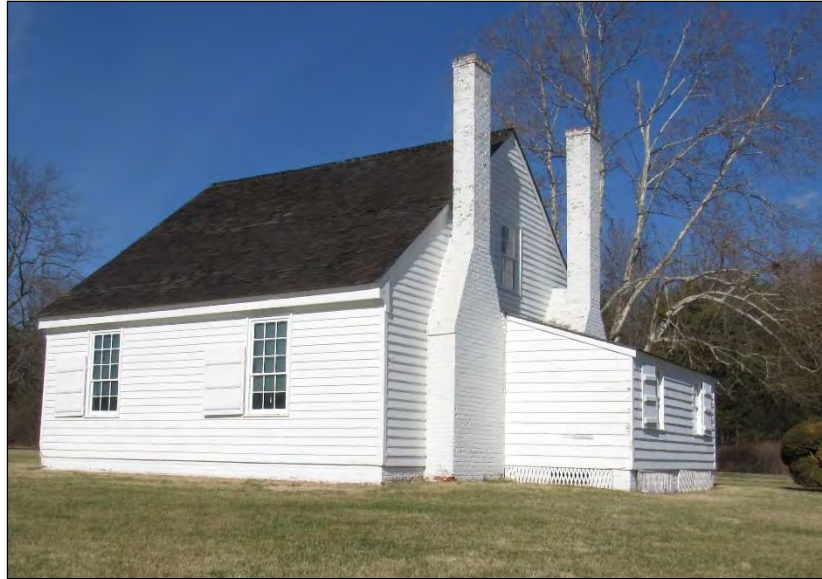
A one-story, lean-to addition with a shed roof lines much of the southeast elevation (Figure 3-41). This addition is a reconstruction and was added during the 1962 restoration of the property. It is supported by a brick-pier foundation with wood lattice between piers and is clad in beaded weatherboard. A single entrance is located on the northeast elevation and consists of a single-leaf, board-and-batten door accessed by a set of wood steps. Two six-over-six, double-hung-sash, wood windows with board-and-batten shutters mark the southeast elevation.

FIGURE 3-41: VIEW OF REAR ADDITION AND EXTERIOR-END BRICK CHIMNEYS, LOOKING NORTH

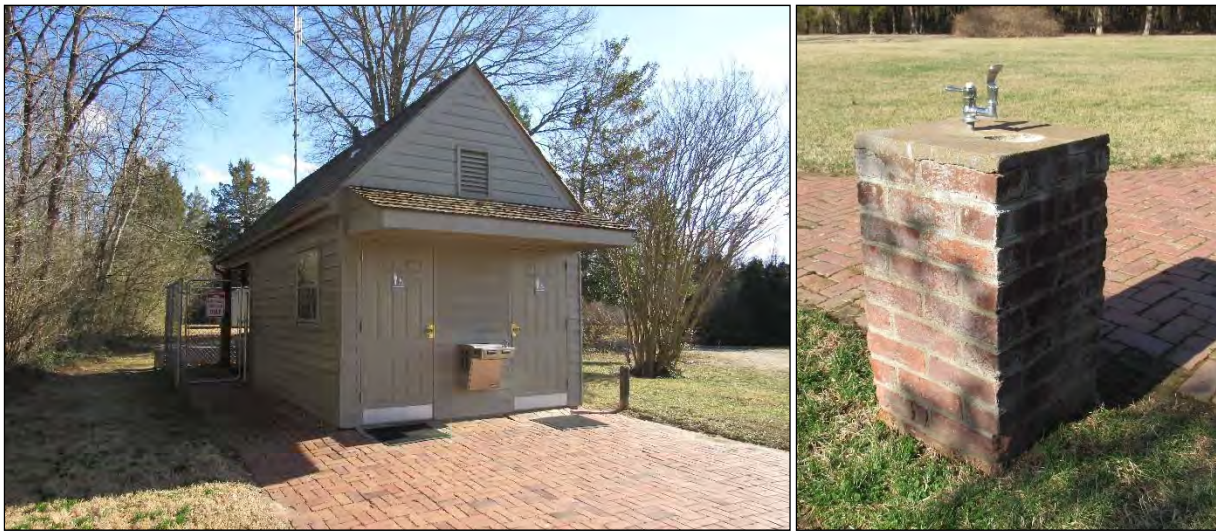
FIGURE 3-45: NORTH OBLIQUE OF RESTROOM BUILDING (AT LEFT) AND DETAIL OF FOUNTAIN, LOOKING NORTH (RIGHT)

A one-story building housing restrooms for visitors is located approximately 270 feet southeast of the primary resource and was constructed in 1985. It has a poured-concrete foundation, a frame structural system clad in weatherboard, and a front-gabled, wood-shingle roof. Two single-leaf doors on the northwest elevation leading to men's and women's restrooms are covered by a wood-shingled pent roof. The fenestration consists of six-over-six, double-hung sash, wood windows. Access to an additional room, likely housing maintenance or technical equipment, is located on the southeast elevation and is blocked from public access by chain-link fencing. Pedestrian access to the bathroom is provided by a basket weave brick walkway. A brick water fountain, likely added to the property in the mid-twentieth century, is situated at the west corner of the parking area, along the brick walkway that extends north to the office building (Figure 3-45).

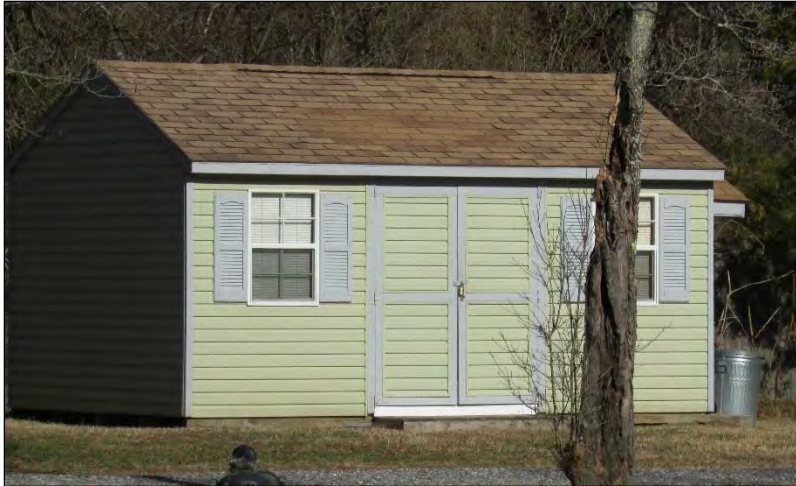
A one-story, prefabricated shed constructed in 2012 is located approximately 65 feet east of the secondary dwelling (Figure 3-48). The frame structure clad in vinyl siding has a side-gabled roof covered in asphalt shingles. A majority of the building rests on a pier-type foundation, although a small poured-concrete slab was seen at the southeast elevation where an electrical meter attaches to the resource. A double-leaf entrance is centrally located on the southwest elevation, flanked by one-over-one, double-hung, vinyl sash windows with false muntins and false shutters.

FIGURE 3-48: SHED ASSOCIATED WITH PRIVATE RESIDENCE

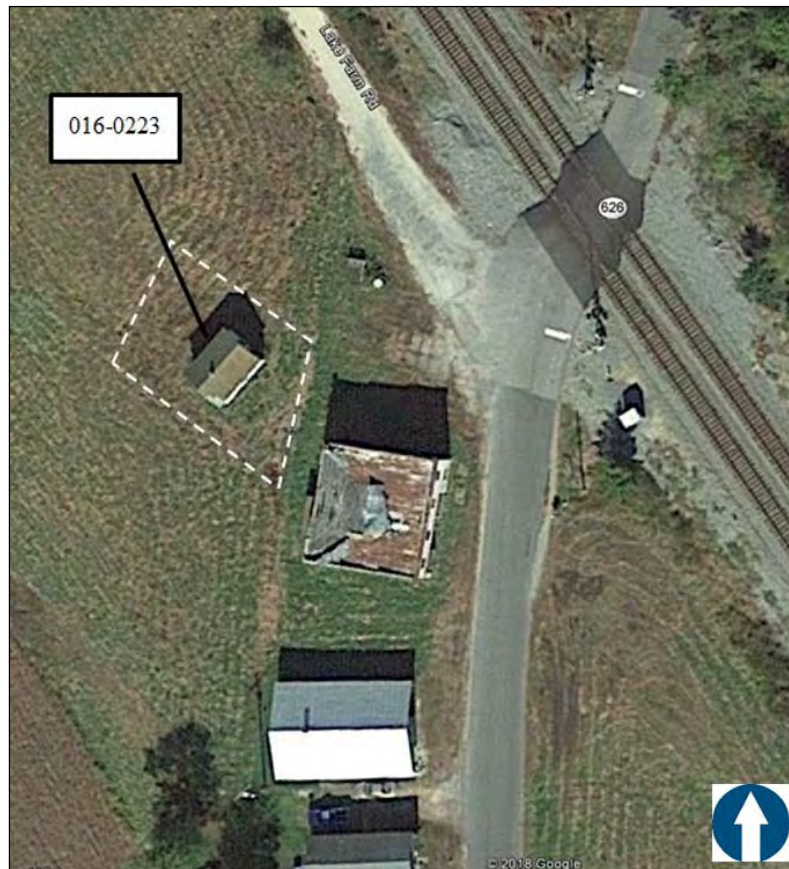
The First Woodford Post Office (016-0223) is a small rectangular building constructed circa 1875 located at the southeast corner of the intersection of Lake Farm Road and Woodford Road, also known as Route 626 (Figures 3-67 and 3-68). This one-story, one-bay building features elements of the Queen Anne and Folk Victorian styles (Figures 3-69 through 3-71). It rests on a poured-concrete pier foundation that likely dates from the circa-1947 relocation of the building. The frame structural system is clad in weatherboard with plain cornerboards. The front-gabled roof is covered by standing-seam metal and features exposed rafter tails at the side elevations. A small, internal, brick chimney pierces the roof's ridge near the southwest end of the building and was likely used to vent a wood stove. A full cornice return lines the façade, or northeast elevation,

FIGURE 3-67: FIRST WOODFORD POST OFFICE (016-0223) SITE PLAN (GOOGLE EARTH 2018) (MAP NOT TO SCALE)

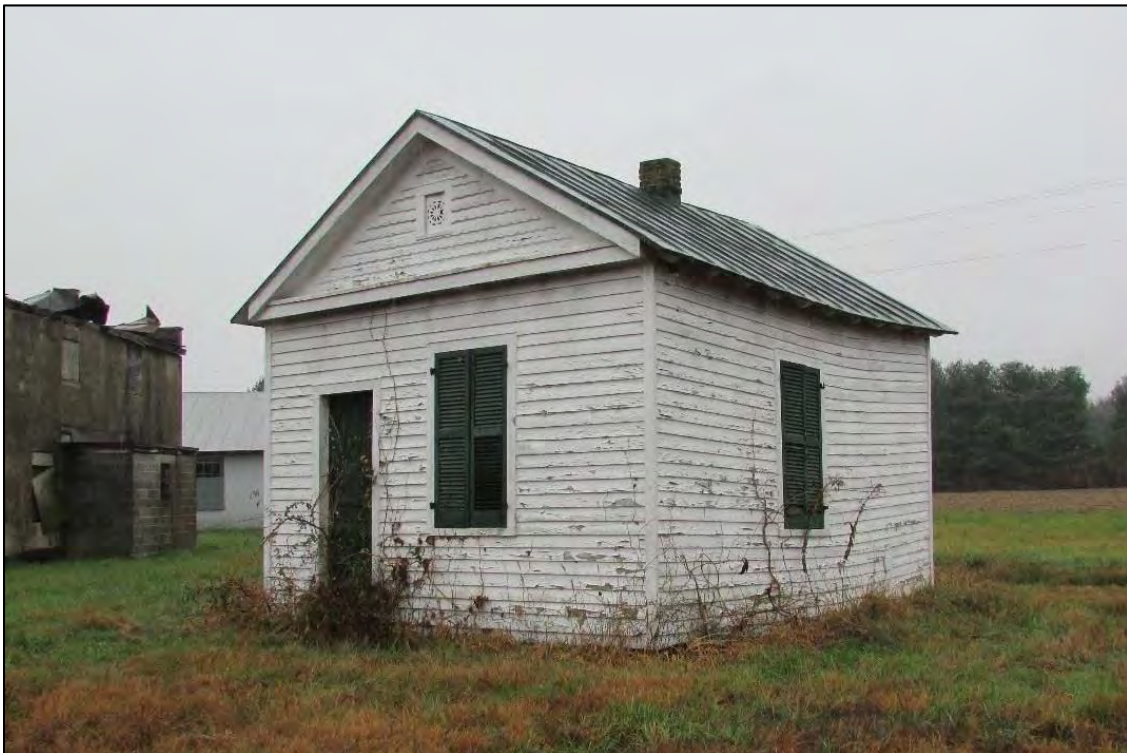
FIGURE 3-69: FIRST WOODFORD POST OFFICE, NORTH OBLIQUE

The main entrance is located on the northeast-facing façade and consists of a single-leaf, five-panel, wood door. A single window dots every elevation and is filled by a two-over-two, double-hung-sash, wood-framed window (vertical muntins) and covered by double-leaf, operable, louvered, wood shutters on all but the southwest elevation where the shutters have been removed, although some hardware remains extant.

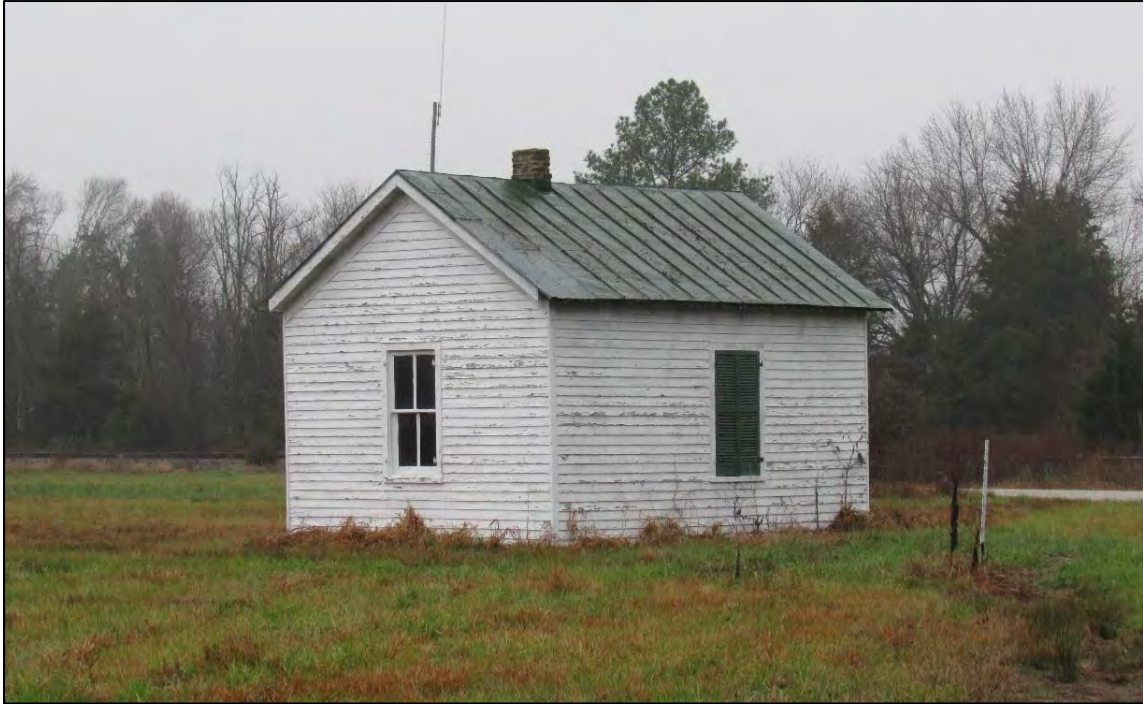
FIGURE 3-70: FIRST WOODFORD POST OFFICE, SOUTH OBLIQUE

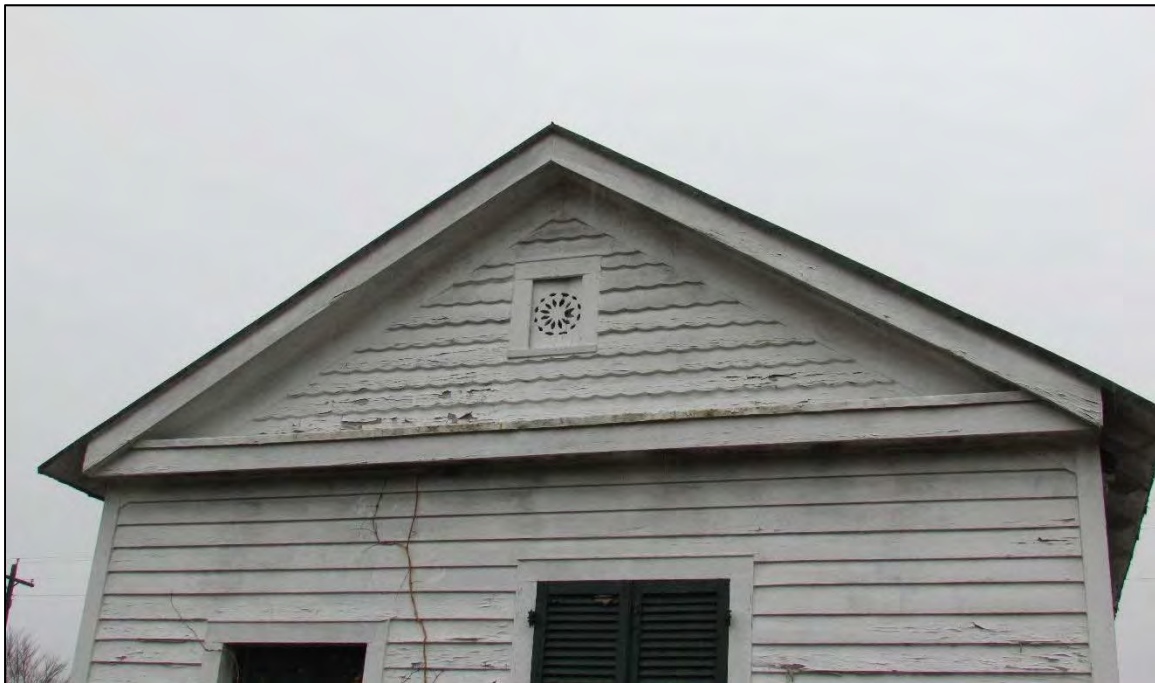
where the gable end is clad in scalloped weatherboard and features a central decorative sawn vent.

FIGURE 3-71: FIRST WOODFORD POST OFFICE, DETAIL OF SCALLOPED SIDING AND DECORATIVE VENT IN GABLE OF FAÇADE

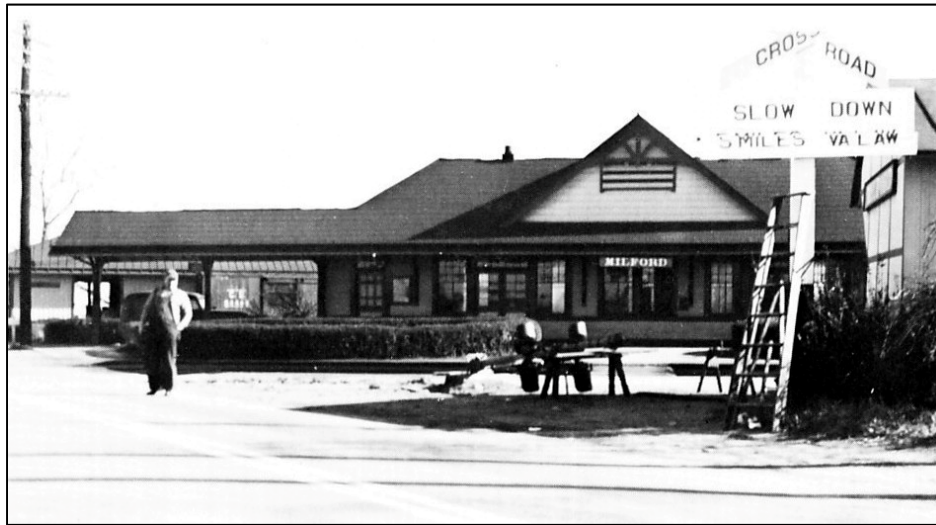
The combination freight-passenger station, also called a combination depot, was a relatively common station form in small towns during the late-nineteenth and early-twentieth centuries (Griffin 1984:57). Combination depots were generally rectangular in shape and contained a freight room, passenger waiting room, and a depot agent's office (Storey 2016). On the freight end of the building, large sliding doors could be found on both sides for loading and unloading. Sometimes a depot agent's office bay window projected from the track-side elevation to provide better visibility up and down the tracks and may also have served to visually separate the freight and passenger sections of the depot (Storey 2016). This projecting bay element can be clearly seen at the Woodford depot as well as on other combination depots in rural Virginia (Figures 3-76 through 3-78).

**FIGURE 3-76: SEPARATE PASSENGER DEPOT (FRONT) AND FREIGHT DEPOT (REAR)
AT MILFORD, CIRCA 1940 (GRAY 1985:98)**

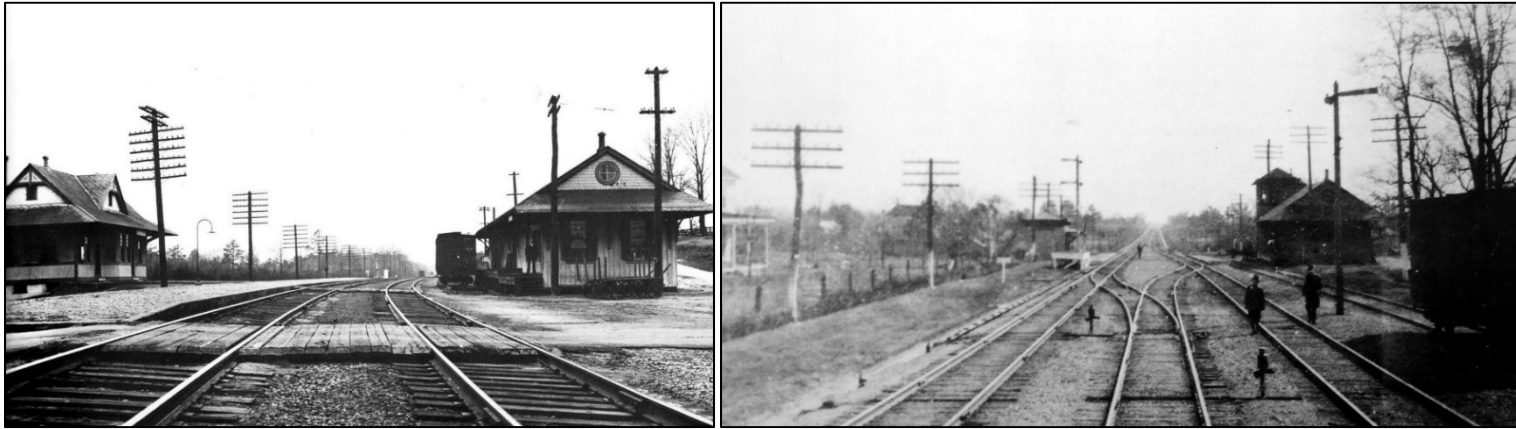
FIGURE 3-77: SEPARATE PASSENGER DEPOT (LEFT) AND FREIGHT DEPOT (RIGHT) AT PENOLA IN 1938 (LEFT); CIRCA-1920 PHOTOGRAPH OF PASSENGER DEPOT AT GUINEA, PICTURED ON THE RIGHT (GRIFFIN 1984:85, 99) (RIGHT)

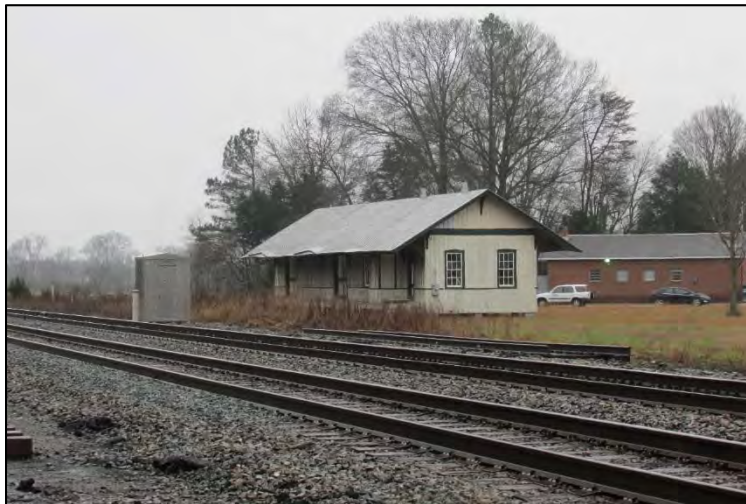
The Woodford Freight and Passenger Depot is a long, rectangular, one-story building measuring approximately 100 feet in length and 35 feet wide (Figures 3-79 and 3-80). The frame building was constructed circa 1900 and rests on a foundation of concrete-block piers that appear to be replacements. It is clad in wood board-and-batten siding. The side-gabled roof is covered with standing-seam-metal roofing with wide overhanging eaves supported by simple decorative brackets, protecting the platform along the east elevation (Figures 3-80 and 3-81). Metal ice dams project from the roof surface above each of the freight doors (two on the northeast elevation and two on the southwest elevation) to divert runoff, protecting freight as it was being loaded and unloaded. Two round metal-stove vents pierce the roof near the northwest end of the building.

FIGURE 3-80: WOODFORD FREIGHT & PASSENGER DEPOT, VIEW SOUTH FROM RAILROAD CROSSING

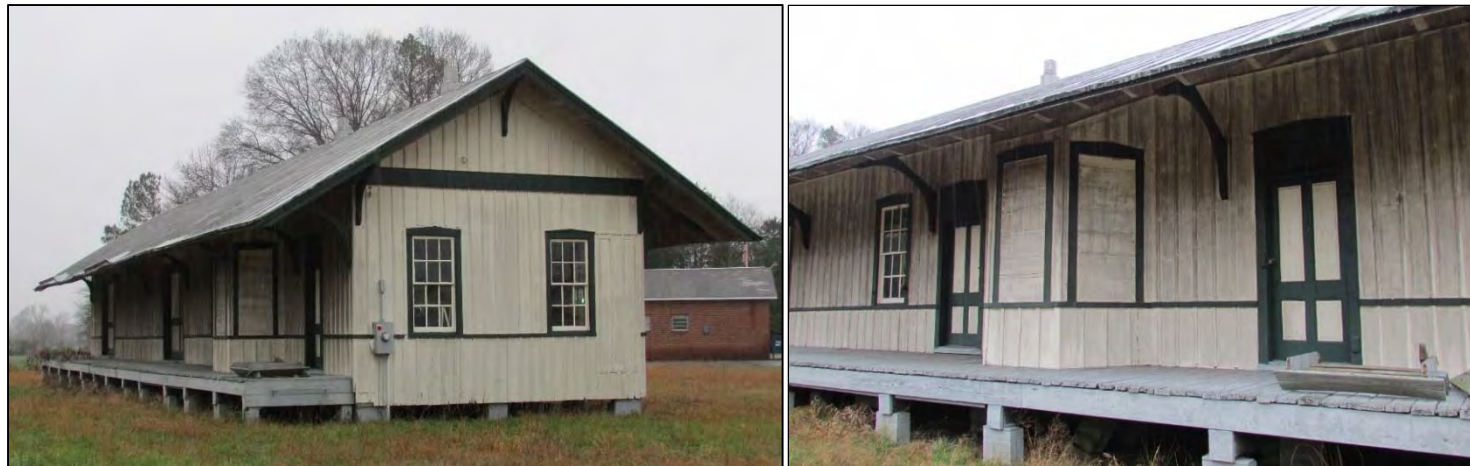
FIGURE 3-81: NORTH OBLIQUE (LEFT); DETAIL OF PROJECTING BAY WINDOW AND DOOR TO PASSENGER WAITING ROOM, EAST ELEVATION (RIGHT)

In the southeast half of the façade, two large sliding doors constructed of diagonal wood boards arranged into four panels provide access to the freight portion of the building (Figure 3-81). Two identical freight doors are located on the southwest elevation and are accessed via a smaller, raised, wood platform (Figure 3-81). The window openings on this elevation have been boarded over; however, the rest of the windows on the building contain six-over-six, double-hung, wood sashes with slightly peaked lintels. On the façade, two single-leaf, paneled, wood doors with transoms lead out to the covered freight/passenger platform with a wood deck that spans the entire width of the northeast façade parallel to the railroad tracks (Figure 3-82). The northwest end of the façade, which provided access to the passenger section of the station, features a polygonal bay window that likely contained the ticket office (Figure 3-82).

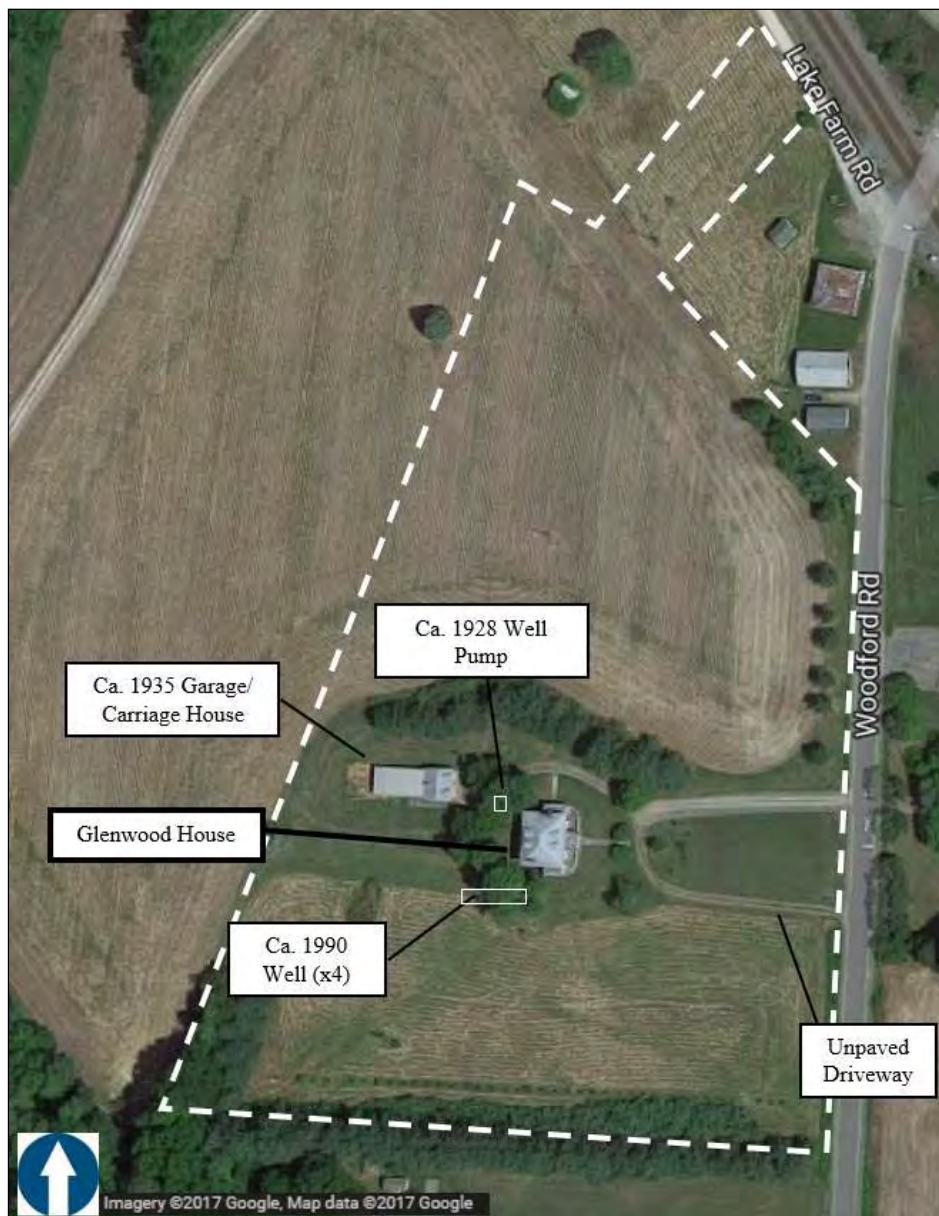
FIGURE 3-86: SITE PLAN OF THE GLENWOOD HOUSE (NOT TO SCALE)

The building known as the Glenwood House is a two-and-one-half-story, five-bay, single-family dwelling constructed circa 1928 in the American Foursquare form with Colonial Revival and Craftsman-style details composed of a central two-and-one-half-story core with flanking one-story wings (Figures 3-86 through 3-88). The continuous raised foundation supports a structural system that is clad in multi-tone brick, laid in a Flemish bond embellished with brick quoins, a typical Colonial Revival detail. The building is covered by a moderately pitched, hipped roof sheathed in standing-seam metal with wide eaves featuring wood modillions. Two hipped dormers with wide eaves pierce the roof on the west and east elevation and contain louvered vents. The roof also features two brick chimneys with stepped metal flashing, one being an

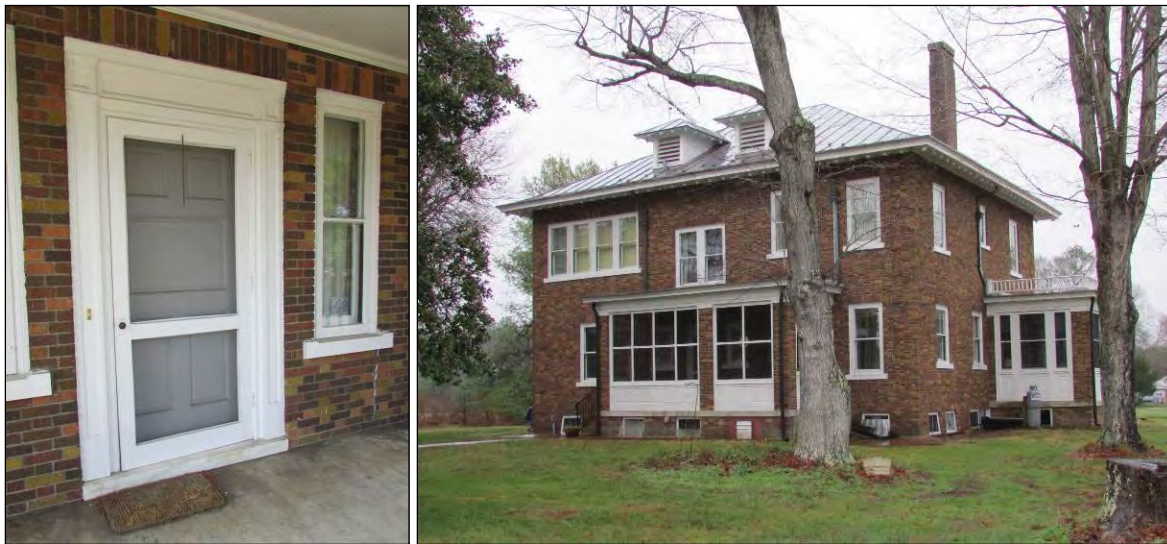
FIGURE 3-89: PRIMARY ENTRANCE, EAST ELEVATION (LEFT); SOUTHWEST OBLIQUE (RIGHT)

The primary entrance, centered on the east elevation, is filled with a single-leaf, wood, five-paneled door with a wood-and-screen storm door. The entrance is elaborated by a wood surround with squared pilasters. Flanking the door are single, one-over-one, double-hung, wood-frame, windows on concrete sills with wood-framed screens (Figure 3-89). Centered in front of the primary entrance is a one-story, one-bay brick porch with a concrete deck covered by a flat roof with a iron balustrade. The roof is supported by squared brick posts with fluted, Doric columns, and the porch is accessed by a set of concrete steps flanked by brick retaining walls. The porch continues on the north and south sides as a raised, uncovered, curved veranda lined with a molded concrete balustrade which extends to both of the flanking one-story wings. Other fenestration consists of one-over-one, wood-frame, double-hung-sash windows situated in a single, paired, or ribbon pattern that also feature wood surrounds and concrete sills. In the raised basement are three-light, wood-frame awning windows.

The screened porch wings, each located in the eastern half of the north and south elevations, are virtually identical, each covered by a low-pitched hipped roof lined with a low squared balustrade supported by squared brick posts with wood-frame screens and wood paneling along the base. The north wing also features a secondary entrance. Another screened porch similar to the north and south wings is off-centered on the west elevation and provides an additional entrance to the dwelling (Figure 3-89). This porch is supported by a continuous brick foundation and has wood-framed screened windows on the north, west, and south elevations. A patinated copper drain pipe is centrally located on the west elevation.

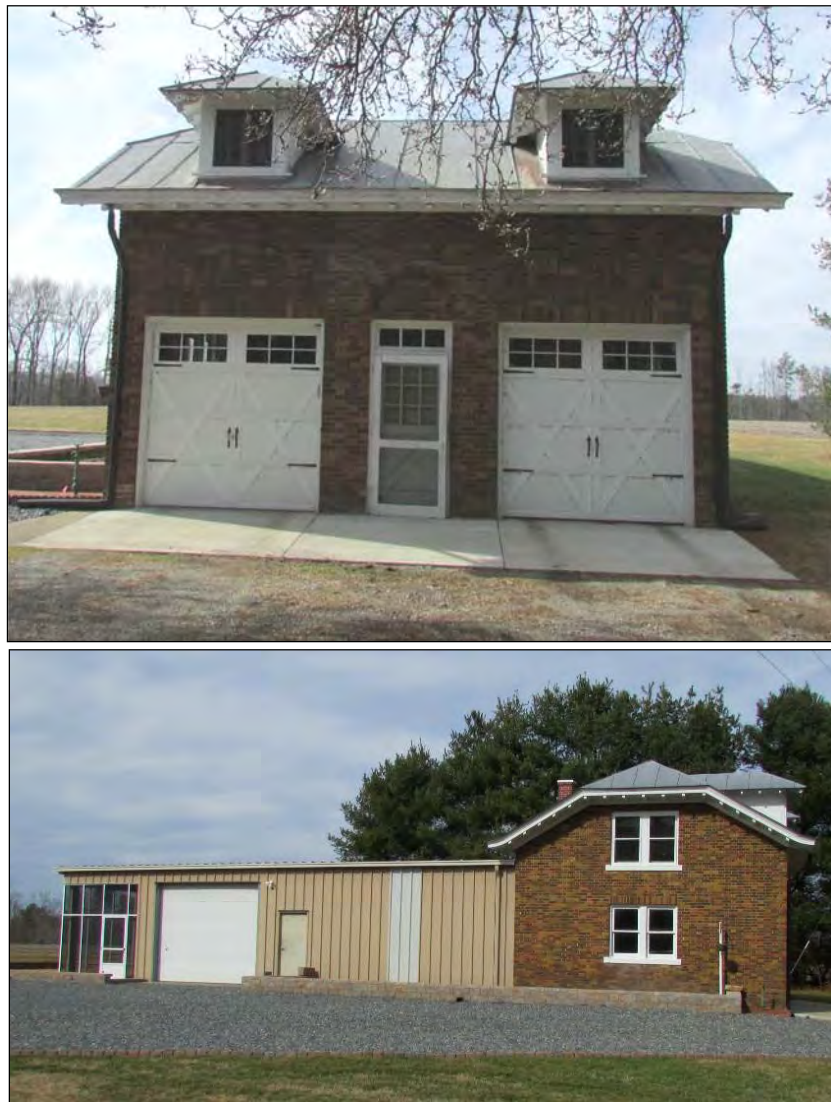
FIGURE 3-90: GARAGE, EAST ELEVATION (TOP); SOUTH ELEVATION (BOTTOM)

Situated northwest of the primary resource is a circa-1930, one-and-one-half-story, three-bay garage (Figure 3-90). The exterior is clad in brick laid in a variety of bond patterns: Flemish bond

in the center of the east elevation and a basketweave pattern on the remainder of the building. It is covered by a steeply pitched clipped gabled roof sheathed in standing-seam metal with flared eaves and scrolled modillions. Two hipped dormers are situated on the east elevation and an interior-end brick chimney on the west elevation. The large garage bays are filled with wood, sectional garage doors made to resemble double-leaf, board-and-batten doors. In between the garage doors is a single-leaf door with a three-light, wood-frame transom set above. Extending from the west elevation is a one-story, frame, flat-roof addition primarily clad in snap-on batten-with-clip metal siding (Figure 3-90). The west elevation of this addition has a metal-frame, screened, multi-bay porch. A circa-1928 metal well pump is situated west of the dwelling, on the south side of a concrete walkway leading from the dwelling to the garage (Figure 3-91). A set of four circa-1990 wells are located southwest of the primary resource. They are all covered by circular metal caps (Figure 3-91).
