ARCHITECTURAL INTENSIVE INVESTIGATIONS

D.C. TO RICHMOND SOUTHEAST HIGH SPEED RAIL

Architectural Intensive Investigations for the Washington, D.C. to Richmond Southeast High Speed Rail (DC2RVA) Project

DHR #2014-0666

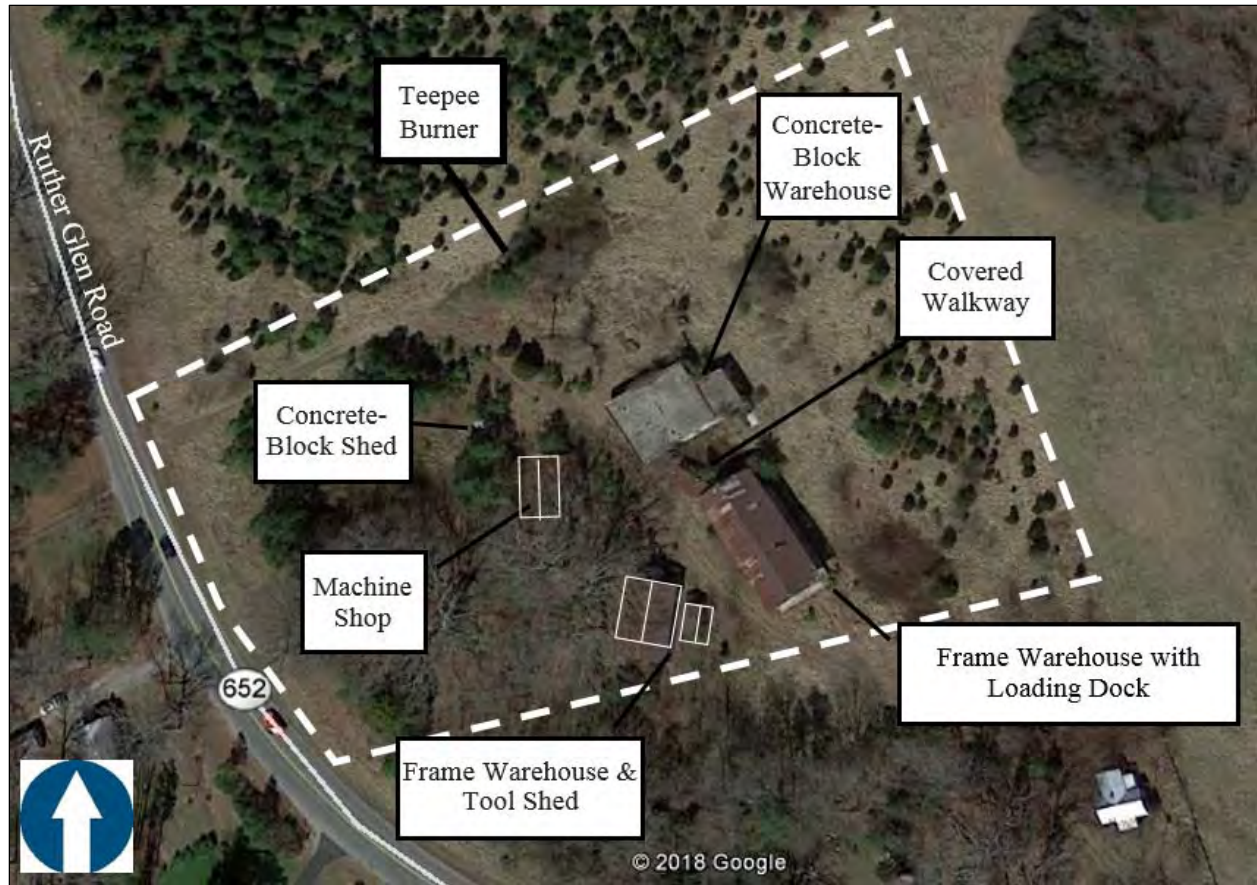
FIGURE 3-98: SITE PLAN OF RUTHER GLEN EXCELSIOR MILL #1 (GOOGLE EARTH 2018)

Excelsior Mill #1 is west of Ruther Glen. A dirt and gravel drive runs through the center of the lot connecting an entrance on Chesterfield Road with another on Ruther Glen Road, with the majority of the buildings lining the drive on either side. The parcel currently contains a conical teepee burner and six buildings of varying materials, massing, and size (Figure 3-98 through Figure 3-100). The circa-1950 teepee waste burner rests on a poured-concrete foundation. The structural system is constructed of sheet metal over a metal frame lined with corrugated metal. The structure is open at the top, and vents and an access doorway are found near the base. The funnel-shaped attachment located at the southeast corner of the burner is commonly known as a cyclone or dust precipitator (Mihalyo 1997:32). The function of the sawdust cyclone “was to funnel planar shavings and small particles of sawdust into the burner. These particles were blown through a pipe into the cyclone from the mill itself. Once inside the cyclone, the chips, dust, and shavings were then drawn by gravity into the core of the burner” (Mihalyo 1997:32). Four frame buildings—two large warehouses, a small tool shed, and a machine shop—and one concrete-block warehouse are also associated with this property, all of which appear to have been constructed between 1950 and 1970. The concrete-block warehouse and the frame warehouse with the loading deck are connected by a covered walkway accessed by a poured-concrete ramp. All of the buildings are vacant and in deteriorating condition. Historically, a house appears to have been situated just west of the mill complex, but this building has been demolished.

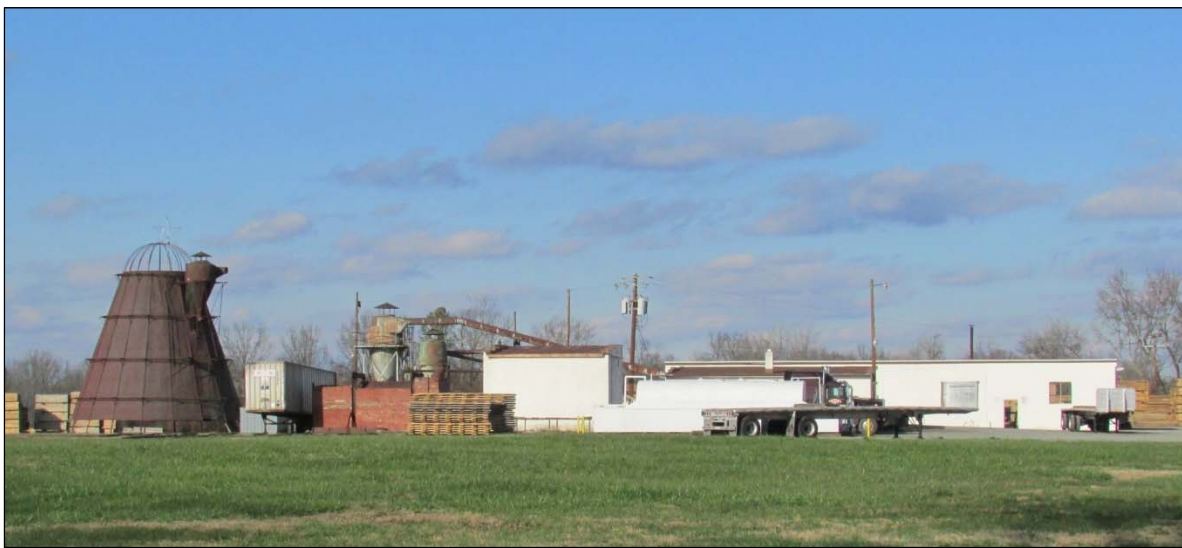
FIGURE 3-107: OVERVIEW OF THE DEJARNETTE LUMBER COMPANY, LOOKING NORTH

Although the DeJarnette Lumber Company no longer produces excelsior, numerous extant resources once associated with the business can still be found within the lumber company complex (Figures 3-106 and 3-107). The most prominent resource is a large circa-1940 teepee or wigwam-style, wood-waste burner (Figure 3-108). The burner measures an estimated 50 feet tall and approximately 35 feet in diameter at the base and has a conical shape formed by metal plates mounted to an exterior metal frame of compression rings. The base of the burner is open, and the top is covered by an open metal frame that would have once been covered with metal mesh, referred to as a spark arresting screen (Mihalyo 1997). Other resources include a large wood processing building (which is still referred to as the planer building today despite a move away from excelsior), a sawdust cyclone, a re-saw/fine-planing building, a lunch room/tool shop, a storage building, an office/warehouse, and a boiler house.

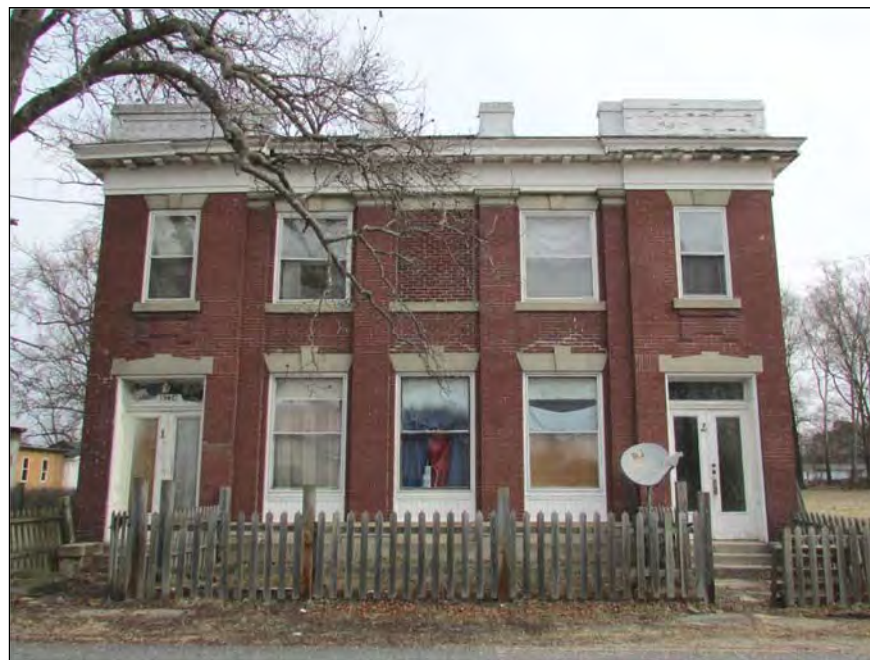
FIGURE 3-131: SOUTHWEST ELEVATION

The Milford State Bank, located at 15461 Antioch Road, is a two-story brick building constructed circa 1910 in the Classical Revival style (Figures 3-130 through 3-132). The building has a continuous, poured-concrete foundation and a masonry structural system of red brick laid in an American bond. The building's façade (southwest elevation) is divided into five distinct bays via brick pilasters with plain capitals of concrete. Courses of soldier and rowlock brick on the northwest and southeast elevations create decorative bands that horizontally break up the wall surface. The building is covered by a low-pitched, asphalt-shingled, hipped roof with boxed eaves containing a denticulated cornice that appears to have been replaced with aluminum dentils (Figure 3-133). A painted brick parapet wall caps the southwest elevation (Figure 3-133). An interior-end, brick chimney is centered on the northwest elevation and an additional brick chimney can be seen at the juncture of the northeast elevation and a rear addition.

The building has a pair of slightly recessed entrances on the façade, one in each of the outermost bays (west and south corners). Each entrance contains a double-leafed wood door with full rectangular lights topped by a single-light, wood-frame transom and concrete jack-arched lintels with keystones. Decorative wood paneling embellishes the inset sides of each entrance. Other fenestration includes single, one-over-over, vinyl, replacement windows. Window openings at the façade feature concrete sills and jack-arched lintels and in the outermost bays are further elaborated by decorative brick aprons (Figure 3-134). The central bay in the second story of the façade once contained a window but has since been removed and the space filled with brick.

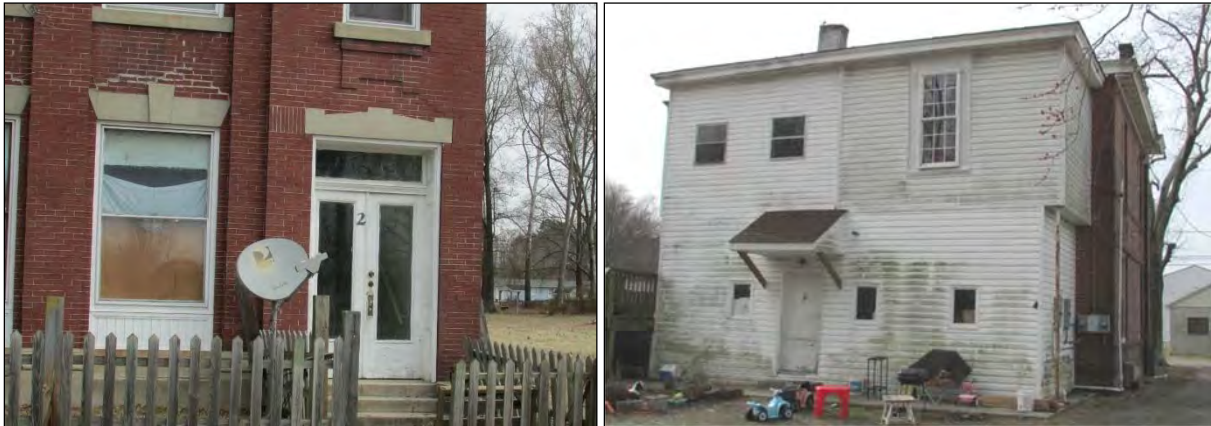
FIGURE 3-134: DETAIL OF FENESTRATION, SOUTHWEST ELEVATION (LEFT); NORTHEAST ADDITION OF THE MILFORD STATE BANK (RIGHT)

A two-story addition, spanning a majority of the northeast elevation, is clad in vinyl siding and is covered by a low-pitched, hipped, standing-seam-metal roof (Figure 3-134). The north corner of the second story features a different shade of vinyl siding and the northwest portion protrudes slightly and is supported by a metal post. Though construction seams are obscured by the vinyl siding, the addition was possibly built in stages. A secondary entrance is situated on the northeast

elevation of the addition and filled with a single-leaf, metal, paneled door. A set of concrete stairs is used to access the secondary entrance; the entrance is sheltered by a pent roof supported by wood brackets. Fenestration in the addition includes several one-over-one, vinyl, double-hung, and single-light, metal-frame, casement, replacement windows. A wood deck extends from the east half of the northeast elevation of the core of the building with a set of wood steps extending from the northeast.

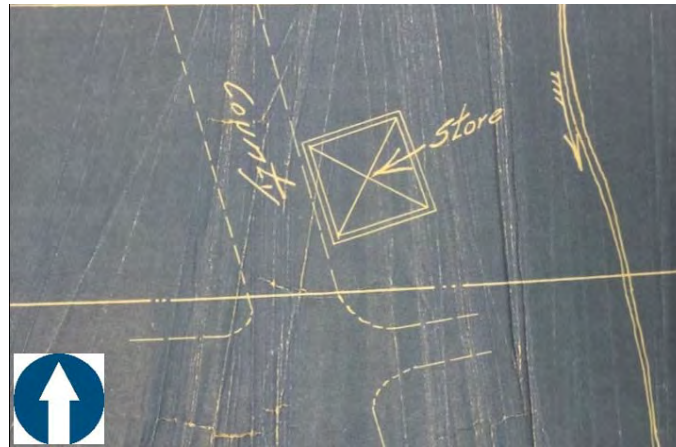
FIGURE 3-136: DETAIL OF 1917 PLAT MAP OF IMPROVEMENTS TO THE STATION AT PENOLA, SHOWING FOOTPRINT OF THE COGHILL-JETER STORE (RF&P RAILROAD COMPANY 1917) (MAP NOT TO SCALE)

By 1908, W.R. Jeter and T.B. Jeter dissolved their partnership and partitioned their assets with T.B. assuming ownership of the tract of land (CCDB 74:594). A 1917 plat shows the original core of the store without additions (Figure 3-136). T.B. Jeter continued to operate the store and farm the associated land, and his son, Henry Jeter, was employed as a store clerk by 1940 (Fall 1989:227; U.S. Census 1920, 1930, 1940; Wingfield 1924:291). When T.B. Jeter died in 1941, Henry continued to operate the store according to a 1949 newspaper article (The Bee 1950; CCDB 134:381; Fredericksburg Free Lance-Star 1949a, 1949b). As the popularity of the automobile increased, railroad passenger and freight traffic at Penola declined, as did the population and commercial enterprises that catered to them. By 1940, Penola and the nearby community of Peatross, located approximately 3 miles to the south, were listed with a combined population of just 25 people, and by 1969, neither the Penola post office nor the Penola depot were in service (Fall 1989:227).

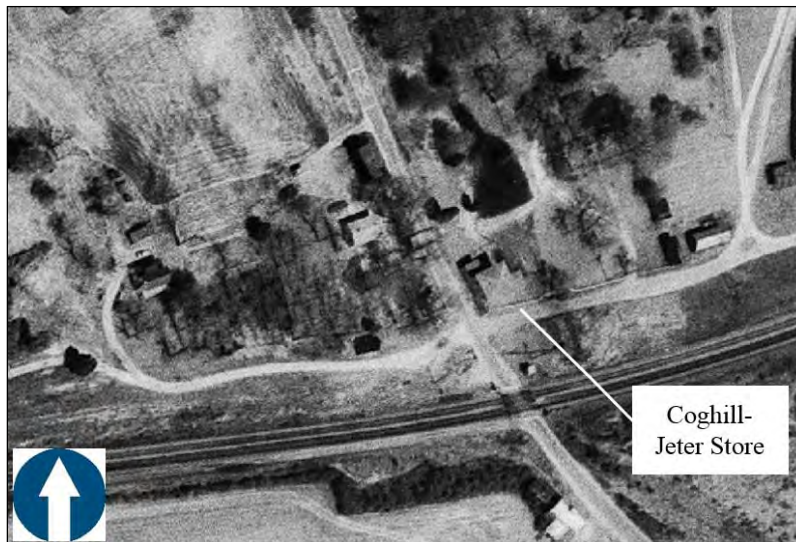
FIGURE 3-137: 1966 AERIAL VIEW OF PENOLA AND THE COGHILL-JETER STORE (USDA 1966B)

Upon his death in 1960, the property passed to Henry’s widow, Lucy F. Jeter, who conveyed a small parcel of 4.40 acres containing the store and the house to Gail & Kitty Gordon in 1964 (CCWB 41:389; CCDB 158:375). An aerial photograph taken two years later shows the store with at least two additions (Figure 3-137). This parcel is currently owned by their heirs, Lucas A. Gordon and Elizabeth B. Gordon, subject to the life estate of Kitty Gordon (CCDB 1197:796). The remainder of the property remains in the hands of the Jeter family and others.

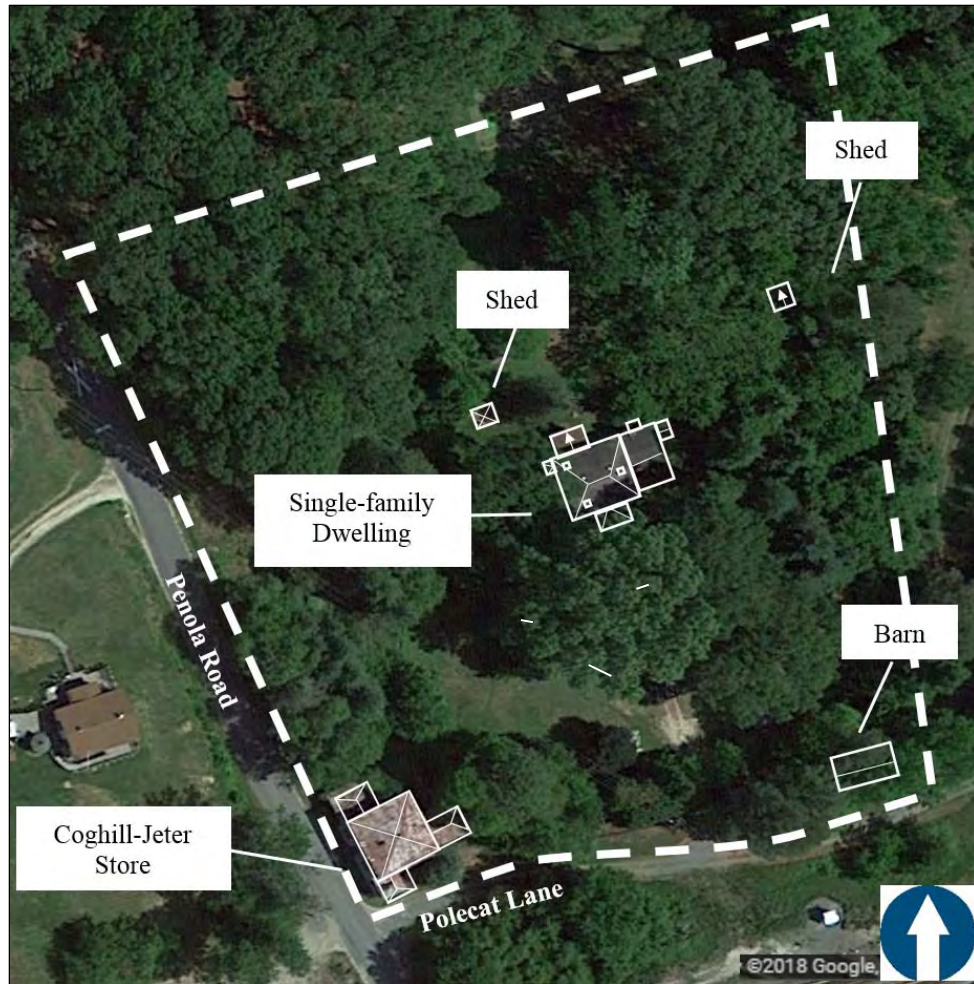
FIGURE 3-138: SITE PLAN OF THE COGHILL-JETER STORE (016-0286) (GOOGLE EARTH 2018) (NOT TO SCALE)

The primary resource, the Coghill-Jeter Store, is a two-story building consisting of a square central block and three smaller one-story wings (Figures 3-138 and 3-139). The 1917 plat shows a simple square building with pyramidal roof devoid of wings or additions, suggesting that all

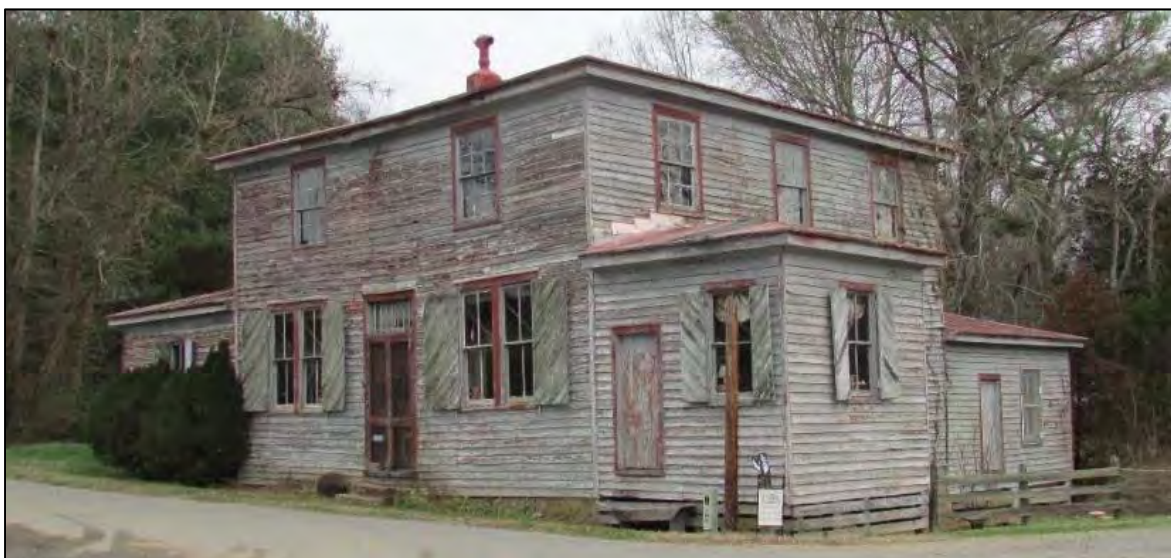
FIGURE 3-139: STORE, SOUTH OBLIQUE

three projecting wings were later additions (Figure 3-139) (RF&P Railroad Company 1917). The central block, which is the original core, has a continuous brick foundation with periodic parging that supports a frame structure clad in weatherboard (Figure 3-140). The pyramidal roof is covered with standing-seam metal and a vent pierces the roof on the southwest slope. A rectangular metal cap is located on the peak of the roof, suggesting that a chimney stack may have been removed at some time. The primary entrance is centered on the southwest-facing façade and consists of double-leaf wood doors of vertical boards with a double-leaf, wood-framed screen door topped by a two-light transom with security bars and a commercial-style gooseneck light fixture. A set of poured-concrete steps provide access to the main entrance. A secondary entrance is located on the southeast elevation facing the railroad tracks and consists of double-leaf, paneled wood door with porcelain knob topped by a two-light transom with security bars. The steps accessing this entrance have been removed. Windows consists primarily of six-over-six, double-hung, wood sashes in the upper story and paired, two-over-two, double-hung, wood sashes with vertical muntins and operable wood shutters of diagonal boards in the lower story of the façade.

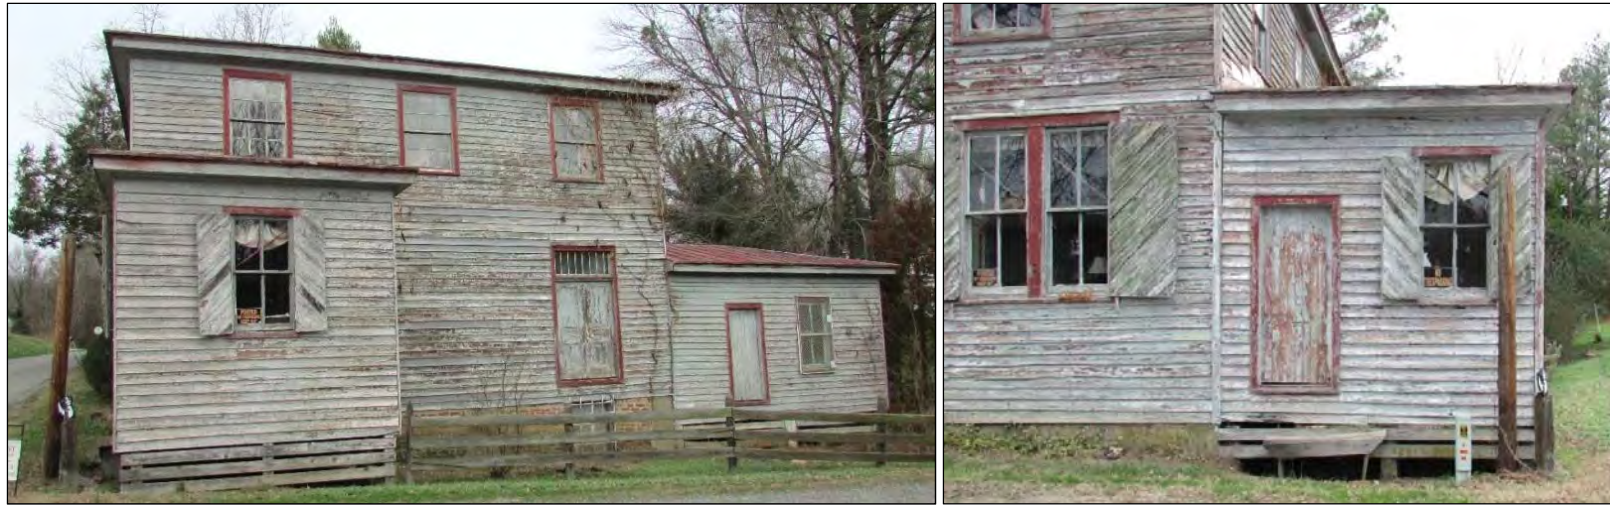
FIGURE 3-140: STORE, SOUTHEAST ELEVATION (LEFT) AND SOUTHWEST ELEVATION AND ADDITION (RIGHT)

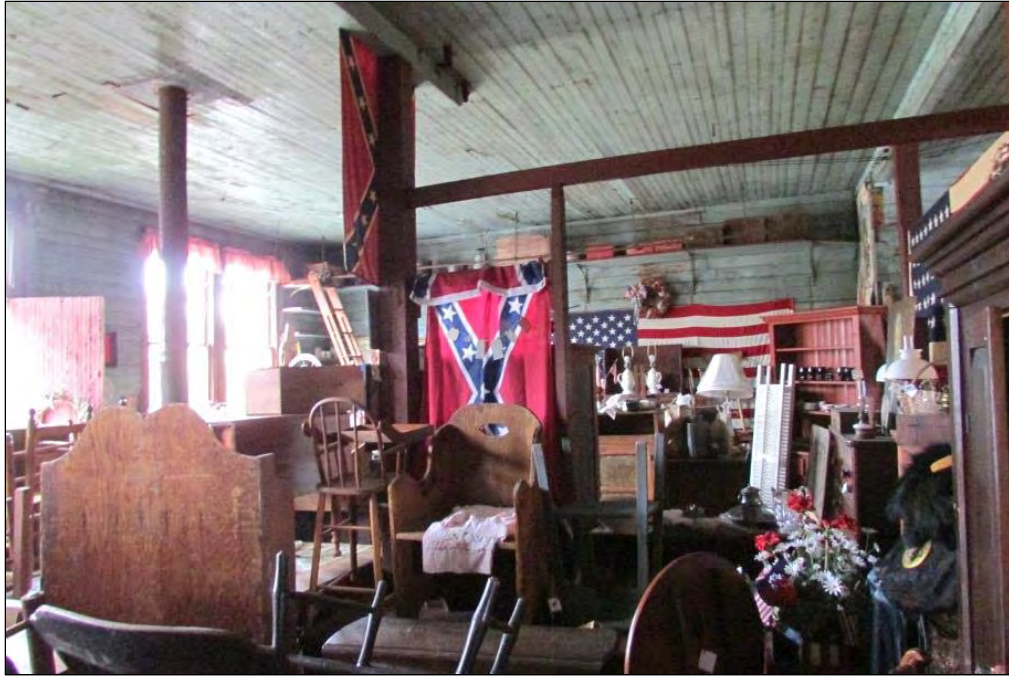
The first story of the Coghill-Jeter Store has a one-room open core, with interior doors leading to all three additions to the north, east, and west of the primary entrance (Figures 3-142 and 3-143). A fixed icebox grocery counter is located in the center of the room (Figure 3-144). The ceiling and interior walls are clad in shiplap siding. Piping for a stove or other exhaust outlet extends from the center of the room to the second floor via a central ceiling vent. Two of the first story additions have the same treatment as the core room: ceiling and interior walls clad in horizontal beveled wood siding, and the third has plaster coated walls and ceiling. The Coghill-Jeter Store also has several operating F. E. Meyer & Brothers ladders with shelf-tracks on the north, west, and south ends of the primary room. Established in 1870, the Meyer Company produced pulleys and hardware out of Ashland, Ohio.

FIGURE 3-143: FIRST STORY, FACING NORTHWEST

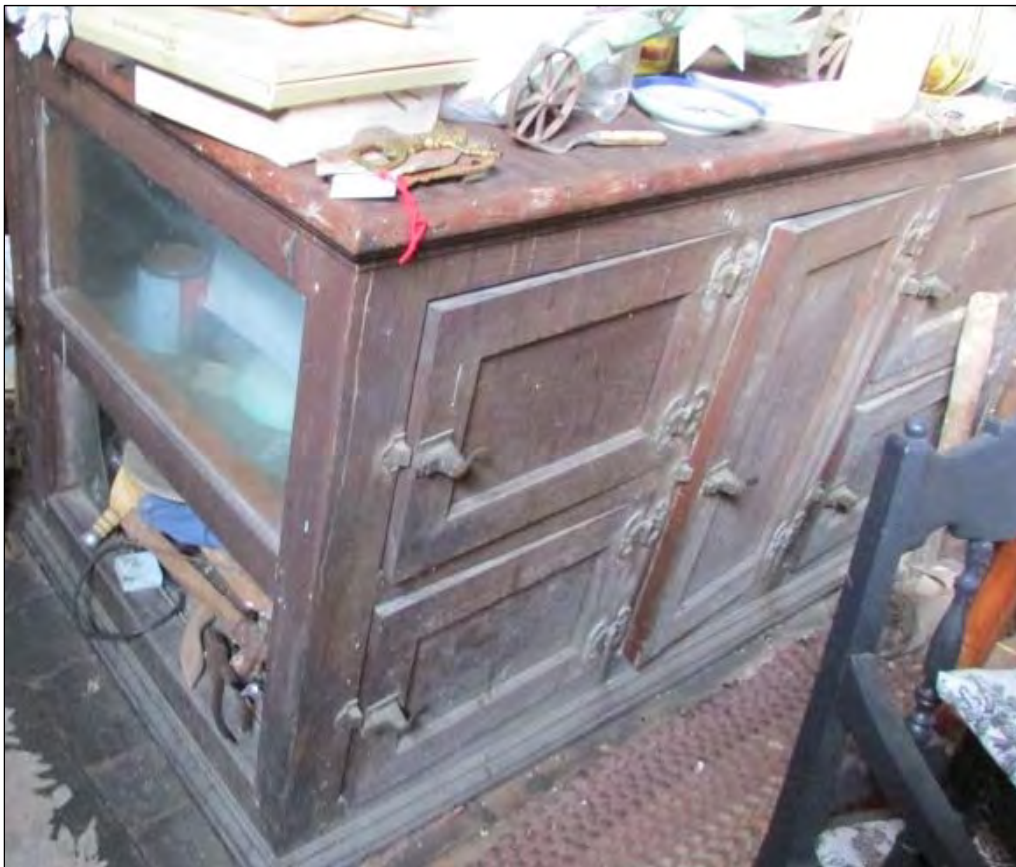
FIGURE 3-144: CENTRAL COUNTER, DETAIL IN FIRST STORY, LOOKING NORTHWEST

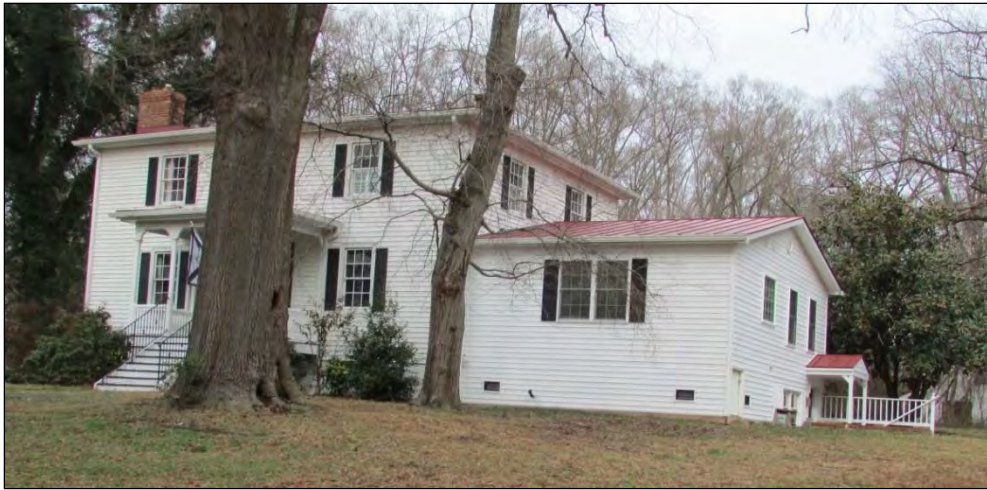
FIGURE 3-146: DWELLING AT 16095 POLECAT LANE, SOUTHEAST OBLIQUE

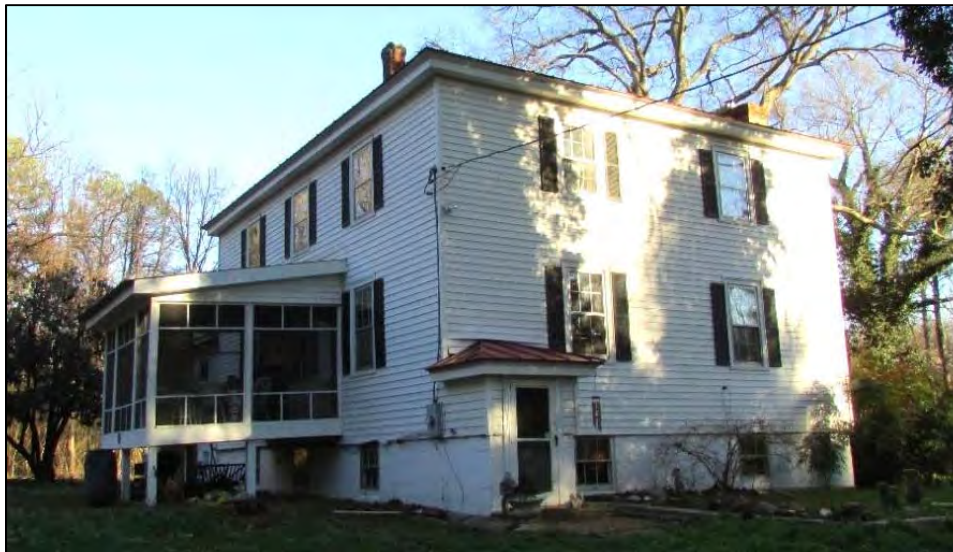
The single-family dwelling at 16095 Polecat Lane is located northeast of the Coghill-Jeter Store on the same parcel. According to historic topographic maps, tax assessment records, and field inspection, the house is believed to have been constructed circa 1911. The two-and-a-half-story building with partially excavated lower story is three bays wide, two bays deep, and has an overall square plan (**Error! Reference source not found.**-146). A one-story addition on the northeast elevation was constructed sometime after 1966 and was enlarged in 2015. The building has a raised, continuous, concrete-block foundation that supports a frame structural system clad in vinyl siding. The hipped roof is covered with standing-seam metal and displays interior brick chimneys near the southwest and northwest corners and an interior chimney of concrete block on the northeast slope. The primary entrance is located on the southeast elevation and consists of a single-leaf, paneled, wood door with modern storm door flanked by two-light sidelights and topped by a three-light transom. The entrance is accessed via a raised porch with a wood deck resting on poured-concrete piers. Chamfered wood columns with flat decorative capitals support a hipped roof. The balustrade consists of flat panels with decorative geometric cutouts, and the porch is accessed via a set of five wood steps with wood railing. A secondary entrance is located in a small, one-story, ground-level projection at the northwest corner and appears to provide access to a basement or cellar. A raised, one-story, frame screened-in porch on the rear (northwest) elevation has post-in-ground construction and a shed roof (Figure 3-147).

FIGURE 3-147: DWELLING AT 16095 POLECAT LANE, NORTHWEST OBLIQUE

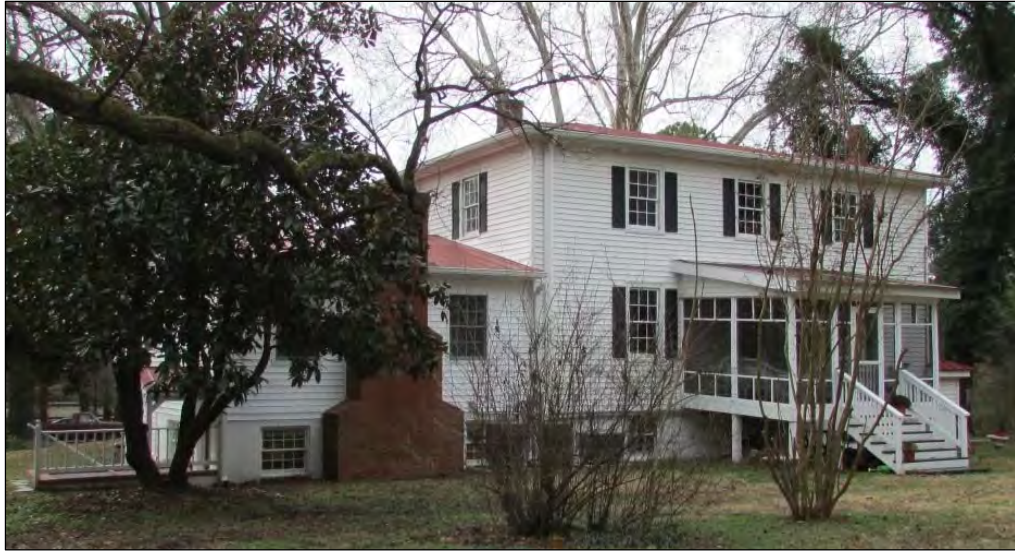
Other fenestration consists primarily of six-over-six, double-hung, vinyl replacement windows flanked by fixed shutters. A one-and-a-half-story, post-1966 addition at the northeast corner of the dwelling features a raised concrete-block foundation, frame structural system clad in vinyl siding, and a side-gabled roof. An exterior brick chimney with two sets of shoulders is located on the northwest elevation of the addition. On the northeast elevation, a set of concrete steps leads down to a subterranean entrance that accesses the basement. In 2015, construction was underway

to expand the addition with a raised, post-in-ground extension on the southeast elevation and a new gabled roof (Figure 3-148).

FIGURE 3-148: DWELLING AT 16095 POLECAT LANE, NORTHEAST ELEVATION

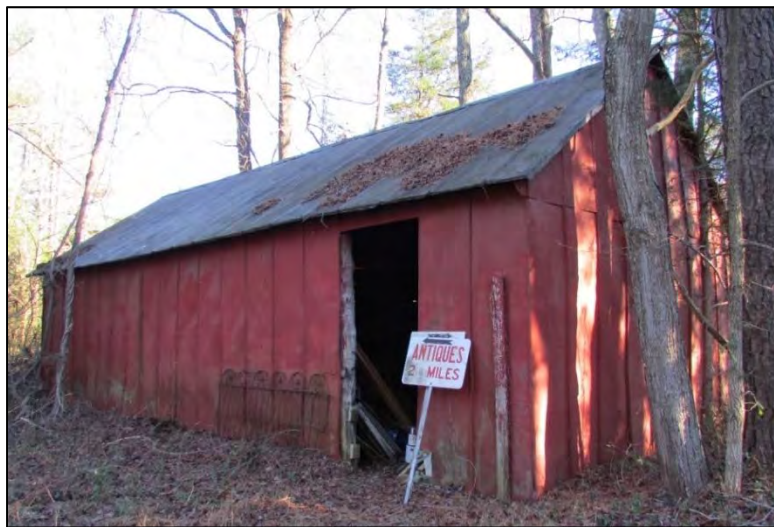
A small, rectangular, frame barn with a side-gabled roof is located in the southeast corner of the property, immediately adjacent to Polecat Lane and approximately 125 feet from the railroad tracks (Figure 3-149). According to historic aerial imagery, the barn predates 1966 and is estimated to have been constructed around the same time as the house circa 1911. An entrance on the north elevation provides access to the interior and does not have a door. Two small sheds are located on the north side of the property (Figure 3-150). One of the sheds, constructed around 1911, is a square frame building clad in board-and-batten siding located northwest of the dwelling. The building features a single-leaf door of vertical boards centered on the south elevation. The second small frame shed clad in T1-11 siding is located northeast of the house and is estimated to have been constructed circa 1925. The shed roof is covered with v-crimp metal. Fenestration includes a single-leaf, wood door and six-light, wood-framed windows.

FIGURE 3-149: BARN, NORTHWEST OBLIQUE

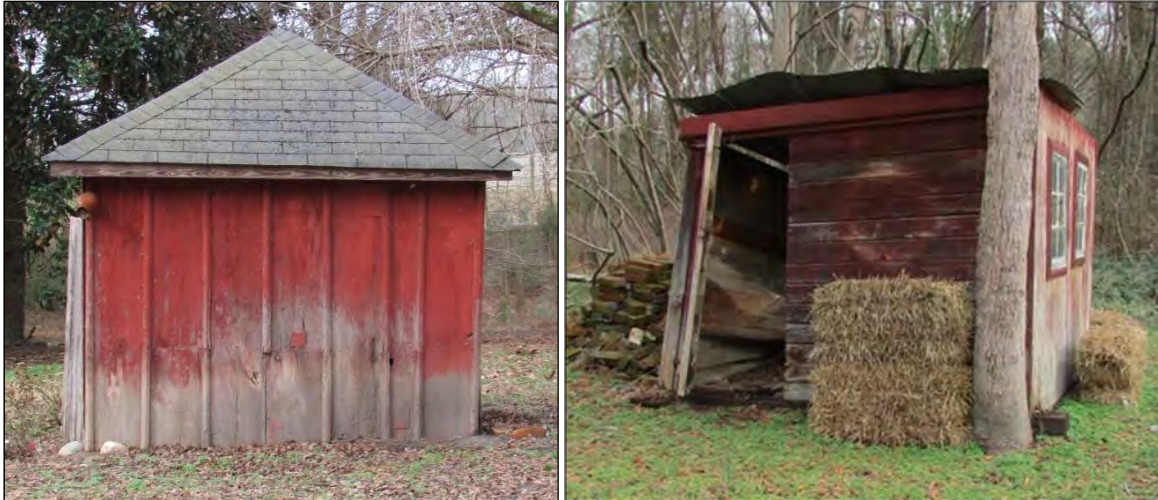
FIGURE 3-150: SOUTH ELEVATION OF CIRCA-1911 SHED (LEFT); NORTHWEST OBLIQUE OF CIRCA-1925 SHED (RIGHT)

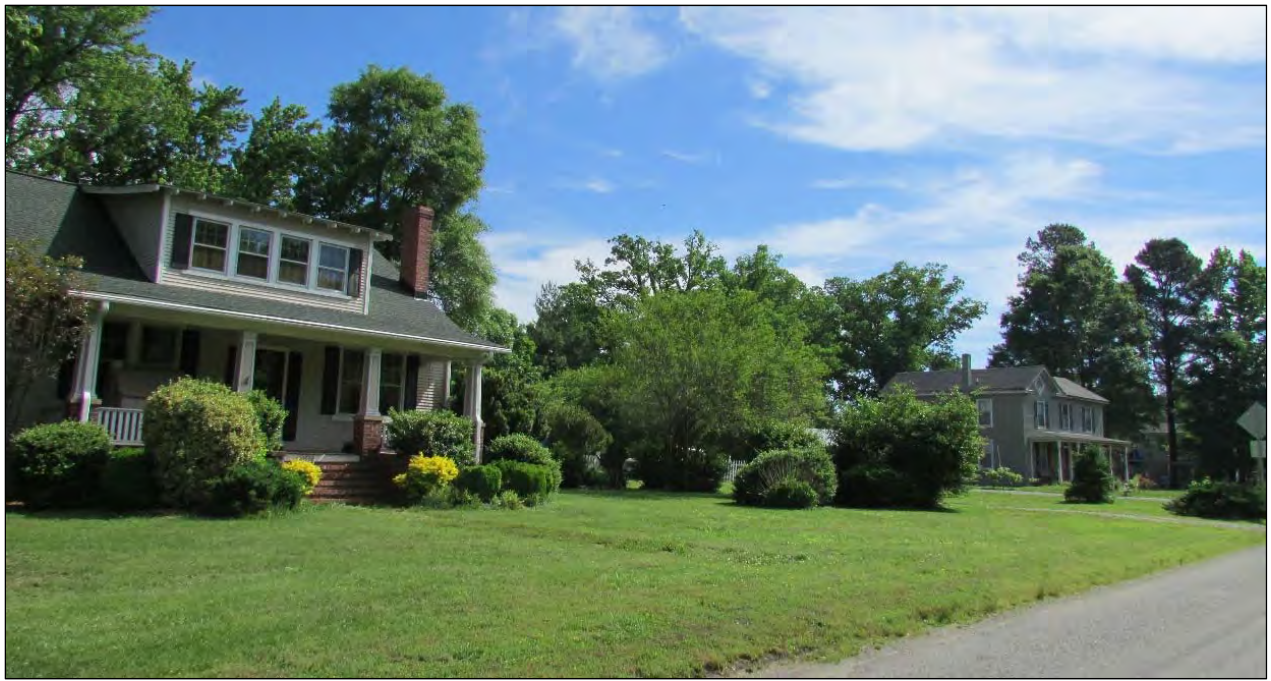
The architectural styles of the residential buildings included within the district boundaries reflect trends seen through this region of Virginia during the turn of the twentieth century, except for the Billy Wright House (042-0477) which was constructed circa 1850. A majority of the residential resources constructed between 1890 and 1900 reflect a vernacular form and are mainly two stories in height and have an L-shape or I-house plan. These include the Flippo House (042-0474), Daniel Campbell House at 10548 Doswell Road (042-0472), Daniel Campbell House at 10540 Doswell Road (042-0473), and Daniel Campbell House at 10564 Doswell Road (042-0475) (Figures 3-159 and 3-160). Following the Eclectic movement that was popularized during this time, other architectural styles or characteristics thereof seen through the village include Georgian Revival and Free Classic (Doswell Inn, 042-0468, and Daniel Campbell House at 10571 Doswell Road, 042-0467) (Figure 3-161) (McAlester 2015). Outliers of the group of residential buildings in the Doswell Historic District is the House at 10558 Doswell Road (042-0471), which was constructed in circa 1927 as a Craftsman-style bungalow, and the House and Warehouses at 10600 Doswell Road (042-5719), which was constructed in circa 1925 in a one-story vernacular form (Figure 3-159).

**FIGURE 3-159: VIEW OF 10558 AND 10548 DOSWELL ROAD (042-0471 AND 042-0472),
LOOKING NORTHEAST**

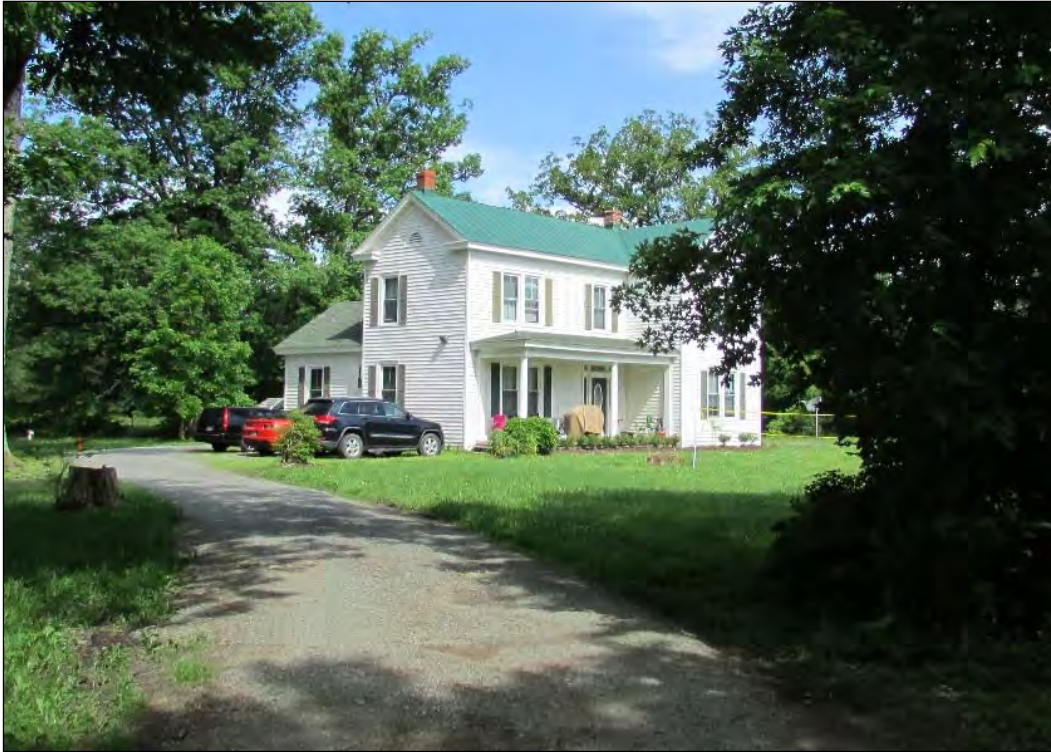
FIGURE 3-160: SOUTHEAST OBLIQUE OF 10536 DOSWELL ROAD (042-0474)

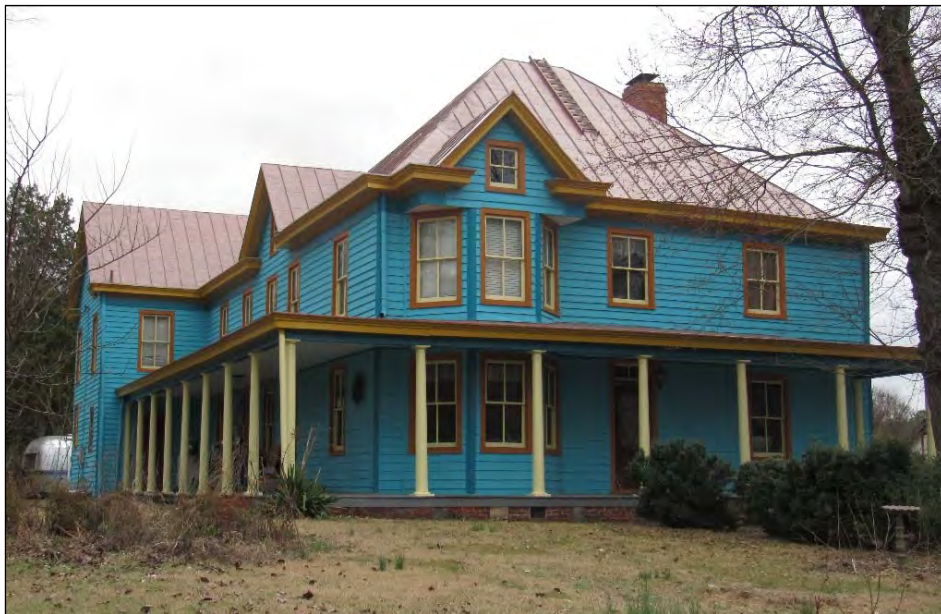
FIGURE 3-161: NORTHWEST OBLIQUE OF 10571 DOSWELL ROAD (042-0467)

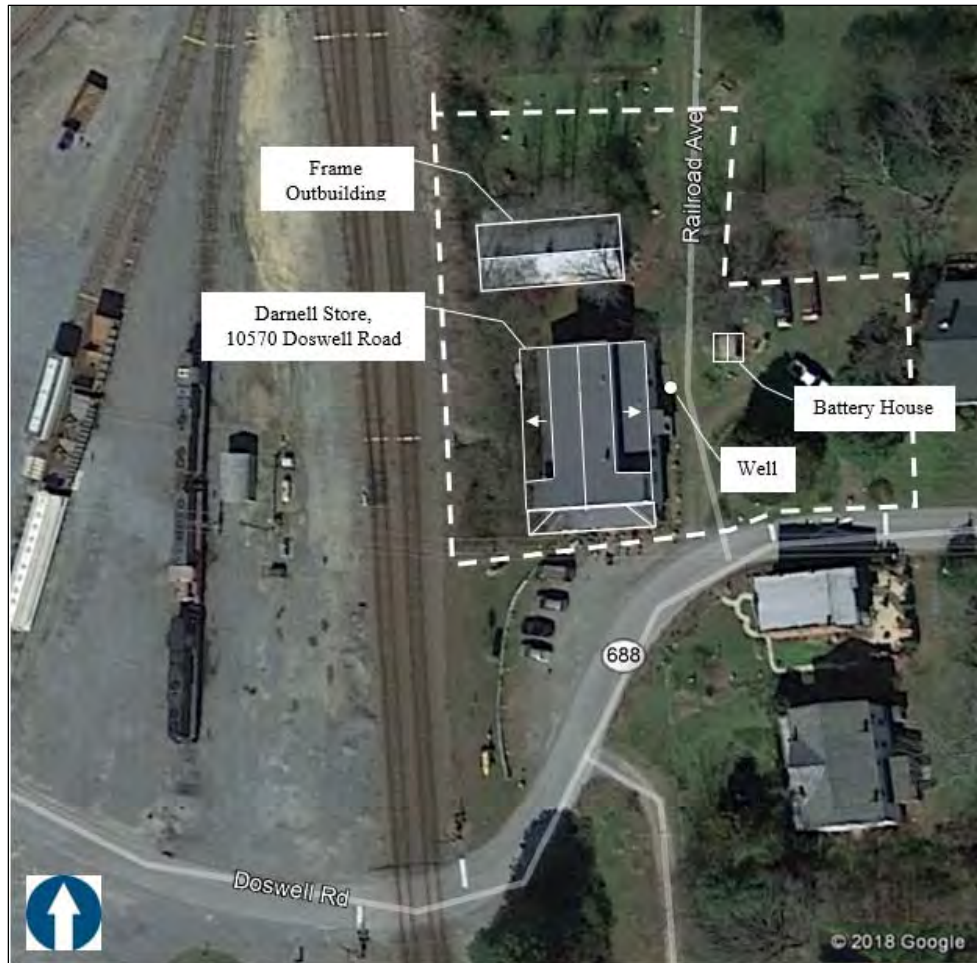
The Darnell Store, a former general store located at 10570 Doswell Road, is a two-and-a-half-story, three-bay, frame, commercial building constructed around 1898 in a vernacular form with a rectangular plan (Figures 3-167 and 3-168). The building rests on a continuous, pier-type, poured-concrete foundation with visible form mark which supports a balloon-frame structural system clad in weatherboard siding with wood corner boards. A monitor-type roof primarily covers the building, while a wide, front-gabled roof is situated on the south elevation (façade) – all of which is sheathed in standing-seam metal. The front-gabled section appears to be original to the building's construction. An interior-slope brick chimney pierces the roof on the east side of the roof ridge in the southeast corner of the building while a metal flue is situated in the northeast corner. An additional brick chimney stack is visible on the west side of the roof's ridge.

FIGURE 3-167: SITE PLAN FOR DARNELL STORE (NOT TO SCALE)

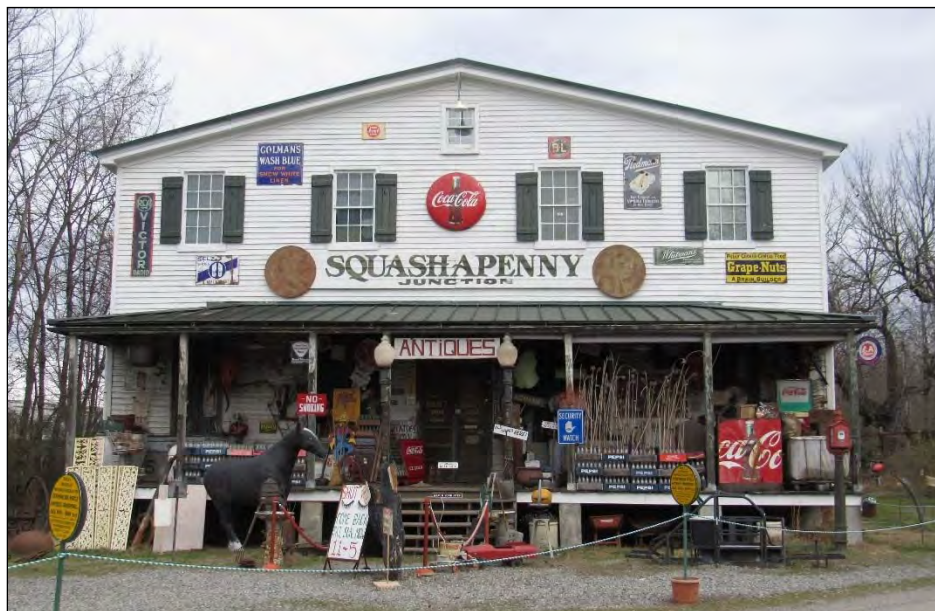
FIGURE 3-168: DARNELL STORE, SOUTH ELEVATION

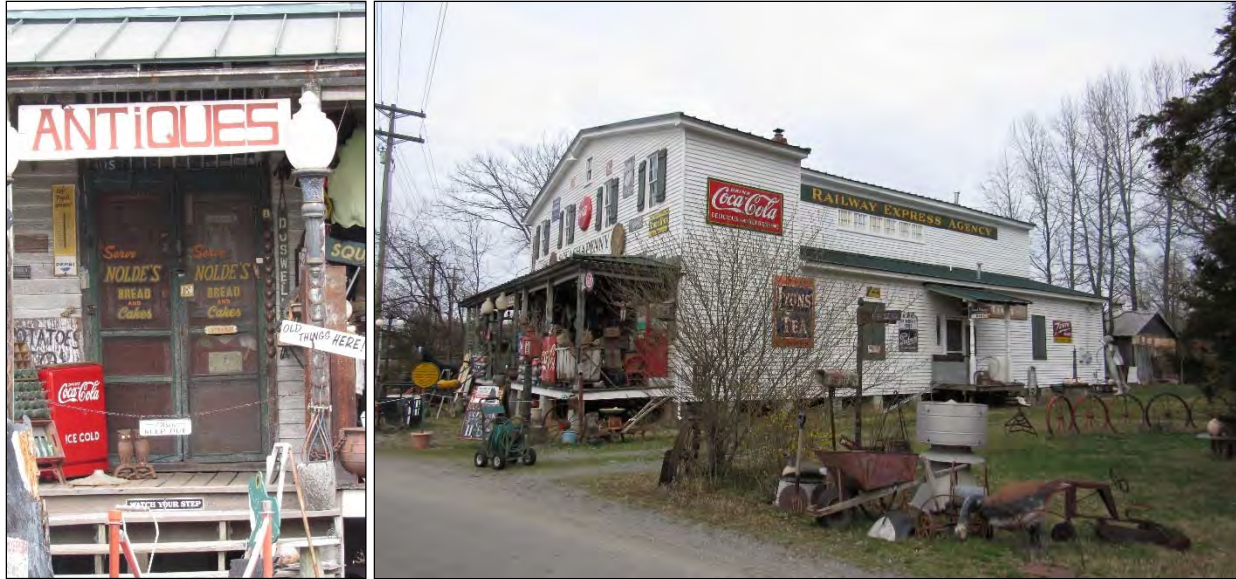
The primary entrance, centered on the façade and surrounded by a wood frame, is filled with a double-leaf, wood, three-paneled, half-glazed door covered by wood, screen doors (Figure 3-169). A large, wood-frame, two-light transom is set above the entrance and is covered by a metal grate. Other fenestration includes single and paired, six-over-six, wood-frame, double-hung sash windows; single and ribbons of multi-light, wood-frame, casement; and single one-over-one, wood-frame, double-hung sash windows. A majority of windows are flanked by wood, board-and-batten shutters and several are covered by metal grates. Secondary entrances were observed on the north and east elevation; the north entrance is filled with a single-leaf, wood-frame, six-paneled door and the east entrance features a similar door covered by a wood-frame, screen door (Figure 3-170). A shed-roof, entry porch with a wood deck set up on wood piers is situated in front of the east entrance. The roof is supported by turned, wood posts and the porch is accessed by a set of wood steps. A wood entry porch raised on wood piers accessed by a set of steps is lined with a wood rail is situated in front of the southern entry. A cellar entrance is off-centered on the east elevation and is filled with a concrete bulkhead with a metal door. A one-story, full-width porch spans the façade. The wood deck set on parged concrete-block piers is covered by a hipped roof supported by squared, wood posts.

FIGURE 3-169: PRIMARY ENTRANCE DETAIL (LEFT) AND SOUTHEAST OBLIQUE (RIGHT)

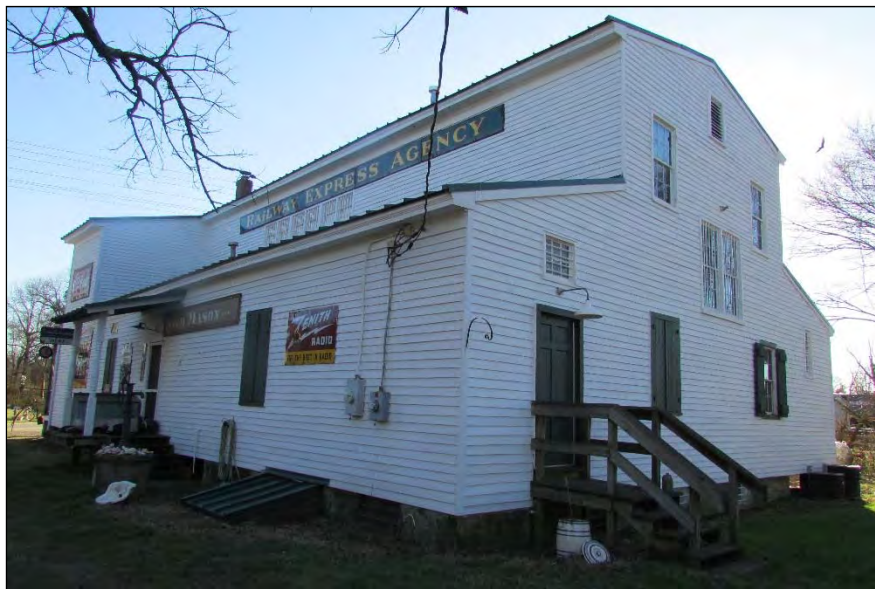
FIGURE 3-170: NORTHEAST OBLIQUE. PHOTO FROM THE FEBRUARY 2016 RECONNAISSANCE-LEVEL SURVEY OF THE DC2RVA PROJECT.

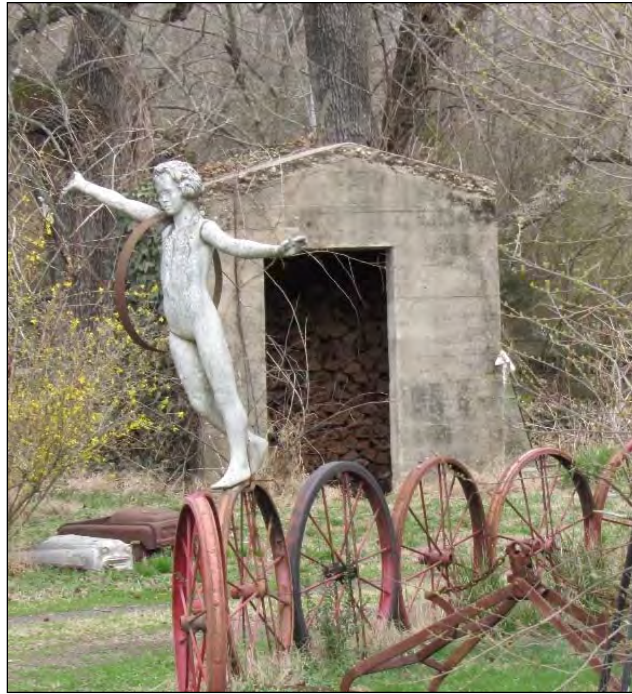
A circa-1960, one-story, one-bay, poured-concrete battery house, is located east of the primary resource (Figure 3-171). Wood form marks are visible on the building's exterior. It is covered by a concrete, front-gabled roof. Situated immediately east of the store is a circa-1920, concrete well superstructure covered by a circular well cap with a central metal water pump.

FIGURE 3-171: BATTERY HOUSE, SOUTH ELEVATION

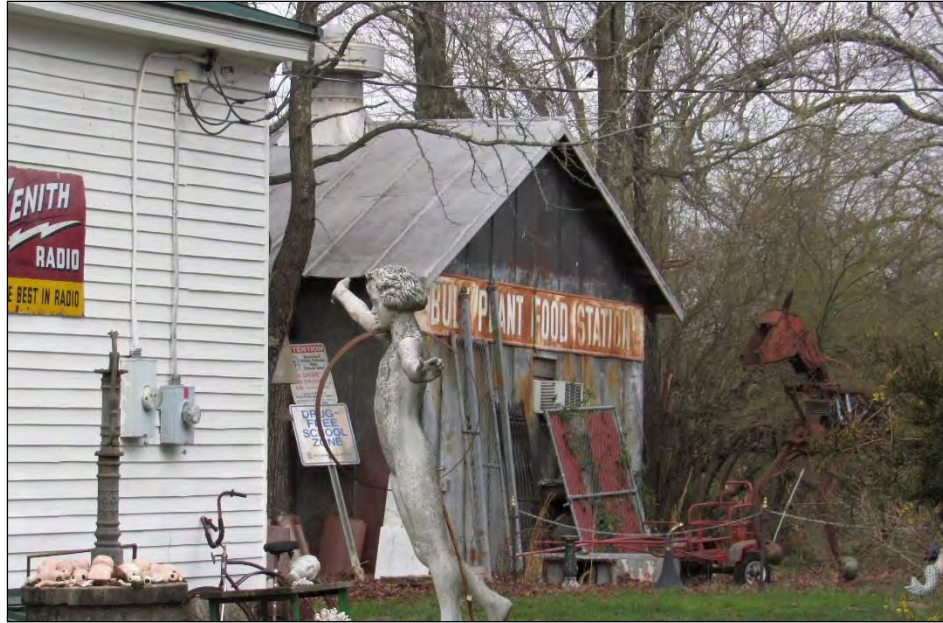
North of the store is a circa-1910, one-story, frame storage building, noted by the current property owner to have been originally used as a stock barn and tack storage building (Figures 3-172 and 3-173). The building is set on a concrete-block pier foundation which supports a frame structural system clad in standing-seam, pressed metal. A sign on the east elevation reads "Bulk Plant Food Station". The rectangular building is covered by a side-gabled roof, with wide eaves featuring exposed wooden rafter tails, and is clad in v-crimp pressed metal. Three modern, metal turbines pierce the roof ridge and are evenly spaced. Two single-leaf, sliding metal doors situated on a metal rail system are located on the south elevation of the building. Window openings have been filled with plywood board.

FIGURE 3-172: FRAME OUTBUILDING AND WELL, EAST ELEVATION

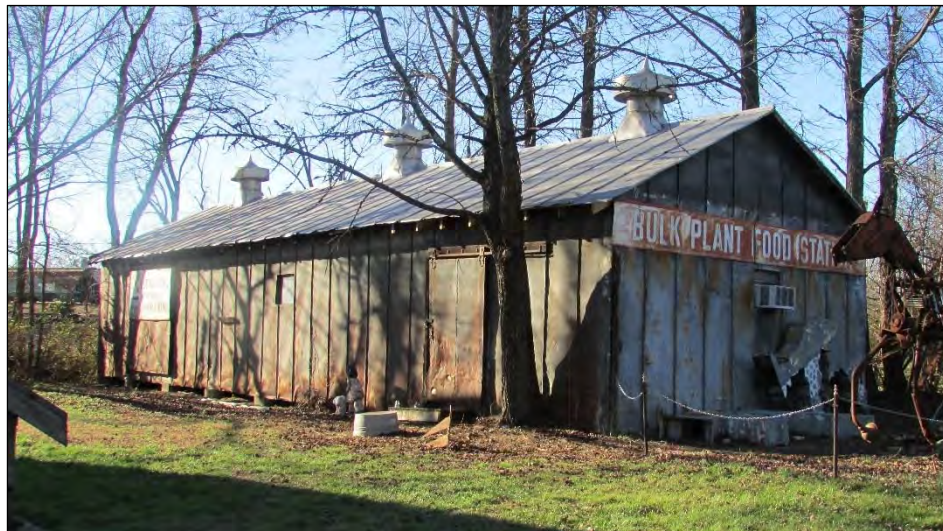
FIGURE 3-173: FRAME OUTBUILDING, SOUTHEAST OBLIQUE. PHOTO FROM THE FEBRUARY 2016 RECONNAISSANCE-LEVEL SURVEY OF THE DC2RVA PROJECT.
