ARCHITECTURAL INTENSIVE INVESTIGATIONS

D.C. TO RICHMOND SOUTHEAST HIGH SPEED RAIL

Architectural Intensive Investigations for the Washington, D.C. to Richmond Southeast High Speed Rail (DC2RVA) Project

DHR #2014-0666

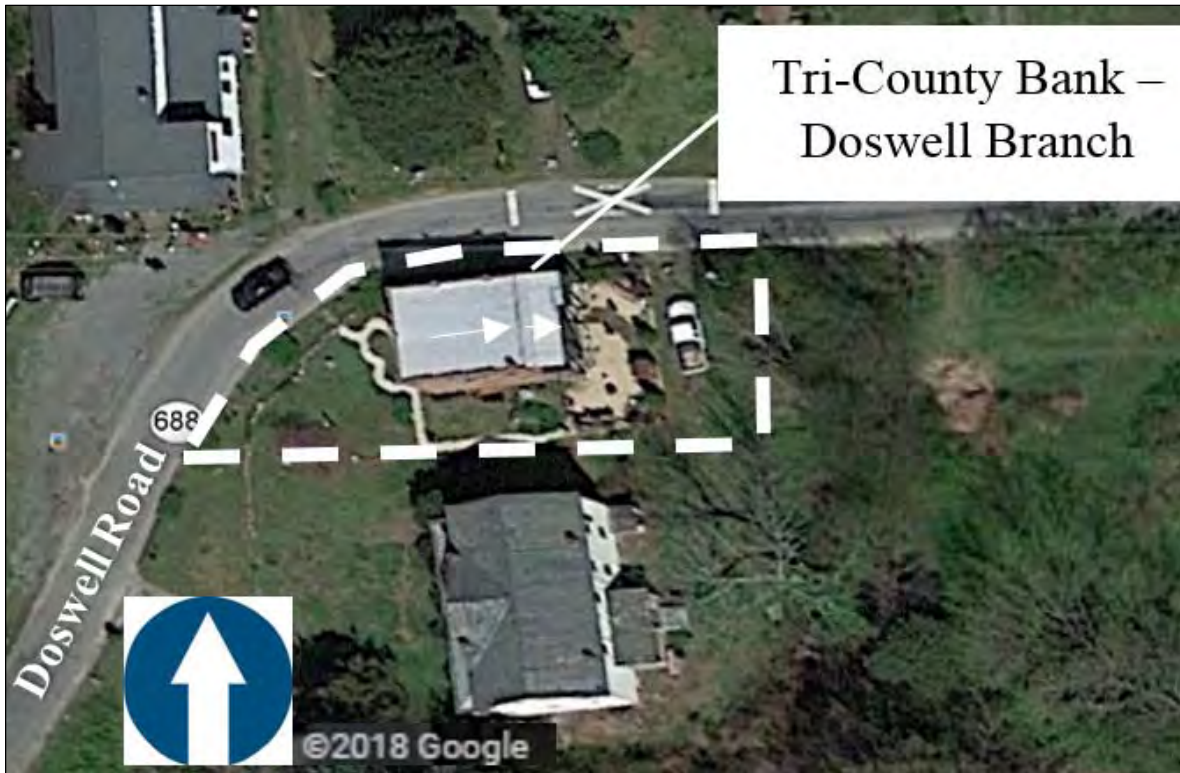
The Tri-County Bank, located at 10561 Doswell Road, is a two-story, three-bay, masonry building constructed circa 1920 in a vernacular commercial building style with limited Colonial Revival elements. The building is set on a continuous, poured-concrete foundation supporting a masonry structural system constructed of brick three wythes thick (Figure 3-176). The brick is laid in a seven-to-one common bond on all elevations save for the façade, which is laid in an English bond. The façade also features three inset panels with six-point metal stars as well as a large, circular metal sign reading "BANK" (Figure 3-177). Three metal hoods shielding rain spouts are evenly spaced on the north and south elevation, and the north elevation also features a decorative metal bracket that once held a sign at the second story. The building is covered by a flat roof surrounded by a stepped, brick parapet with brick coping along the north, west, and south elevations; a metal eagle sits centrally atop the parapet on the façade. Two interior-end brick chimneys are evenly spaced on the north elevation while a similar chimney is situated in the southeast corner of the building.

FIGURE 3-176: SITE PLAN OF THE TRI-COUNTY BANK (NOT TO SCALE)

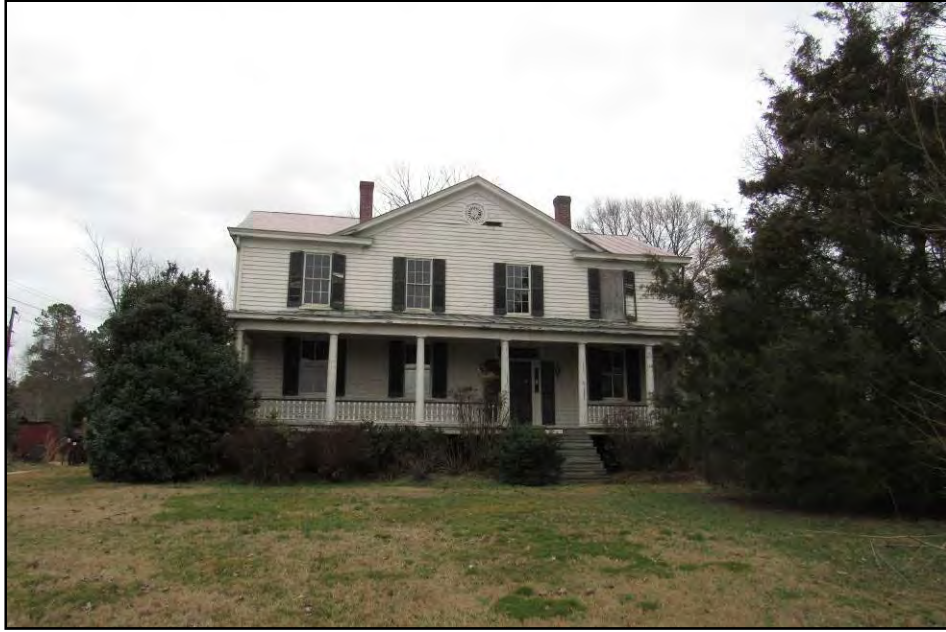
FIGURE 3-183: DOSWELL INN, PRIMARY (WEST) ELEVATION

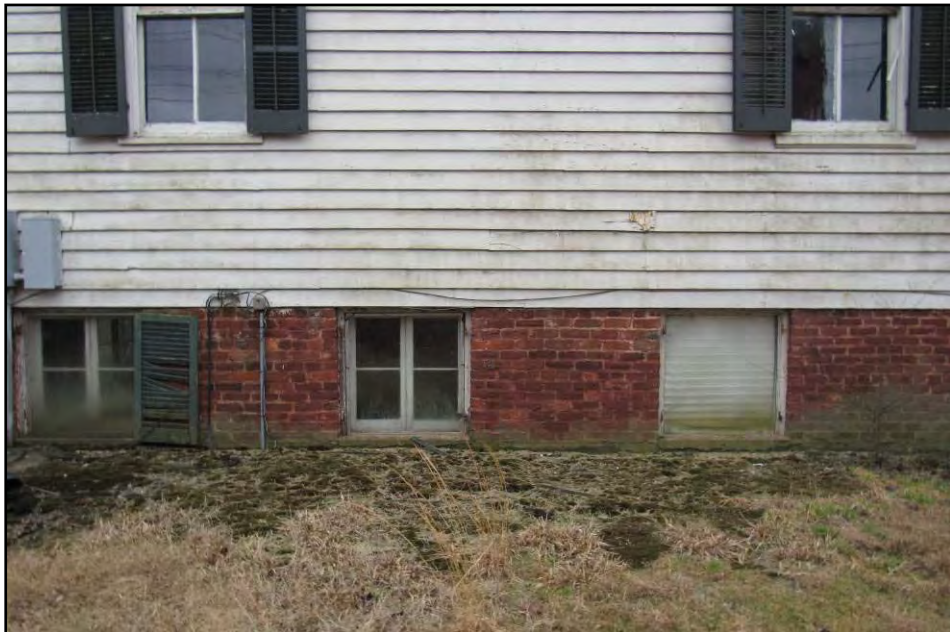
FIGURE 3-184: DOSWELL INN, FOUNDATION DETAIL ON NORTH ELEVATION

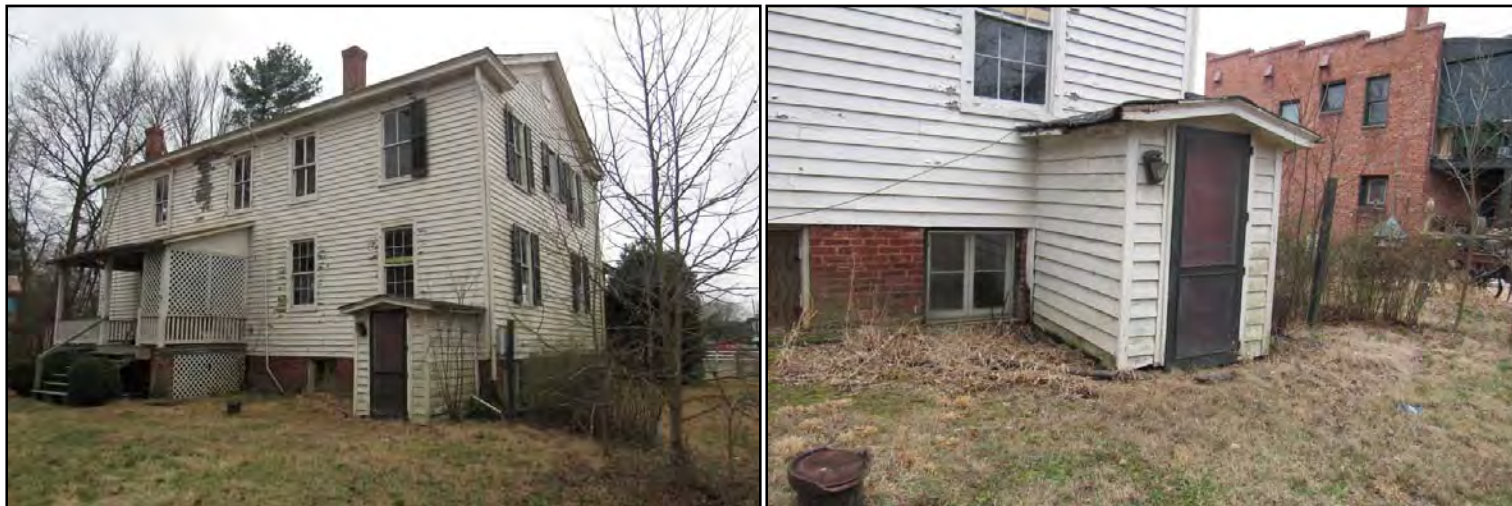
A full-width, one-story porch spans the façade. The porch is set on a brick-pier foundation topped by a wood floor and is covered by a hipped roof supported by wood Tuscan columns. It is accessed by a recently constructed set of wood steps and lined by a turned wood balustrade that appears original to the construction of the building. A one-story, two-bay porch extends from the center of the east elevation (Figure 3-186). Its brick-pier foundation features wood lattice infill, supporting a wood floor, and a shed roof with squared wood posts. The porch is primarily lined by a simple wood balustrade with square rails while the north elevation is screened by wood lattice. A recently constructed set of wood stairs with a wood railing provides access the east porch. A one-story, gabled, exterior, cellar entryway extends from the north corner of the east elevation (Figure 3-186). It is clad in the same materials as the core of the building.

FIGURE 3-186: NORTHEAST OBLIQUE (LEFT); CELLAR ENTRANCE ON NORTH SIDE OF EAST ELEVATION (RIGHT)

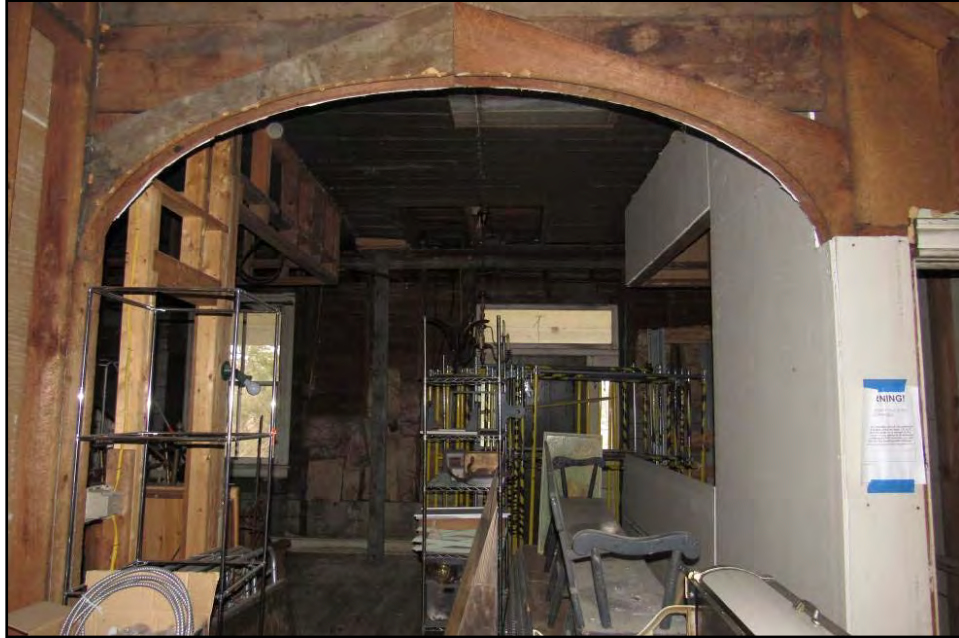
FIGURE 3-188: FIRST STORY HALL, LOOKING EAST

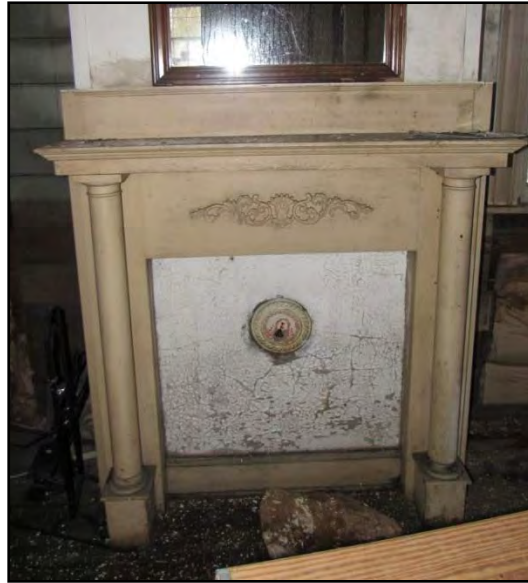
FIGURE 3-190: DETAIL OF FIREPLACE MANTEL IN WEST WALL OF LIVING ROOM

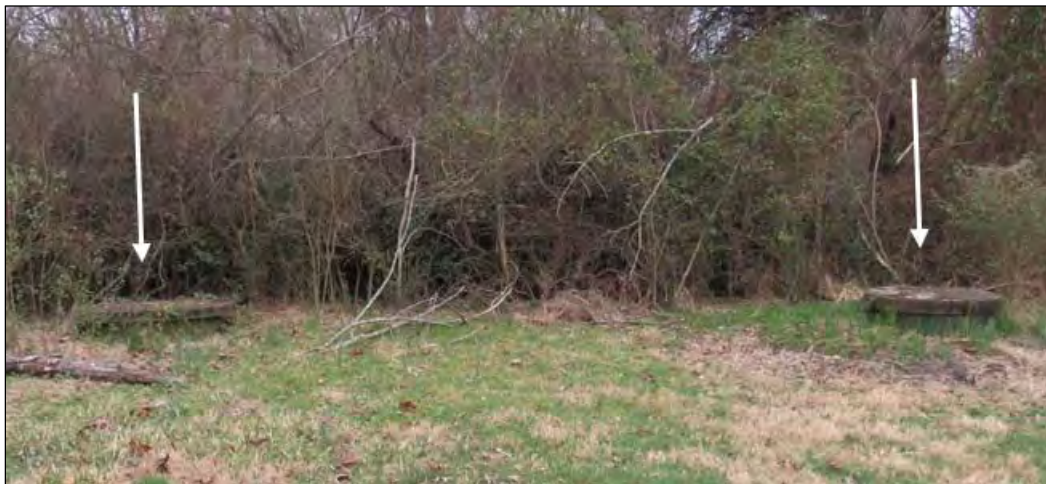
Two circa-1970, concrete well superstructures are located east of the primary resource and are covered by circular, concrete caps (Figure 3-193). An unknown metal superstructure is located immediately east of the primary resource, and it measures approximately 1 foot in height. It is possible that the superstructure is access to a gas tank; however, the current owner could not corroborate this (Figure 3-194). A circa-1910 stone slab is located east of the primary resource near the wells. According to the owner, it is possible that this slab was used as a possible carriage or horse step; however, it may have served as a possible tank slab (Figure 3-194) (Roxanne Pizarro, personal communication 2018).

FIGURE 3-193: VIEW OF WELLS, LOOKING EAST

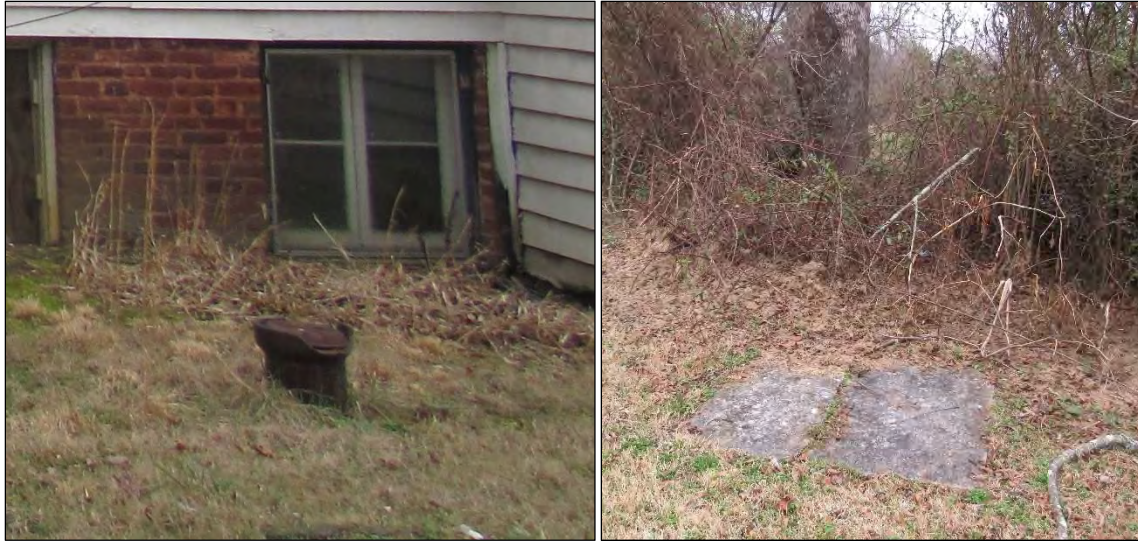
FIGURE 3-194: VIEW OF METAL SUPERSTRUCTURE, LOOKING NORTHWEST (LEFT); VIEW OF STONE SLAB, LOOKING EAST (RIGHT)

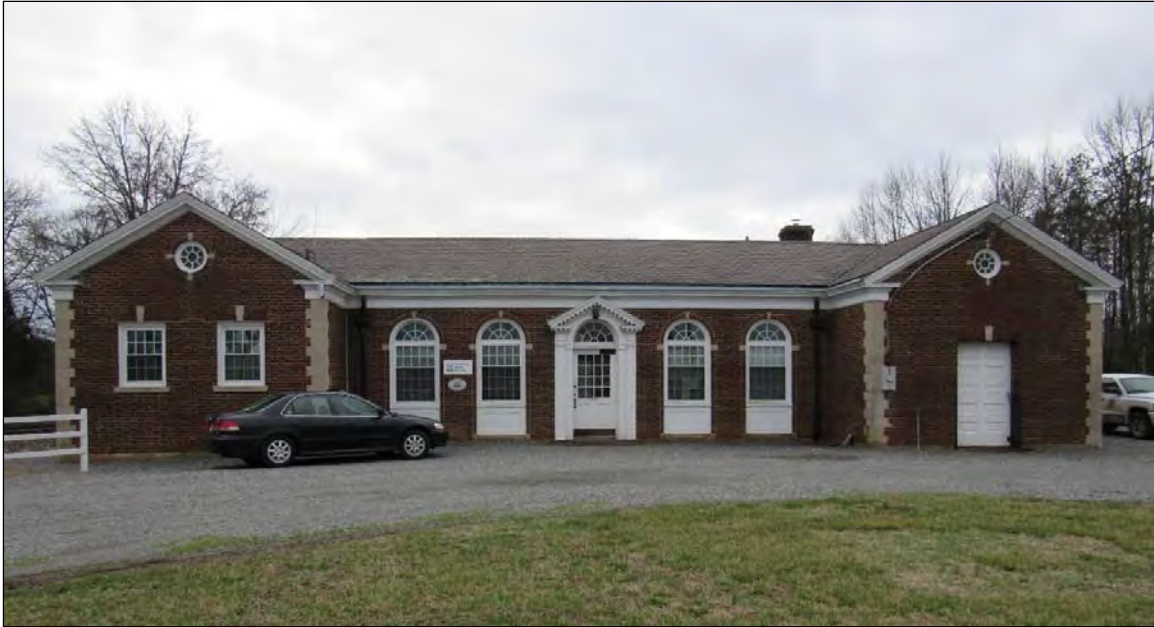
The passenger depot at 10577 Doswell Road is a circa-1927, one-story, eight-bay, Classical Revival-style building with an I-plan (Figure 3-198) (Daily 2015). It rests on a continuous foundation supporting a frame structural system—both of which are clad in a Flemish-bonded brick veneer with cast-stone quoins (Figures 3-199 and 3-200). It is largely covered by a side-gabled roof with two flanking front-gabled wings, all of which are sheathed in slate shingles. A simple, wood, denticulated cornice lines the tight eaves of the roof, and the gabled ends of the building have prominent partial returns. Metal gutters are built into the eave sides of the building.

FIGURE 3-199: NORTHWEST ELEVATION OF THE DOSWELL DEPOT

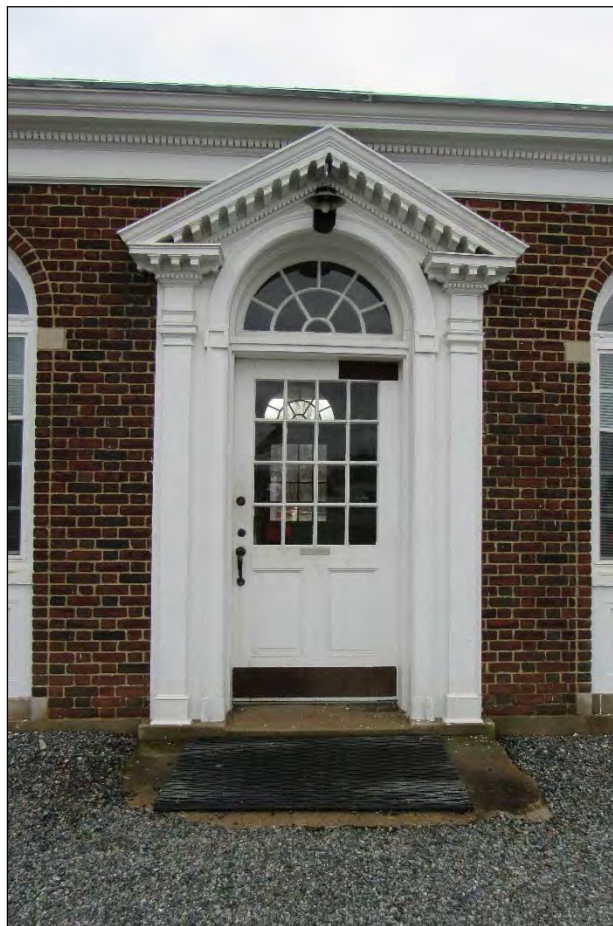
The primary entrance is centrally located on the façade (northwest elevation) and is filled by a wide, single-leaf, half-glazed, wood door topped by a wood-frame fanlight (Figure 3-201). The entrance is surrounded by a classical entablature with a denticulated broken pediment with

modillions and plain pilasters. Windows appear to be largely one-over-one, vinyl replacement units with muntins simulating eight or 10 lights over 12 or 16 in the bottom sash. Many windows are topped by fanlights, some of which are replacements, and supported by wooden aprons below. Decorative brickwork includes cast-stone cornerblocks and keystones in semi-circular or splayed jack arches. Original rounded wood windows are situated in the gable ends of both the east and west wings of the building. A one-story, flat roof promenade spans the non-gabled portion of the southeast elevation (Figure 3-202). The roof, supported by squared Doric-style columns, features a denticulated cornice and a paneled parapet. The promenade leads to a secondary entrance filled with the same style door as the primary entrance. An additional entrance is situated in the southeast elevation of the east gabled wing and is filled with a single-leaf replacement door topped with a flat stepped pediment. Another entrance is located on the same elevation of the west gabled wing and is filled with a large single-leaf, wood, paneled door. It is emphasized by a brick jack arch with a central cast keystone. A similar door is located on the northeast elevation of the west gabled wing.

FIGURE 3-201: DETAIL OF PRIMARY ENTRANCE

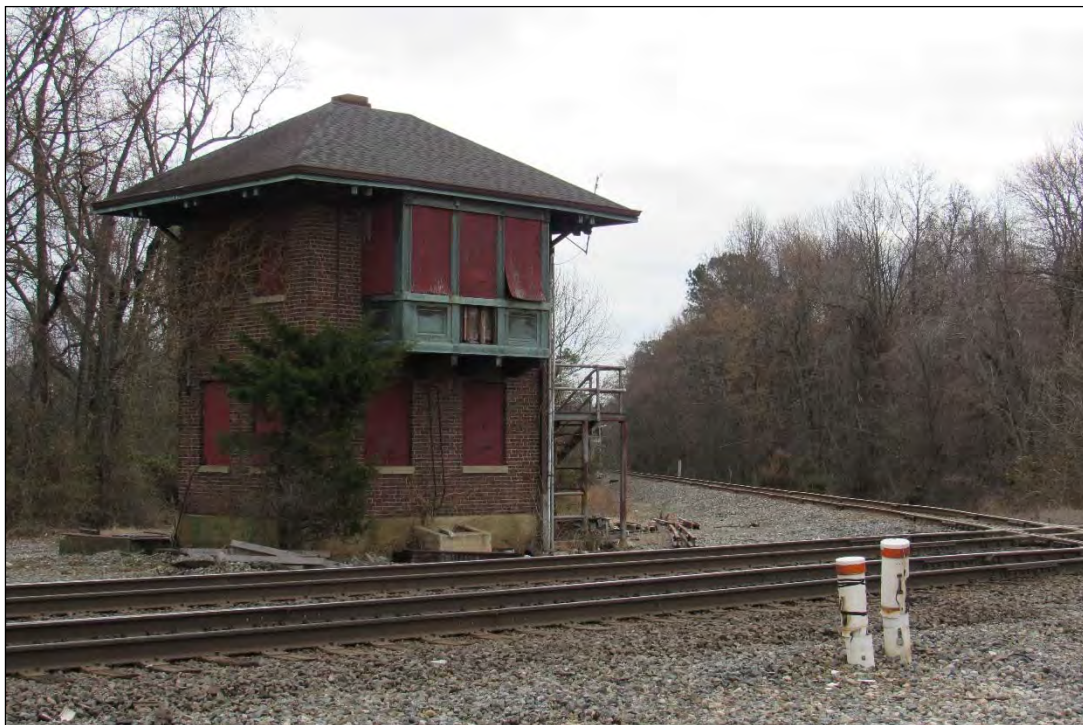
The HN switch tower associated with the passenger depot building is said to have been constructed around 1929 (Figures 3-204 and 3-205) (Daily 2015). This structure housed electrical systems on the ground floor that managed an interlocking device permitting safe crossing of trains over both railroads and an office for an operator on the second floor. The tower rests on a continuous poured-concrete foundation and has a structural system that is clad in a Flemish-bonded brick veneer. The building is covered by a steeply pitched, hipped roof sheathed in asphalt shingles with an interior-slope, brick chimney piercing its southwest corner. The roof's wide overhanging eaves are marked by paired copper-clad brackets. A copper-clad bay window projects from the second story of the tower at the west elevation overlooking the intersection of the RF&P and C&O Railroad tracks and has the letters "HN" embossed on it. This bay window serves as a defining feature for interlocking stations as the projecting bay allowed for better visual observation for the operator along the rail line (Bupp et al. 2016). A metal pipe staircase leads to the tower's upper level at the south elevation. Doors and many windows in the building are currently boarded over, as the tower no longer functions as a manned mechanized interlocking control tower.

FIGURE 3-204: VIEW OF HN TOWER AND RAILROAD, LOOKING SOUTHEAST

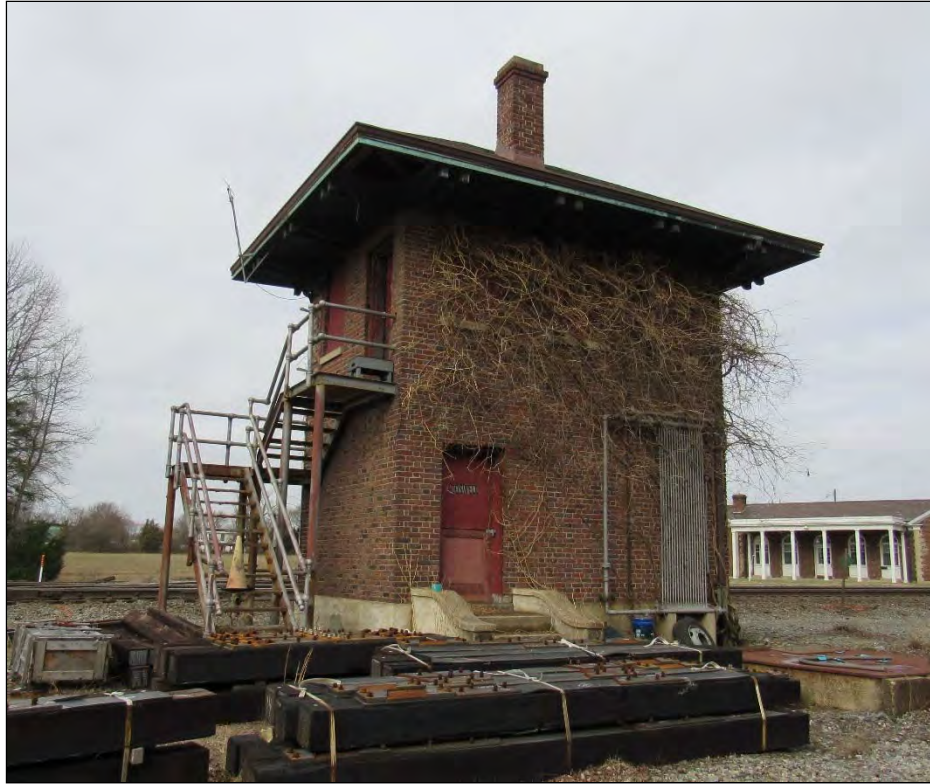
FIGURE 3-205: SOUTHEAST OBLIQUE OF THE HN TOWER

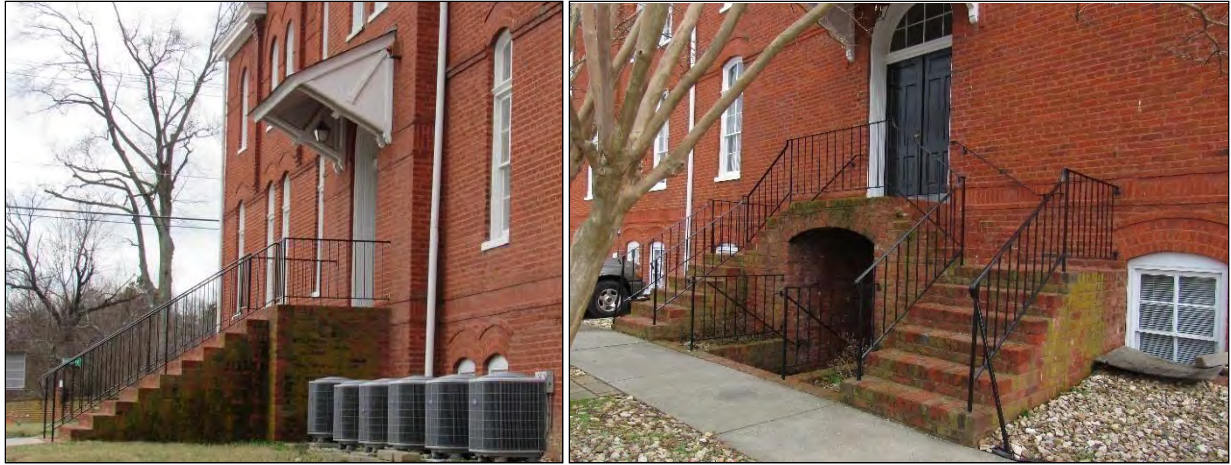
The building's primary entrance is situated in the center of the east elevation, beneath the central gable, with a similar entrance mirrored on the west (Figure 3-214). They are both filled with replacement, double-leaf, paneled doors featuring an eight-light, arched, wood transom. The eastern entrance is accessed by a raised brick stoop lined with a metal railing and is covered by a pent roof supported by wood brackets and sheathed in slate shingles. An arched opening on the south side of the stoop provides direct access to a basement-level entrance that is filled with a single-leaf, metal door. The western entrance also has a brick stoop with a shed overhang; however, a set of stairs extends north and south from the stoop providing a central (western), arched access to a basement-level entrance. This entrance features a double-leaf, half-glazed, metal door. An additional basement-level entrance is off-centered in the north elevation and is filled with a single-leaf, metal door with a single-light wood transom above. A poured-concrete walkway lined by brick retaining walls provides access to the northern basement entrance.

FIGURE 3-214: EAST ENTRANCE, LOOKING SOUTH (LEFT); WEST ENTRANCE, LOOKING NORTHEAST (RIGHT)

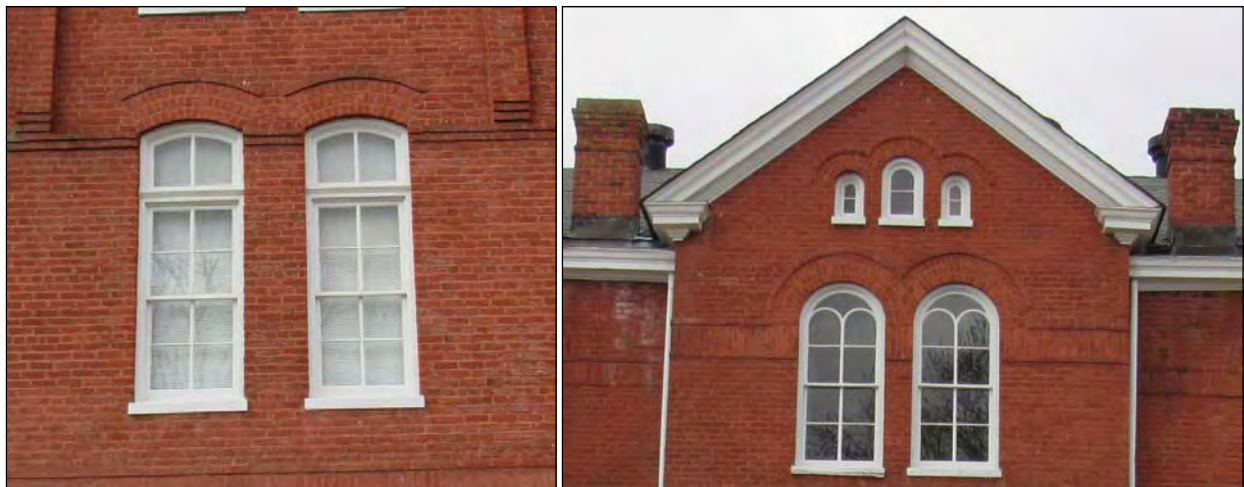
The building contains a variety of fenestration, all detailed with segmental and arched openings—a hallmark of the Romanesque Revival style (Figure 3-215) (McAlester 2015:387–394). The second story includes single and paired, Venetian-style windows with five-over-four, wood-frame, double-hung sashes and wood sills. The first story features single and paired, four-over-four, wood-frame, double-hung-sash windows with a segmental arch, two-light, transom above and wood sills below. Windows in the basement-level include four-over-four, wood-frame, double-hung-sash windows set within segmental arch openings. All of the window arches are composed of brick headers with wood sills below. At the first and second floors, the decorative brickwork of each arch is connected by a belt course that wraps around the entire building. A set of three two-light, wood-frame, arched, possible casement windows are located in the central gable of the east elevation; they also feature brick arches and wood sills. Two circular, boarded up openings are centered within the gables in the north and south elevations; they are encircled by brick headers.

FIGURE 3-215: FIRST STORY WINDOW DETAIL, EAST ELEVATION (LEFT); SECOND STORY AND GABLED WINDOW DETAIL, EAST ELEVATION (RIGHT)

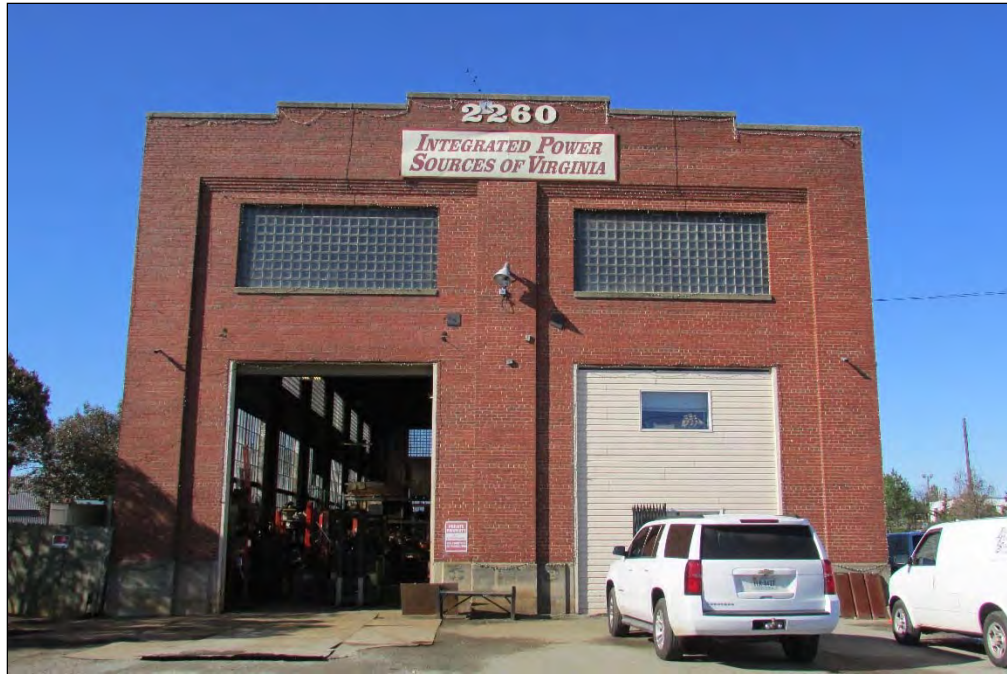
The resource is a one-story, two-bay commercial building with a rectangular plan with elements of the Art Deco and Moderne architectural styles (Figures 3-224 and 3-225). It is built on a poured-concrete foundation and is constructed of brick laid in a five-to-one common bond with low-relief corbeling framing fenestration, often seen in Art Deco/Moderne buildings (Figure 3-226) (McAlester 2015). Similar to many commercial buildings of the period, the former paint shop is covered by a very low-pitched, front-gabled roof, featuring a stepped parapet with a concrete cap on the primary (northeast) and rear (southwest) elevations. In the center of the northeast parapet are large metal numbers reading "2260." Iron anchor plates are also visible in those elevations. Current online aerials indicate that the roof has been lined with multiple solar panels.

FIGURE 3-225: NORTHEAST ELEVATION OF RF&P PAINT SHOP

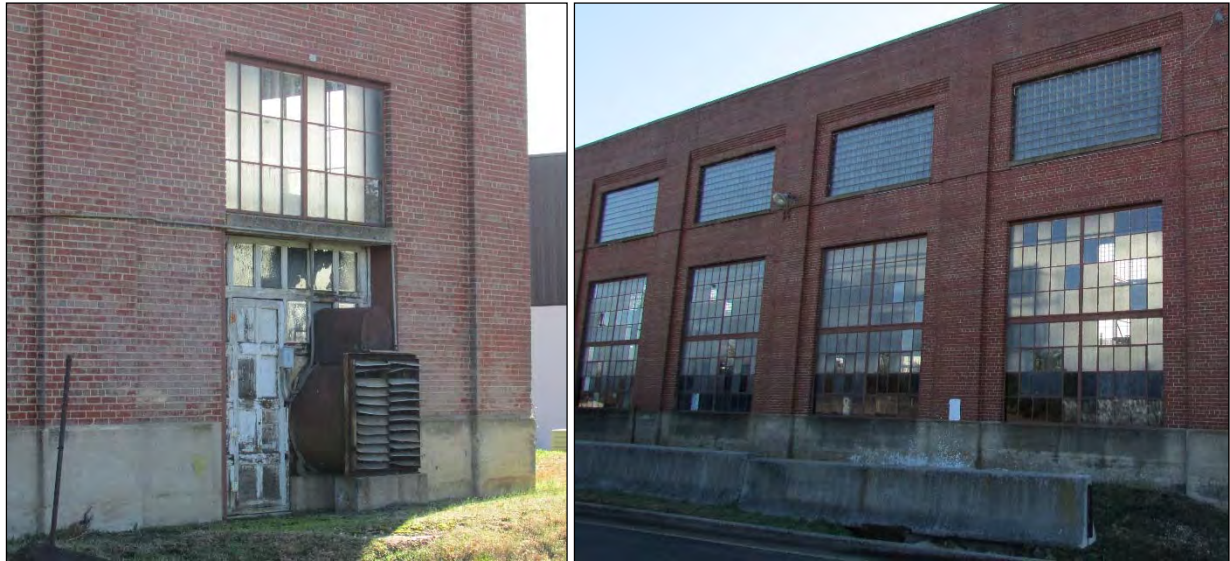
The northeast elevation features two large garage bays. The southern bay is filled with a metal, segmental, overhead garage door while the northern has been filled with vinyl siding and retrofitted to feature a single-leaf door. The southwest elevation mirrors the northeast elevation; however, each garage bay is filled with a wood, paneled, tilt-up garage door with multiple lights and an inset single-leaf pedestrian door (Figure 3-227). Each door has been retrofitted with a large

ventilation unit, most likely leftover from the former use of the building. A square concrete slab protrudes southwest from the center of the southwest elevation between the two garage bays. Additional fenestration includes a combination of multi-light, fixed, metal windows with a central, 10-light, awning sash and rectangular groupings of fixed glass blocks (Figure 3-227). All windows feature a reinforced-concrete sill. Defunct lines of track lead from the parking area into the two bays on the northeast elevation.

FIGURE 3-227: DETAIL OF GARAGE BAY WITH INSET PEDESTRIAN DOOR, SOUTHWEST ELEVATION (LEFT); DETAIL OF WINDOWS, NORTHWEST ELEVATION (RIGHT)

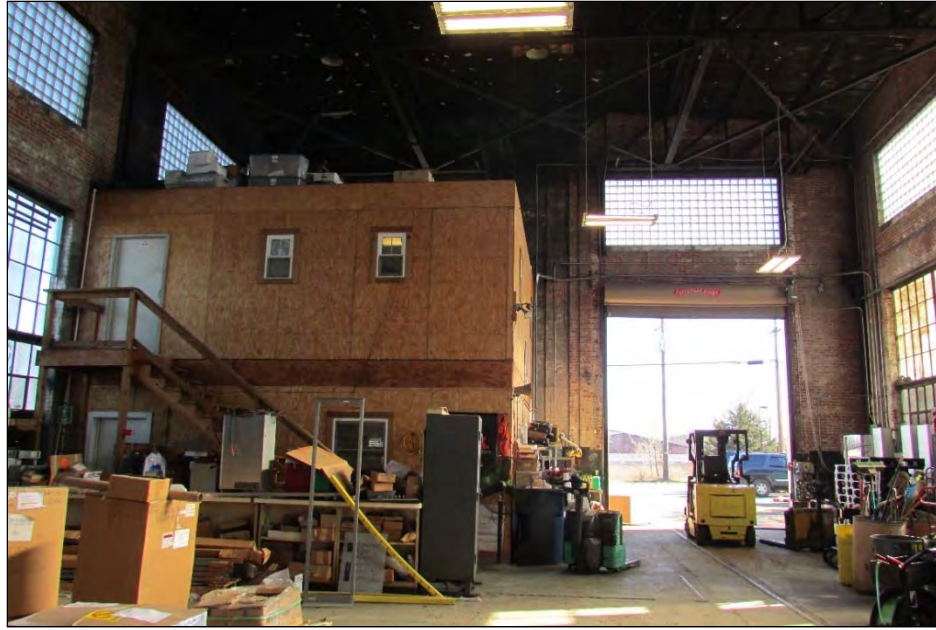
FIGURE 3-230: VIEW OF BUILDOUT AND PRIMARY ENTRANCE, LOOKING NORTHEAST. NOTE DEFUNCT TRACK LINES IN BOTTOM RIGHT OF IMAGE.

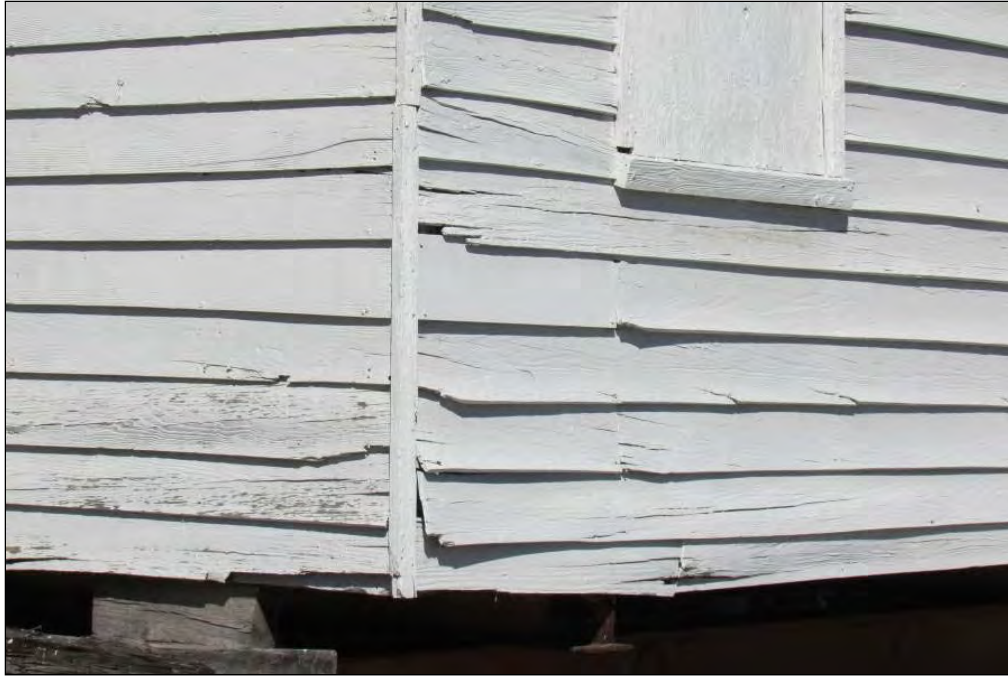
FIGURE 2-236: DETAIL OF SIDING, SOUTH OBLIQUE

The Winfree Cottage is a one-story dwelling constructed around 1866 within the boundaries of Manchester, then an independent city in Chesterfield County (Figure 3-234). Because it was moved from its original location in 2002 to its current location in Richmond, the foundation is unknown; it is currently set on a metal flatbed raised on pieces of cut lumber. A moderately pitched, hipped roof sheathed in standing-seam metal covers the weatherboard-clad frame structural system (Figures 3-235 and 3-236). Boxed eaves are clad in wood and extend

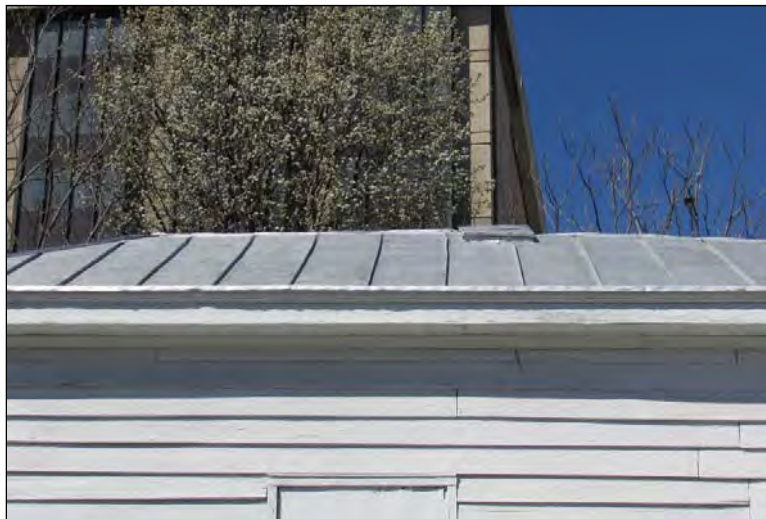
FIGURE 3-237: DETAIL OF FORMER LOCATION OF CHIMNEY, LOOKING NORTHWEST

approximately 6 inches from the plane of the wall on all sides. A patched, square hole along the roof's ridge shows where a central-interior brick chimney once stood (Figure 3-237).

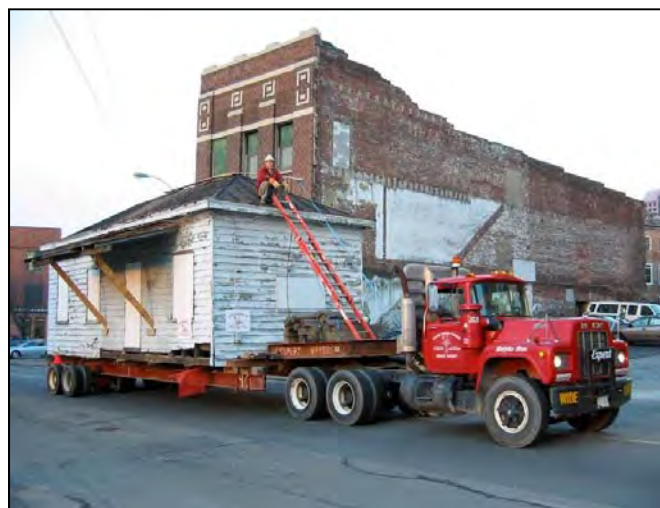
FIGURE 3-239: 2003 PHOTOGRAPH OF THE WINFREE COTTAGE BEING MOVED FROM W. COMMERCE STREET. NOTE THE SURVIVING PORCH ROOF (RICHARDSON 2017).

in standing-seam metal and supported by modern pieces of lumber acting as brackets; this architectural element is no longer extant (Figure 3-239).

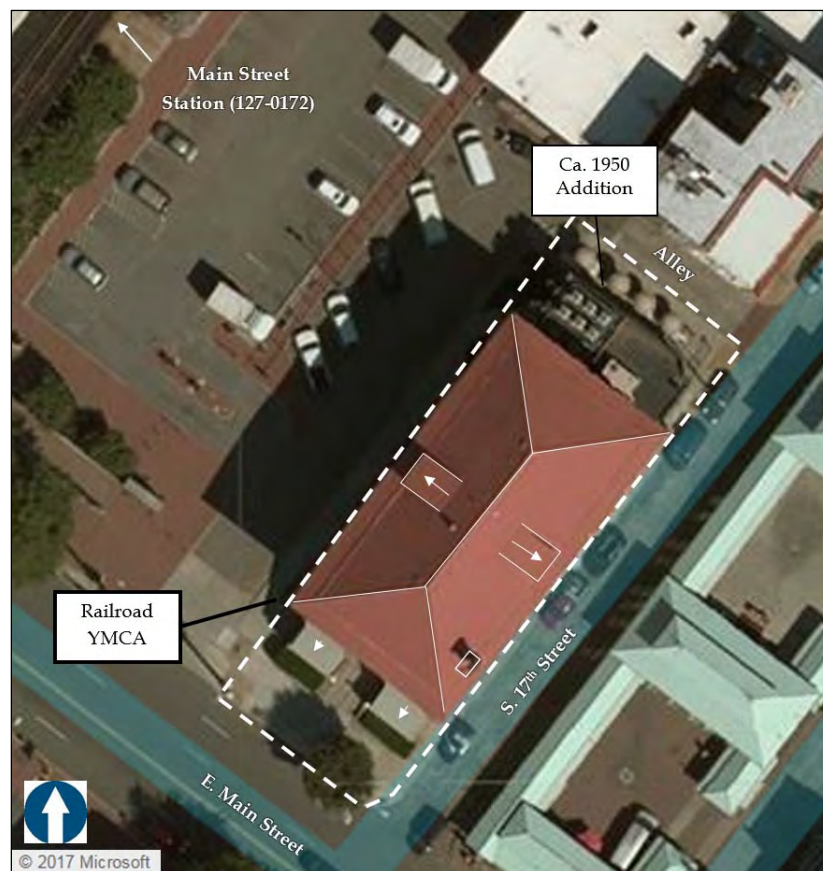
FIGURE 3-248: SITE PLAN OF THE RAILROAD YMCA (MICROSOFT 2017) (NOT TO SCALE)

The Railroad YMCA is a three-story, three-bay, rectangular, Italian Renaissance Revival-style commercial building constructed in 1907 by the Philadelphia architectural firm of Wilson, Harris and Richards (Figures 3-248 through 3-250) (Wilson 2002:192). The building currently is in use as residential lofts and apartments as well as a restaurant (Rosie Connolly's Pub & Restaurant) and a catering event space. The building sits on a continuous, raised basement foundation supporting a masonry structural system all sheathed in a brick laid in a running bond imitating Roman brick, calling to the Italian Renaissance Revival style in which it was constructed. The raised basement is lined with two rows of squared stone at the base, with the top row beveled, and six rows of regular stretcher bond brick to one row of relief stretcher bond brick. A molded concrete water table with a denticulated cornice beneath the table separates the basement from the first story while a denticulated belt course is located between the second and third stories. The building is covered by a low-pitched, hipped roof sheathed in terra cotta tile with open, overhanging eaves containing scrolled, wooden brackets and a geometric cornice (Figure 3-251). An exterior-end chimney with a corbeled cap is located in the south half of the southeast elevation which pierces the overhanging roof eaves and features a corbeled base. A central shed dormer is centered in the northwest and southeast elevations.

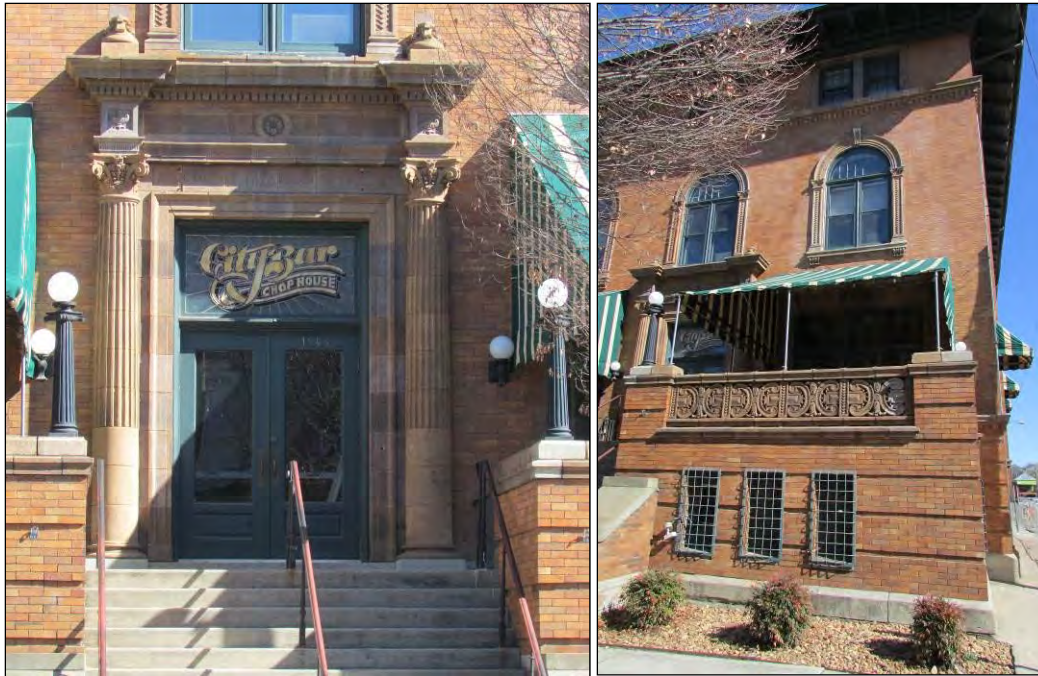
FIGURE 2-252: DETAIL OF PRIMARY ENTRANCE TO EVENT SPACE, SOUTHWEST ELEVATION (LEFT); DETAIL OF TERRACE AND FENESTRATION, SOUTHWEST ELEVATION (RIGHT)

Centered on the southwest elevation (façade) is the former primary entrance to the building. It is currently the primary entrance for the catered event space. The heavily ornamented entrance, typical of the Italian Renaissance Revival style in which the building was constructed, is filled with a double-leaf, single-pane, single-panel, wood door and framed by fluted, engaged columns with Corinthian capitals and a full decorated entablature and architrave (McAlester 2015:406). The entablature is engraved with "Railroad Branch Y.M.C.A." (Figure 3-252). A rectangular, stained glass, metal-frame transom is set above the entrance and reads "Citi Bar Chop House." The remaining two bays in this story are filled with a double-leaf, wood-and-glass door flanked by single-light, wood-frame sidelights and a topped by a large multi-light, wood-frame transom. Metal-frame, cloth-covered awnings extend from the outer bays, providing a protected area of the terrace that spans the façade for outdoor dining. The terrace along the façade is accessed by a grand central staircase, leading directly to the primary access to the catered event space, which comprises 13 concrete steps lined with a squared, concrete-and-brick balustrade (Figure 3-252). Window openings in the foundation are barred with metal. At the pinnacle of the staircase, access to the southern and western portions of the terrace have been blocked by a metal rail. The remainder of the terrace is lined by a decorative balustrade.

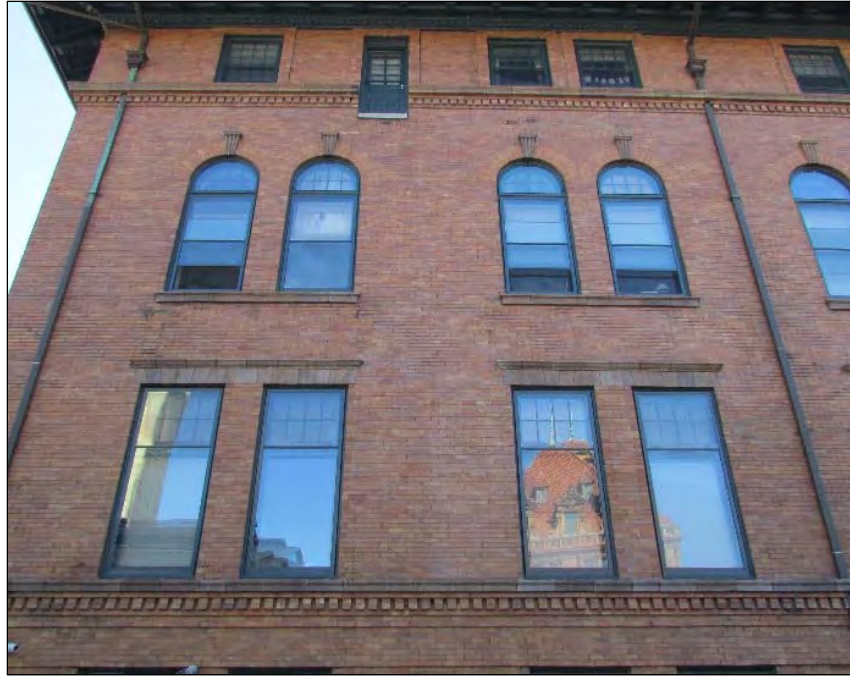
FIGURE 3-253: DETAIL OF FENESTRATION, NORTHWEST ELEVATION

Entrance to the residential portion of the resource is obtained by several single-leaf, metal, paneled doors with multiple lights. Most doors are topped by a single-light, wood-frame, transom. Other fenestration includes paired and single, one-over-one, wood-frame, double-hung-sash windows, some of which feature a single- and multi-light, arched transom set above with a stone keystone (Figure 3-253). Windows in the façade also have decorative stone trim creating a Florentine arch springing from pilasters capped with Corinthian-style capitals. Those with no arched window feature a flat stone lintel. Windows in the raised basement and third story are eight-over-eight, wood-frame, double-hung sashes with wood surrounds and relief brick trim. A “Romeo and Juliet” door is located in the third story of the northwest elevation, although it may have been an access to a fire escape; it is filled with a single-leaf, paneled, wood door with six lights and is covered by a metal rail (Figure 3-253) (Kim Pitts, personal communication 2018). A two-story, flat-roof addition clad in the same materials as the core extends from the north half of the northeast elevation while a one-story, frame addition extends from the east half of the elevation. Both additions were constructed circa 1950 and currently houses a restaurant and its kitchen (Figure 3-254).

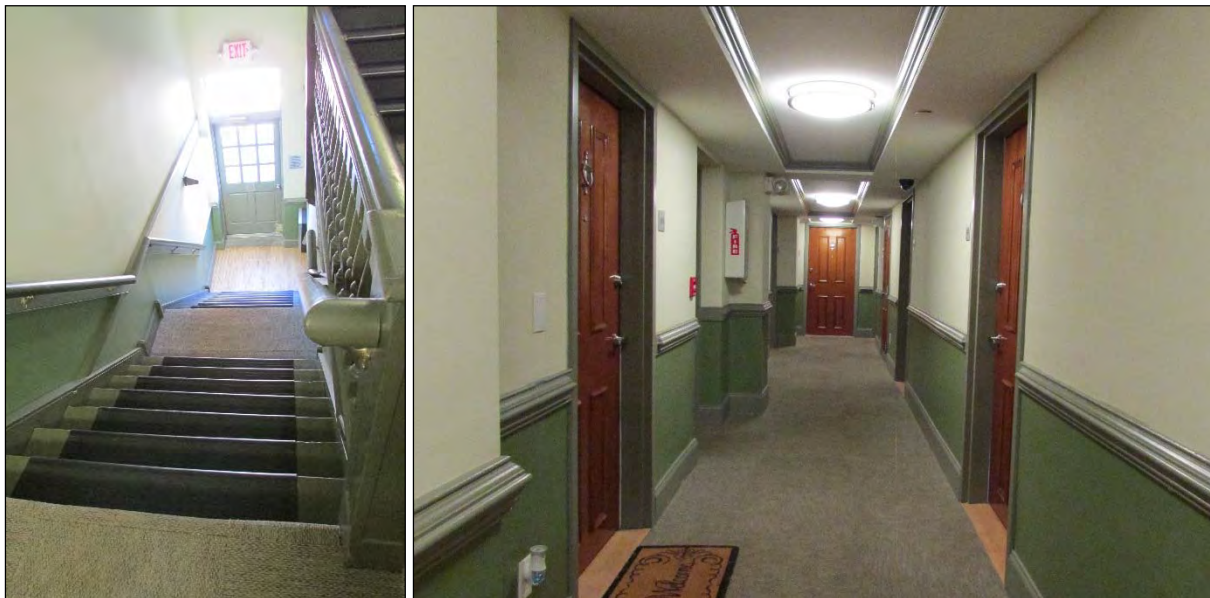
FIGURE 3-255: VIEW OF STAIRWELL FROM FIRST-STORY LANDING (LEFT); VIEW OF THIRD-STORY HALLWAY, LOOKING NORTHEAST (RIGHT)

Entrance to the residential portion of the Railroad YMCA is obtained through a single-leaf door in the basement level of the northwest elevation. It opens into a four-story stairwell featuring a wood staircase that is partially lined with a turned wood balustrade that pauses at a landing in each story (Figure 3-255). The walls that partially house the staircase are drywall with an ADA compliant metal stair rail and chair rail. The stairs themselves are partially covered by rubber matting and the landings feature modern carpeting. An elevator and associated elevator room,

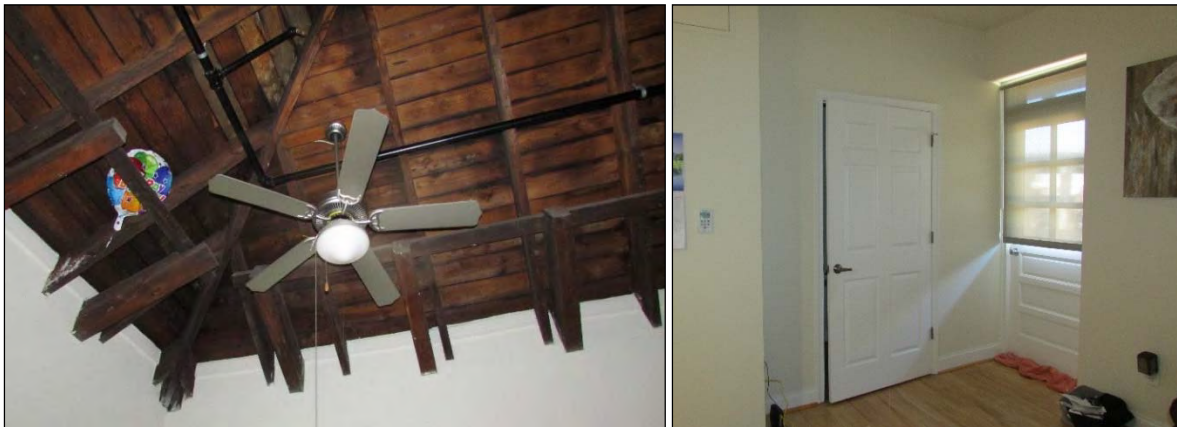
FIGURE 3-257: EXPOSED ROOFING SYSTEM IN THIRD-STORY LOFT (LEFT); VIEW OF “ROMEO AND JULIET” DOOR IN THIRD-STORY LOFT, LOOKING WEST (RIGHT)

kitchenette that lined a portion of the northeast wall. The loft is primarily covered in the original wood flooring save for the kitchenette area which is covered in laminate tile. A carpet-clad, winder staircase lined with a metal and wood rail is situated in the northeast portion of the loft which provides access to the loft space above. The ceiling is open to the wood framing of the hipped roof and eaves (Figure 3-257). This loft features the “Romeo and Juliet” door in the southeast wall previously mentioned (Figure 3-257). The other loft available for viewing during the survey is located in the southwest portion of the second story. Accessed by a single-leaf, wood door, the entrance opens into an open living area with a coffered ceiling and covered in original wood flooring (Figure 3-258). A small kitchenette is in the northeast wall. Along the southeast wall is a bedroom and an enclosed winder staircase that leads to a loft space (Figure 3-258).

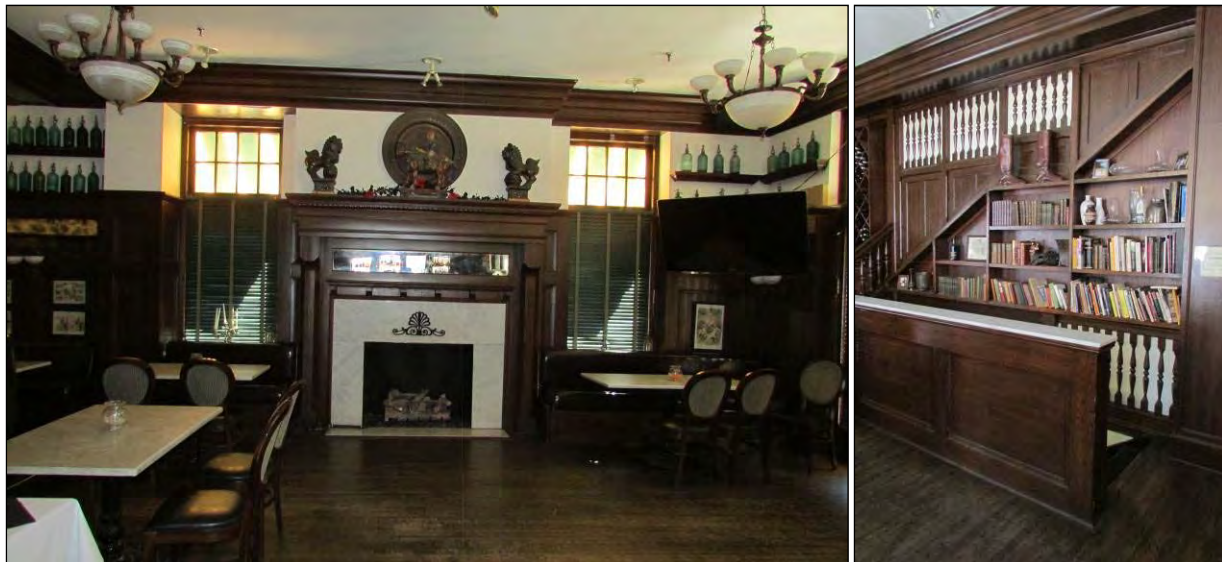
FIGURE 3-259: SOUTHEAST WALL IN CATERING EVENT SPACE IN FIRST STORY (LEFT); STAIRCASE TO BASEMENT LEVEL AND ENCLOSED STAIRCASE TO SECOND STORY, LOOKING NORTH (RIGHT)

The catering and event space encompasses the southwest third of the building in the basement level and first story. The basement level contains a full contemporary kitchen, and an enclosed stairwell along the northeast wall of the kitchen leads to the event space in the first story. The first story event space features wood flooring and paneled wood walls. A bar is located along the northwest wall while a large chimney opening with a marble mantel surround is in the southeast wall (Figure 3-259). A recessed panel filled with a mirror is set beneath the simply decorated wood mantelshelf and beveled wood columns. Two partition walls block off the primary entrance in the southwest elevation and a waiters' area in the northeast portion of the room. An enclosed staircase to the second story is visible in the west half of the northeast wall (Figure 3-259). Access to the remainder of the basement and the restaurant (Rosie Connolly's Pub & Restaurant) on the northeast side of the building was not granted during the current survey.
