ARCHITECTURAL INTENSIVE INVESTIGATIONS

D.C. TO RICHMOND SOUTHEAST HIGH SPEED RAIL

Architectural Intensive Investigations for the Washington, D.C. to Richmond Southeast High Speed Rail (DC2RVA) Project

DHR #2014-0666

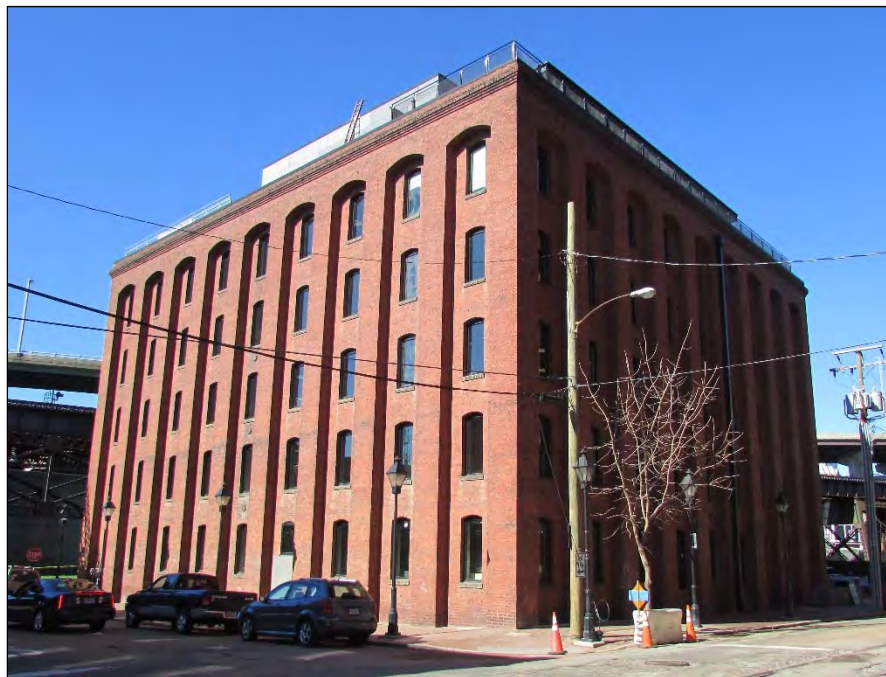
FIGURE 3-267: EAST ELEVATION OF THE PHILIP MORRIS STORAGE WAREHOUSE

The Philip Morris Tobacco Storage Warehouse building is a five-story, 10-bay, trapezium-shaped, utilitarian industrial building constructed around 1914 (Figure 3-266). The building sits on a continuous foundation supporting an indiscernible structural system sheathed in brick laid in a six-to-one common bond (Figure 3-267). Each elevation features a series of arched recesses that emphasize each bay. The central bay of the southeast elevation contains a circular metal cap between each story that may be former fire alarm bells. The warehouse is covered by an asphalt-clad flat roof lined with a low brick parapet with metal coping on all elevations. A corbelled brick cornice is situated beneath the parapet. Chimneys or flues were not observed during the survey.

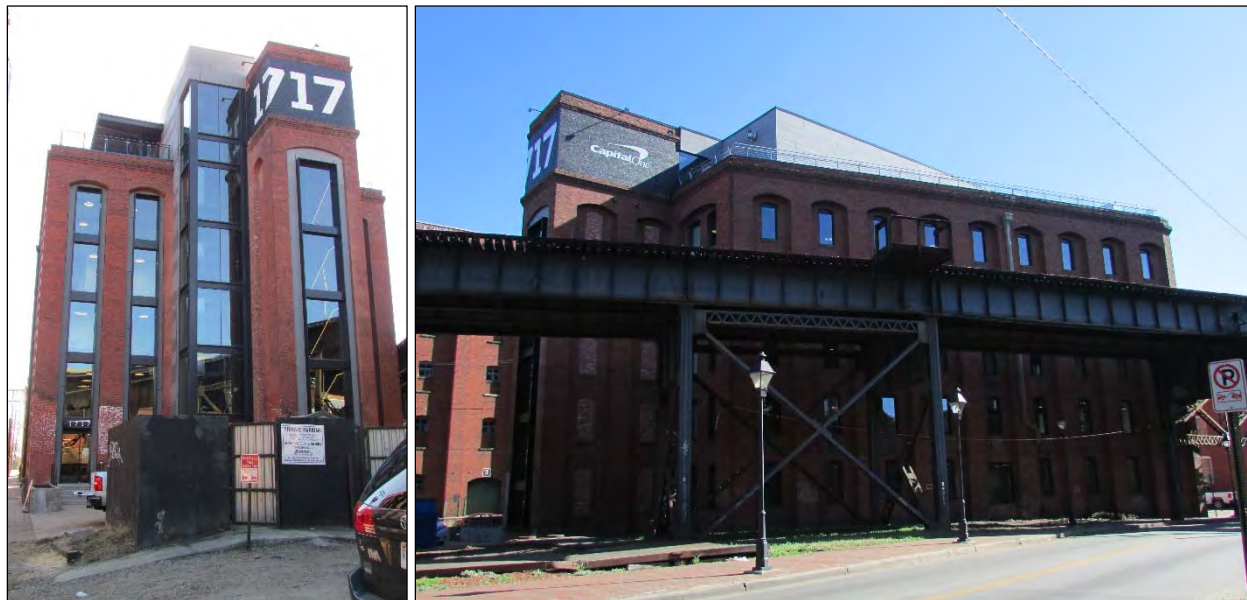
FIGURE 3-268: SOUTHWEST ELEVATION (LEFT) AND NORTHWEST ELEVATION (RIGHT) OF THE PHILIP MORRIS STORAGE WAREHOUSE

The current primary entrance is located in the north half of the northwest elevation. It is filled with a single-leaf, glass door with a single, commercial-style sidelight. A flat, metal awning set above the door features a metal “1717” sign (Figure 3-268). A secondary entrance, filled with a single-leaf, metal door with an arched, metal-frame transom set above, is off-centered in the southeast elevation. Set within larger window openings, the building contains replacement single-light, metal-frame, fixed windows. The window openings feature segmental arches and stone sills.

A six-story, flat-roof projection is centered on the northwest elevation providing roof access and is clad in the same materials and in the style as the core of the building (Figure 3-268). Fenestration in this area of the building has been recently replaced by large, commercial-style, metal-frame windows that are horizontally divided by thick metal strips.

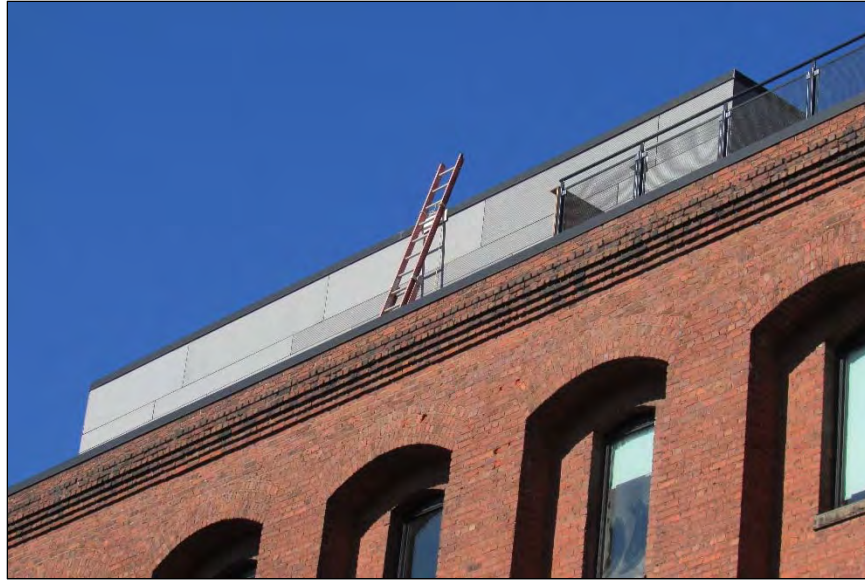
FIGURE 3-269: DETAIL VIEW OF ROOFTOP ADDITION, LOOKING WEST

A circa-2017, one-story, roof-top addition is situated in the western three-quarters of the building while the eastern quarter is lined with a metal-and-glass rail for a roof-top balcony (Figure 3-269). The addition is clad in an indeterminate tile and covered by a flat roof with metal coping. This addition projects along the north side of the brick projection on the northwest elevation and features large, commercial-style, metal-frame windows that are horizontally divided by thick metal strips.

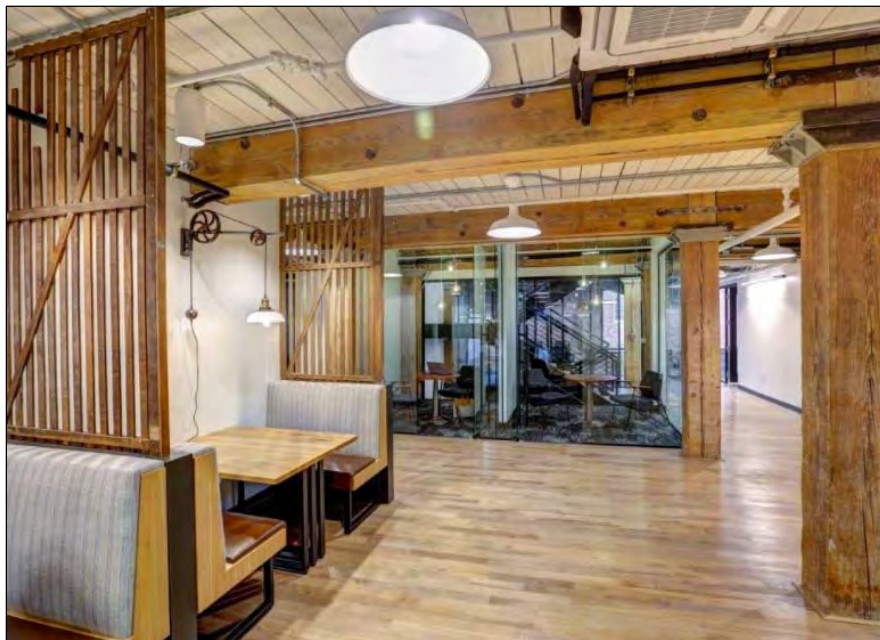
FIGURE 3-270: INTERIOR VIEW OF THE PHILIP MORRIS TOBACCO STORAGE WAREHOUSE (STARTUP VIRGINIA 2018)

Interior access was not obtained during the time of the current survey. However, recent images of the interior have been made electronically available through the Startup Virginia website (Startup Virginia 2018). They show a combination of exposed brick and drywall walls, a mix of poured-concrete and wood flooring, and exposed wood posts and beams (Figure 3-270) (Startup Virginia 2018). Work spaces appear to be divided by glass walls.
